Nepal Engineers' Association

**A REPORT
ON STUDY OF
SUNKOSHI LANDSLIDE DAM
IN JURE, SINDHUPALCHOWK**

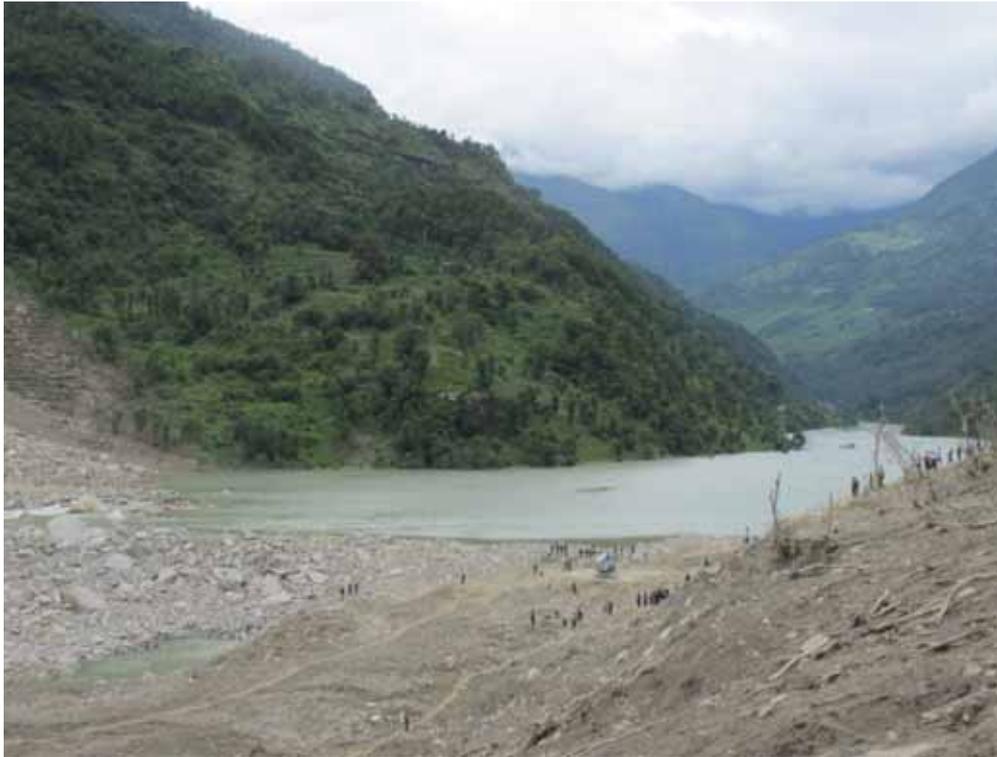
Figure 8.1: Dam Created by Landslide

The dam created by the landslide that occurred on August 2, 2014 is shown in Figure 8.1. The length of the dam was estimated to be of 300m. Based on the contour map of the area, the river bed level at the dam site is about 793 masl. The water surface elevation was estimated to be 840 masl. The Eco-sound measurement of the deepest point in the river also gave 46.7 m of depth. These data show that the maximum water depth at the reservoir is of 47m. The freeboard at the left bank is about 5m. It gives the total height of the dam is of about 52m.

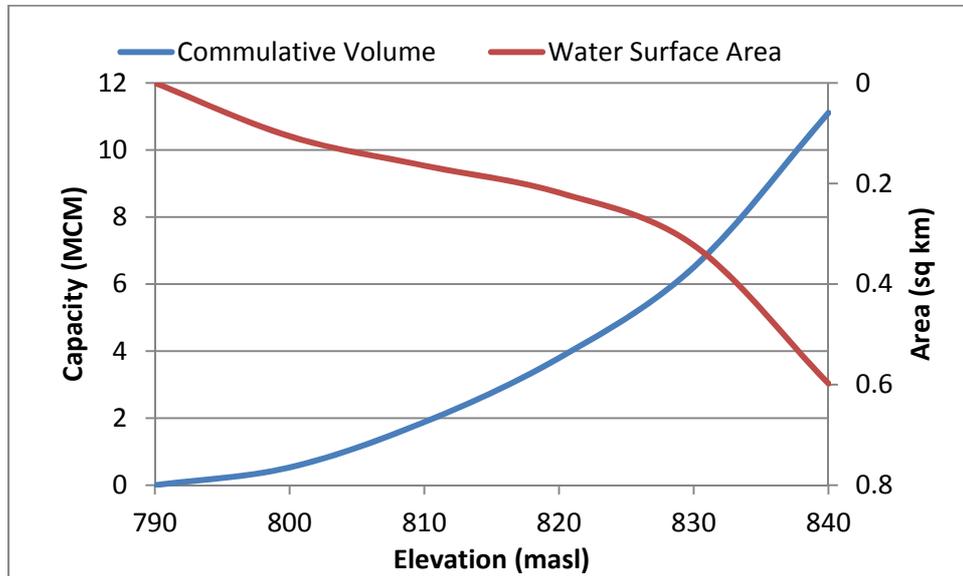
Figure 11.1: Elevation-Area-Capacity Curves of the Reservoir

Elevation-Area-Capacity Curves were drawn using the contour data of the area u/s of the dam as shown in **Figure 11.1**. It shows that the stored volume in the dam at elevation 840 m came to 11.1 million cubic meter (MCM). The measured flow during the dam formation

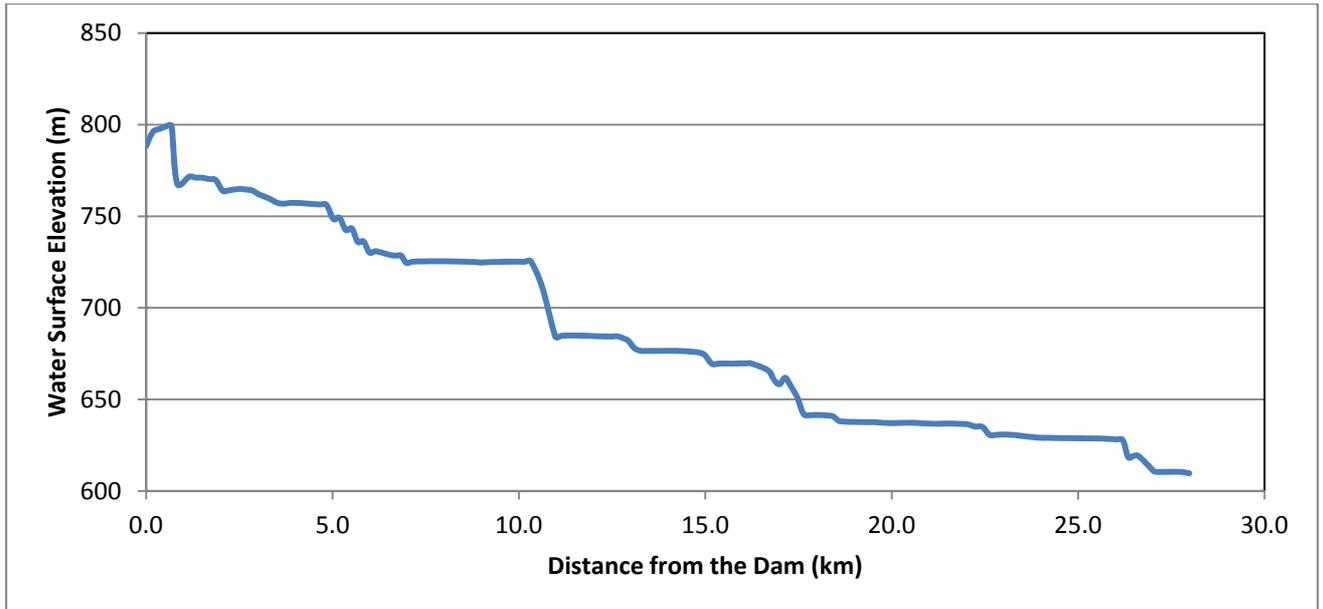
Figure 11.8: The water surface profile of the worst scenario

The water surface profile of the worst scenario is given in **Figure 11.8**.

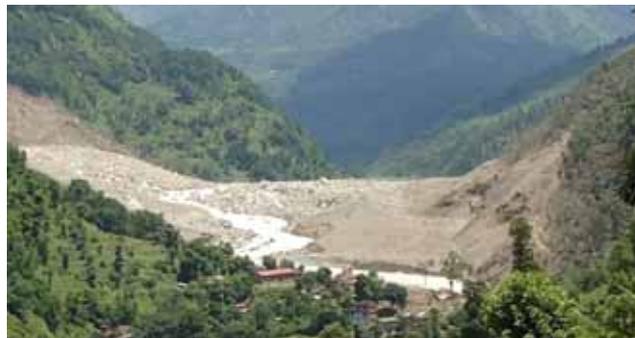
Figure 11.9 Downstream view of the dam

The nature of the material, mild slope of the dam and channel developed at the right side shows that there is less chance of breaching of the dam. However, if the intense rainfall of the magnitude that had occurred in the past takes place, the dam will get filled and overtopping may happen. For example if the recorded highest rainfall (166 mm in 24 hrs) occurs in the catchment, the dam will be filled in 2 hours in which case there is likelihood of the failure of the dam. But the judgement can be made only after:

The view of debris dam as seen from downstream is shown in figure 11.9. Close examination of the dam, its location, debris material, material size, dam dimension indicate that the dam is relatively strong and will not give-up until there is extreme runoff in the river, massive landslide or earthquake.
