Sediment Induced Disasters in the World and 1999-Debris Flow Disasters in Venezuela

Takahisa Mizuyama* and Shinji Egashira**

3. Debris Flow Disasters in Venezuela, 1999

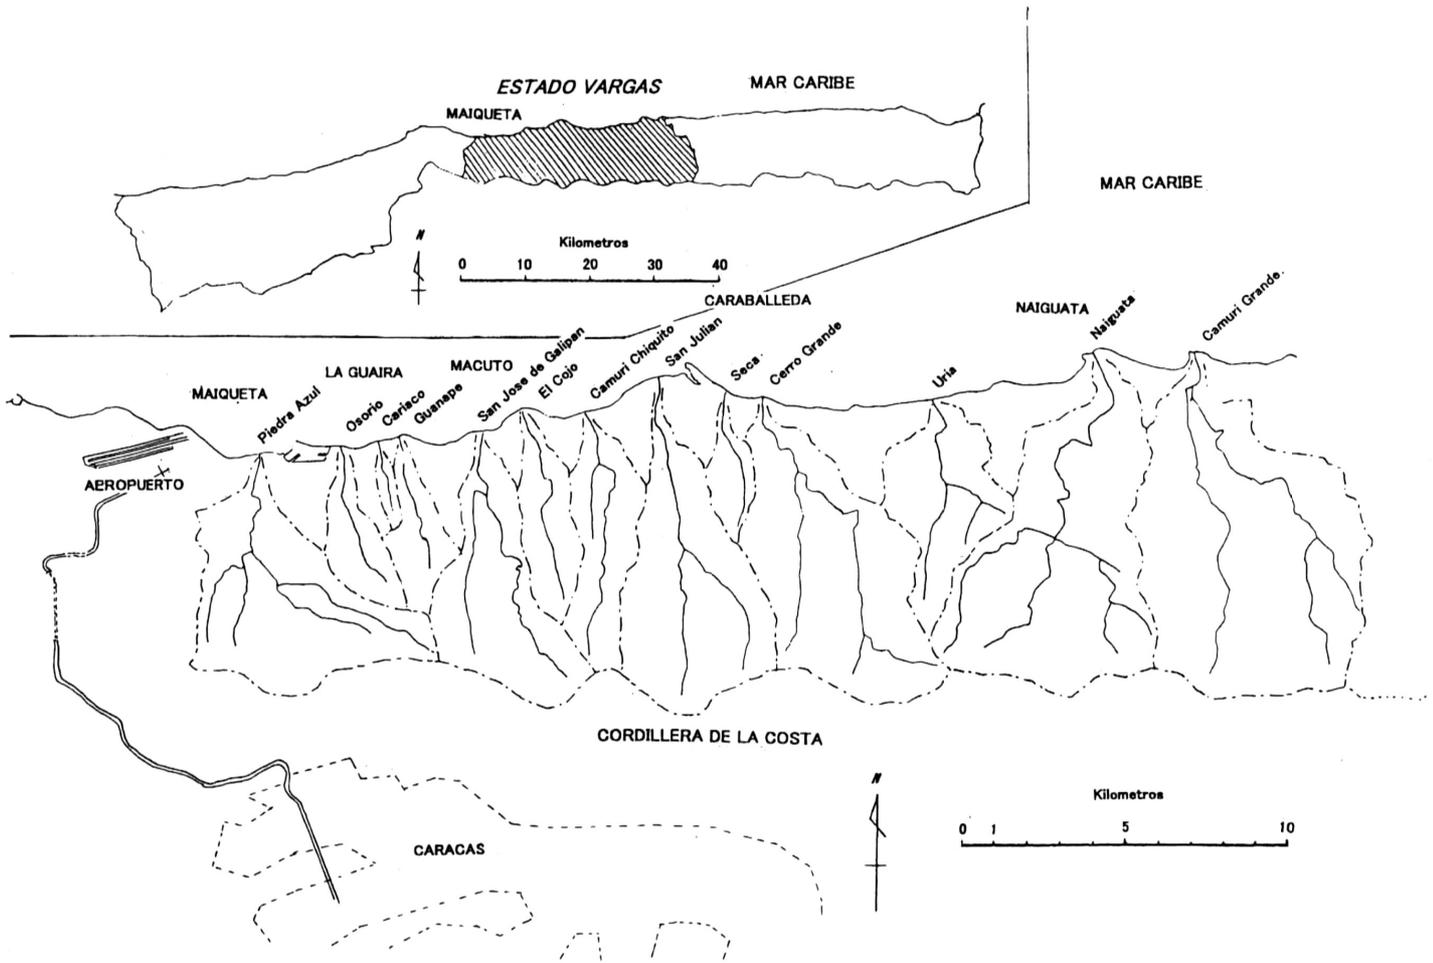
The heavy rain caused a number of debris flows and shallow landslides. The most heavily damaged areas observed were in the coastal area in state of Vargas and along the bypass highway running between Caracas and Maiquetia International Airport (**Fig. 1**). This is in accordance with rainfall distributions.

Of the debris flows evolving in the central portion of state of Vargas, the extensive deposits were observed downstream of the 13 mountain rivers (**Fig. 1**). **Fig. 2** shows an amount of deposited sediment in each mountain river. The basins are very large, 41.5 km² at the largest around the Camuri Grande River and 1.3 km² at the smallest around the Carioca River. These compare with up to around 1 km² and 0.1 km² or less in many cases in Japan.

Fig. 1. 13 Mountain rivers which massively carried sediment.

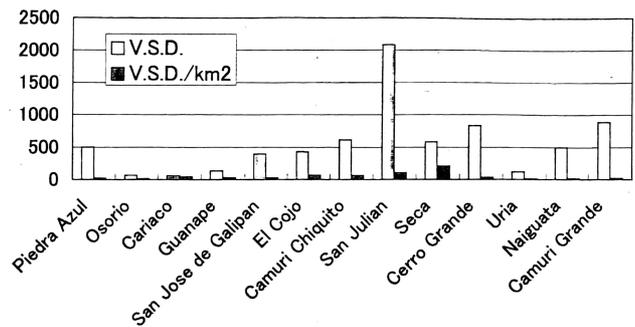
Fig. 2. Amounts of deposited sediment. (V.S.D.: Amount of sediment deposited (1000 m³), V.S.D./km²: Specific amount of deposited sediment (1000 m³/km²))

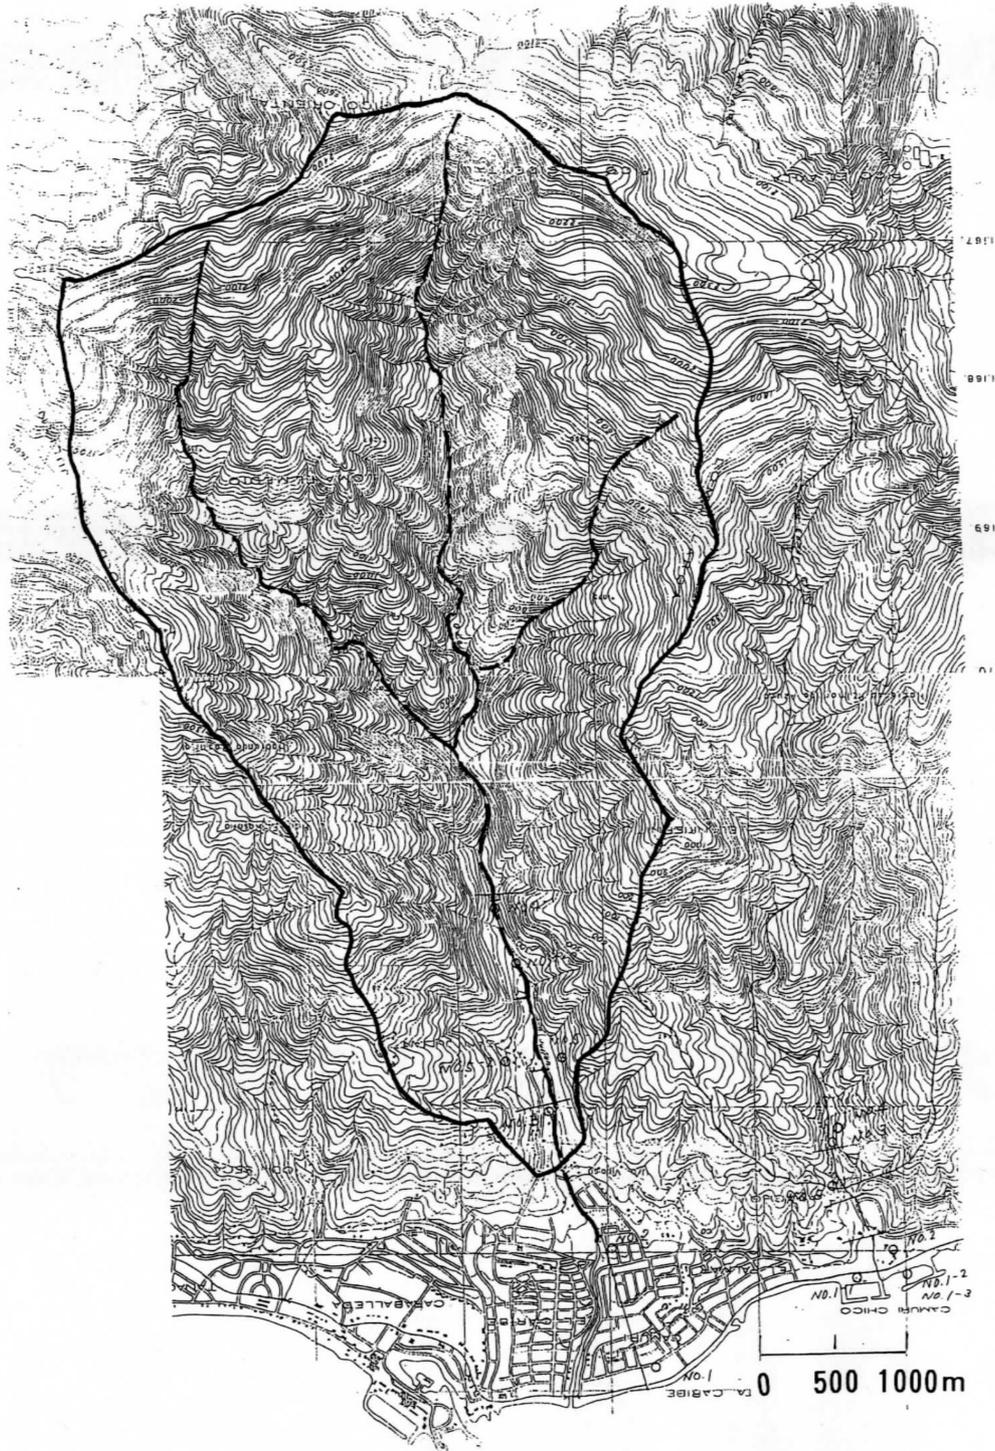
In the basins of the 13 mountain rivers, a number of mountain slopes collapsed, producing large amounts of sediment. In the San Julian River (**Fig. 3**), for example, sediment deposited on the riverbed in the central part of the river can conceivably erode to produce a large amount of sediment. The slopes collapsed to show a number of planar slips and long, thin, valley-like collapses. The average collapse depth was relatively shallow, around 1.0 m. Many of the rivers carried large amounts of sediment, advancing the coastal lines towards the sea by 50 to 100 m.

Fig. 3. Topographic map of the San Julian River Basin.

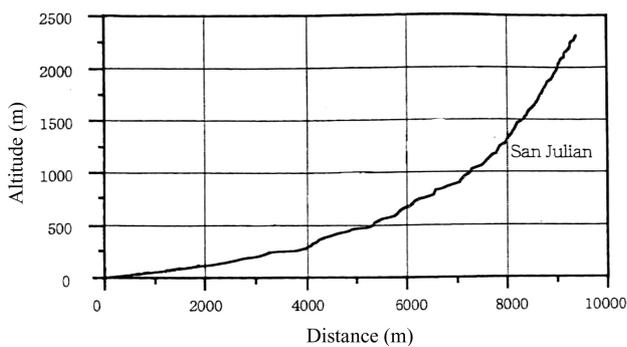
The river originates on Pico Oriental (altitude: 2,700 m) in the Costa Mountains and forms an inverted triangular basin 21.92 km² in area, 9 km in length, and about 4 km in width at the widest point (**Fig. 4**). The valleys are U-shaped and 100 m wide or more, because the slopes have mild inclinations (15 to 20°) at an altitude of 300 m or lower. At higher altitudes, the valley slopes running along the river are steep, having an inclination of 45° or more. These slopes have a specific height of 320 to 360 m. The valleys along the river are V-shaped.

The river runs at an essentially constant bed inclination of 7% (4°) over its 4,000 m length from the coast. The inclination then increases exponentially upstream. In the zone in which altitudes are from 300 to 700 m, the river has strong erosion effects, and the rocks are also geologically crushed by the faults, with the result that short, steep side streams are formed dendritically.

Fig. 4. Longitudinal sectional view of San Julian river.

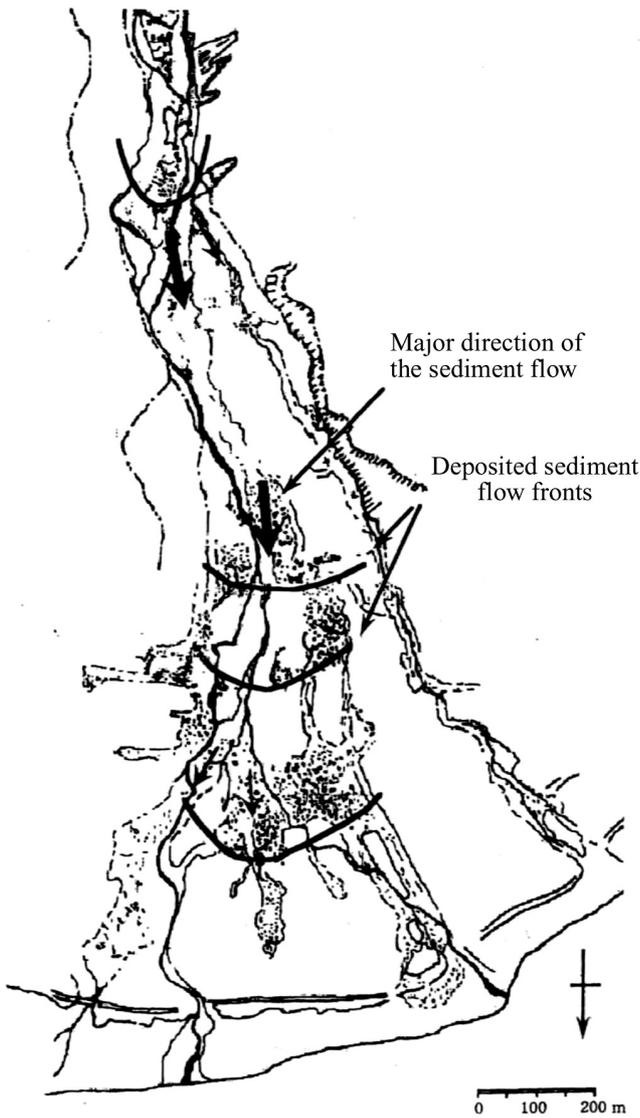
Deposition of the debris flow fronts were found at altitudes of 20, 40, 60 and 110 m, indicating that the flow hit the area in 4 waves (Fig. 5). The inclination was 3.3° (1/16.5) at these spots. The de-

bris flow fronts at altitudes of 110, 50, 40 and 20 m ran towards the left coast side in the alluvial fan, towards the alluvial fan center, towards the left coast side from the fan center, and in the direction of river flow, which may suggest that the spots at which the flows stopped moved from the downstream side due to the sediment deposits.

Fig. 5. Deposited sediment flow fronts.
