**Nepal Government
Ministry of Irrigation**

**Report on
Jure Landslide, Mankha VDC, Sindhupalchowk District**

The Report based on the Study committee formulated by
Ministry of Irrigation (Minister Level) on August 24, 2014 AD (2071/05/08 BS)

**September 21, 2014 AD
(2071/06/05 BS)**

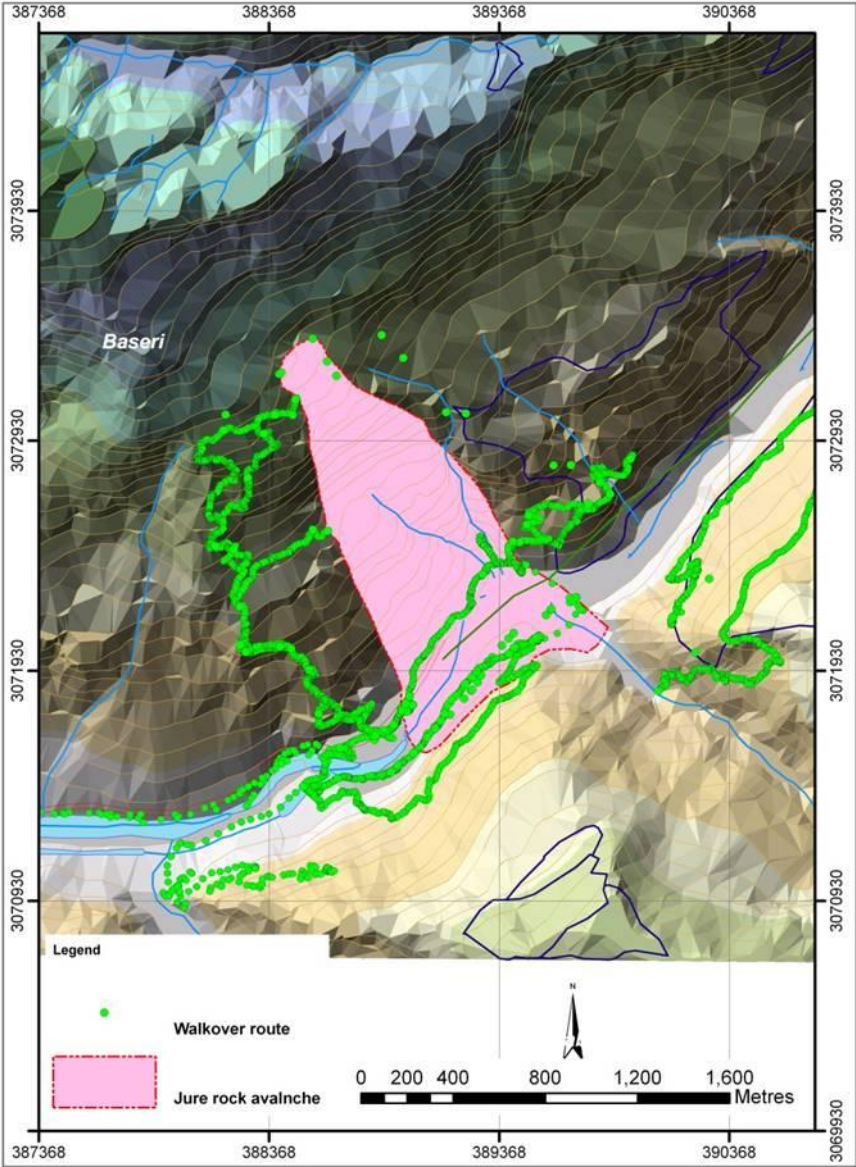
Sketch Map of Rock Avalanche at Jure

Figure 1: GIS map showing Tracks and Location of study points during the Jure Landslide study, Sindhupalchowk.

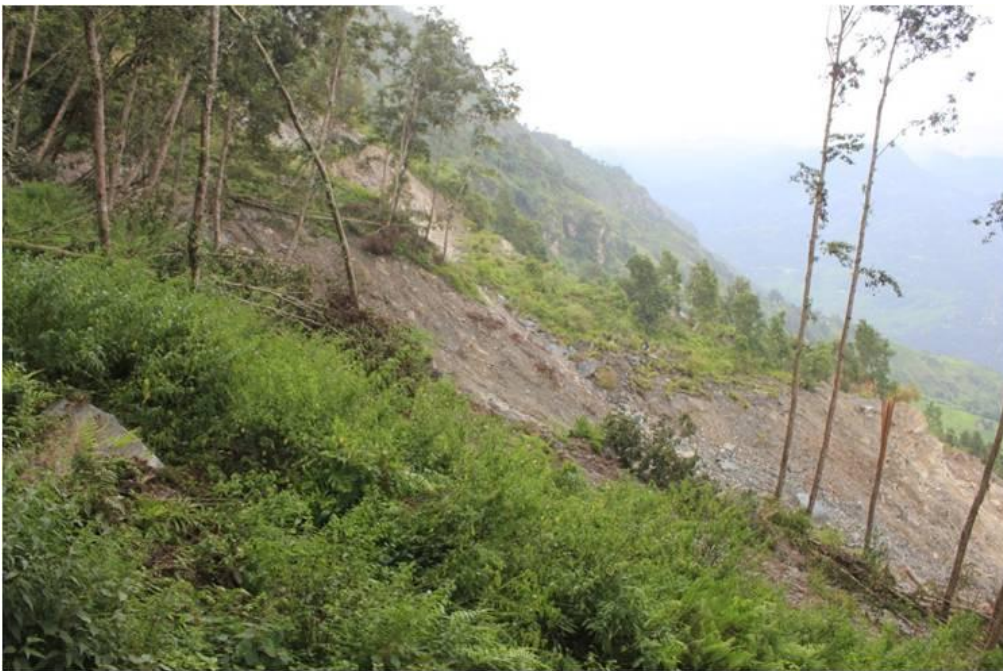
4.1 Crown Part: The altitude of the crown part of the landslide is about 1650m msl. The land surface in the crown part is still in unstable condition. There are present of many cracks, spring water is coming out, different blocks are moving and toppling down from the cracks, trees are tilting down to different directions and about 300m width and about 15m depth body mass are in process to move or slip down slowly. (Figure 2,3,4,5 &6). It was noted that the surface water was flowing into the cracks developed in the crown area

Figure 2: Cracks and disturbed surface in the Crown part of the Jure Landslide

- a) The landslide and debris flow in the Head part of the Jure landslide is still active. So first of all the water available in the crown part should be managed by diverting to another safe side. The landslide and debris flow countermeasure work should be done.
- b) About 100m from the Landside boundary should be warned as Hazardous area. Any type of land uses as Residence, Irrigation and so on should be stopped at the moment.
- c) The unstable part in the Crown part of the landslide should be removed and water management should be done in this area.
- d) The weathered and unstable cliffs with cracks in the shoulder should be trimmed.

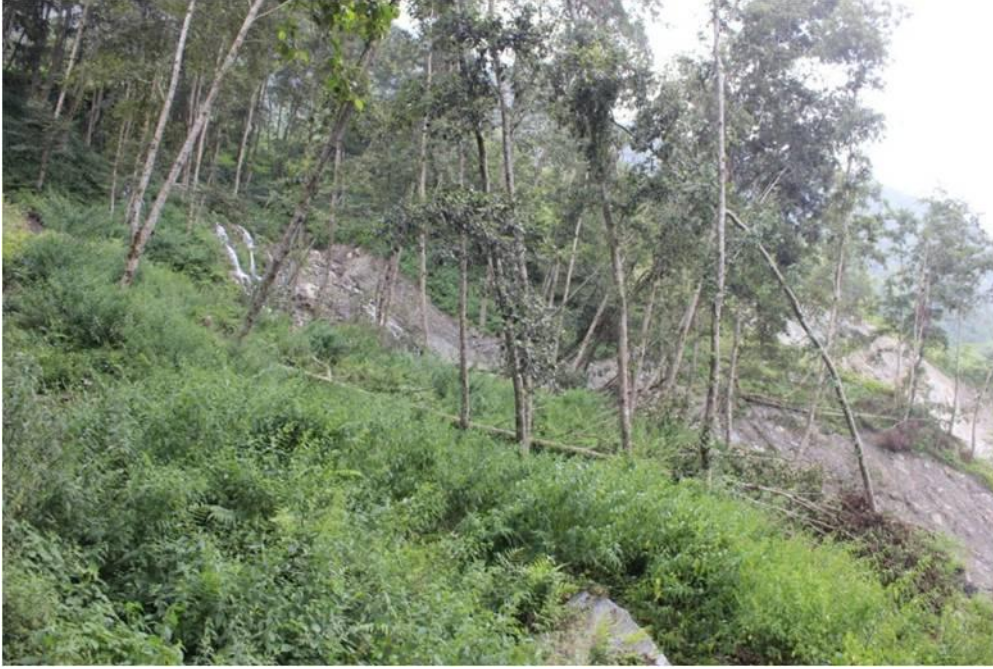
Figure 3: Disturbed and inclined trees in the crown part of the Landslide

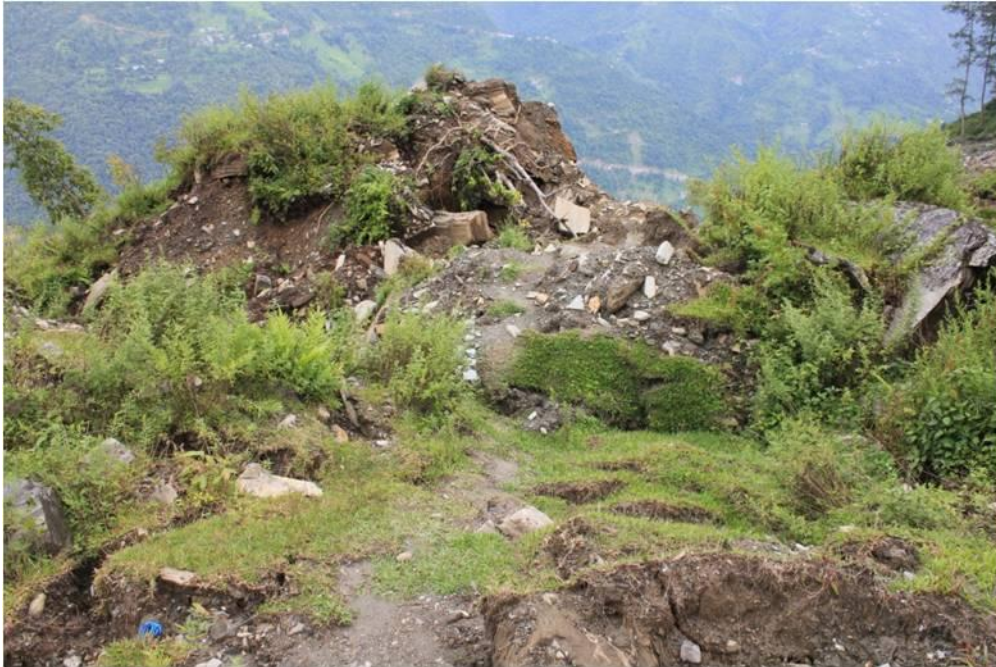
Figure4: Cracks and ready to move mass in the Crown part of the Landslide

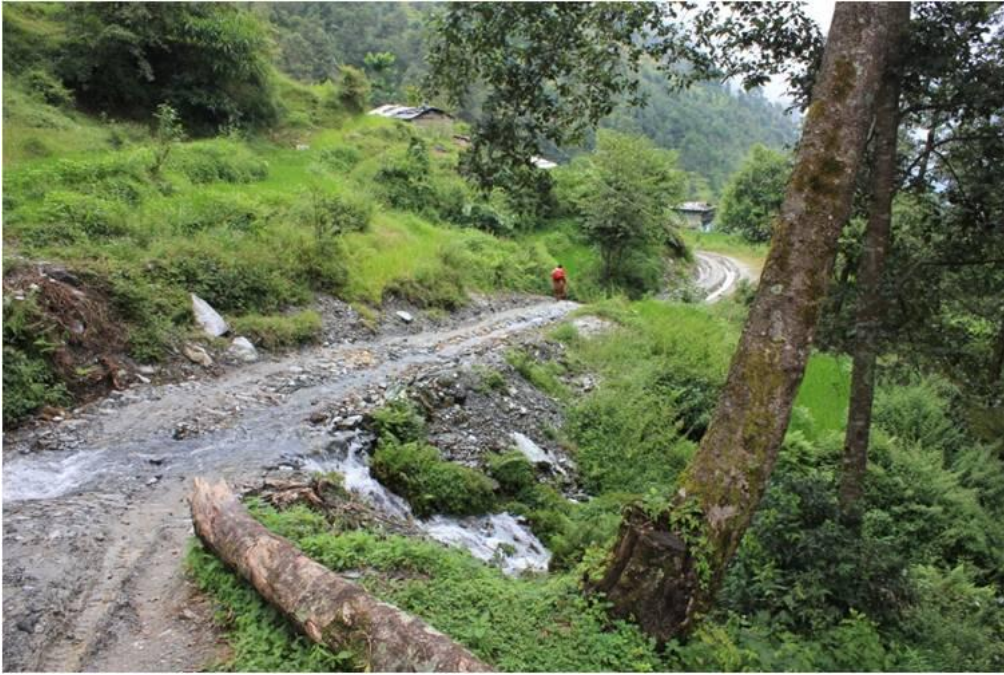
Figure 5: Subsided village road in the crown part of the Landslide

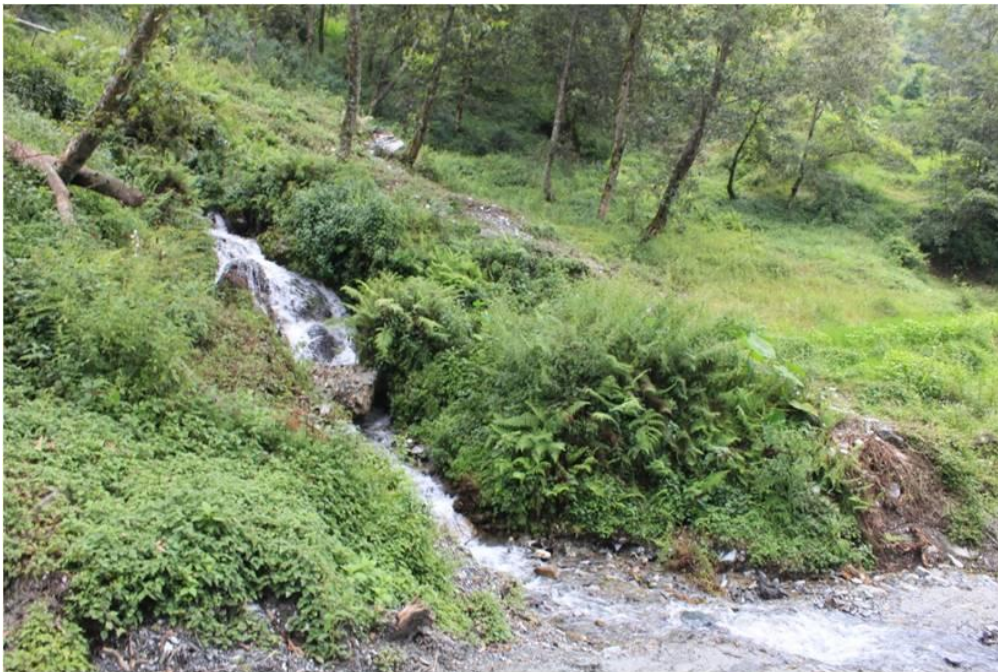
Figure 6: Streams flowing at the Crown part of the Landslide

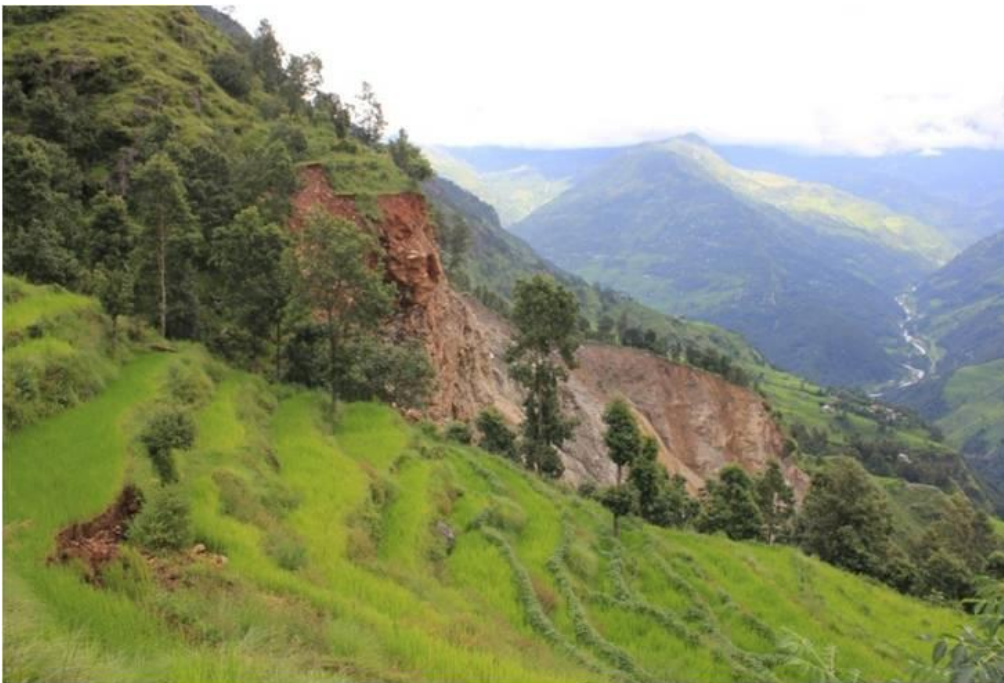
4.2 Crown part to near the Iteni village: There is still existence of large cracks, huge rock boulders and fragments, springs in many places in this area. Debris is flowing down. The slope of this area is much steep (fig 7 &8). Still it can be observed the falling of the rocks from the crown part. The weathered rock bridge (shoulder of the landslide in centre part) about 200m thick is made up of black pyllite and quartzite but in the site it is seen as grey and yellowish in color. These conditions of the rocks are due to the interaction of water and chemical weathering since long time back. It is most probable to rock fall, topple and debris flow in this area in near future due to existence of sufficient spring water and fractured rock debris.

Figure 7: Hanging block at the upper boundary part of the Landslide

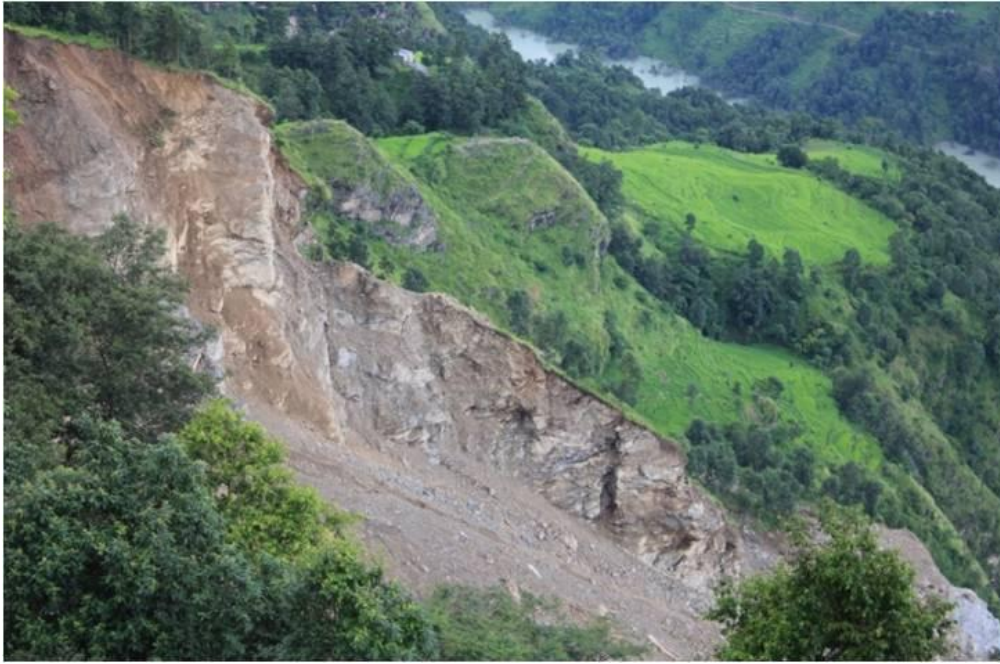
Figure 8: Big cracks near the border of Landslide

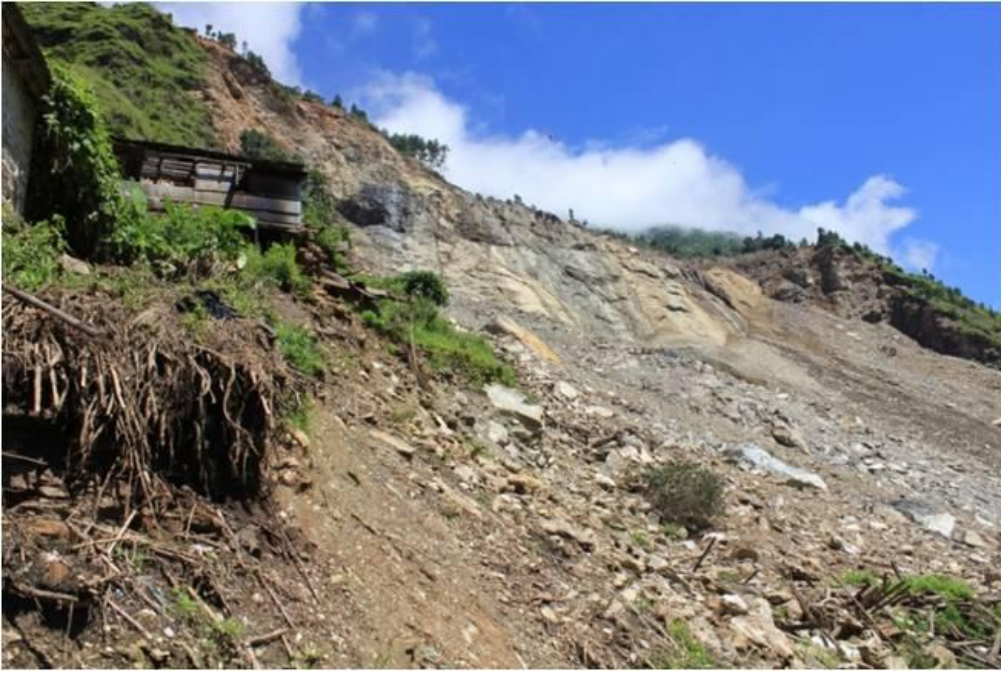
4.3 Nearby the Iteni village part: There is a comparatively hard rock bridge (shoulder) about 100m down from this area where debris fan is deposited about 20-25m span. There are some huge rock boulders/fragments of about 3m*3m*2m size which are in high hazardous condition that could be fell/roll down any time. In this place, the debris is still flowing down continuously. Here the part of the Iteny village is completely damaged (fig 9, 10, 11).

Figure 9: Landslide near the damaged village Iteni

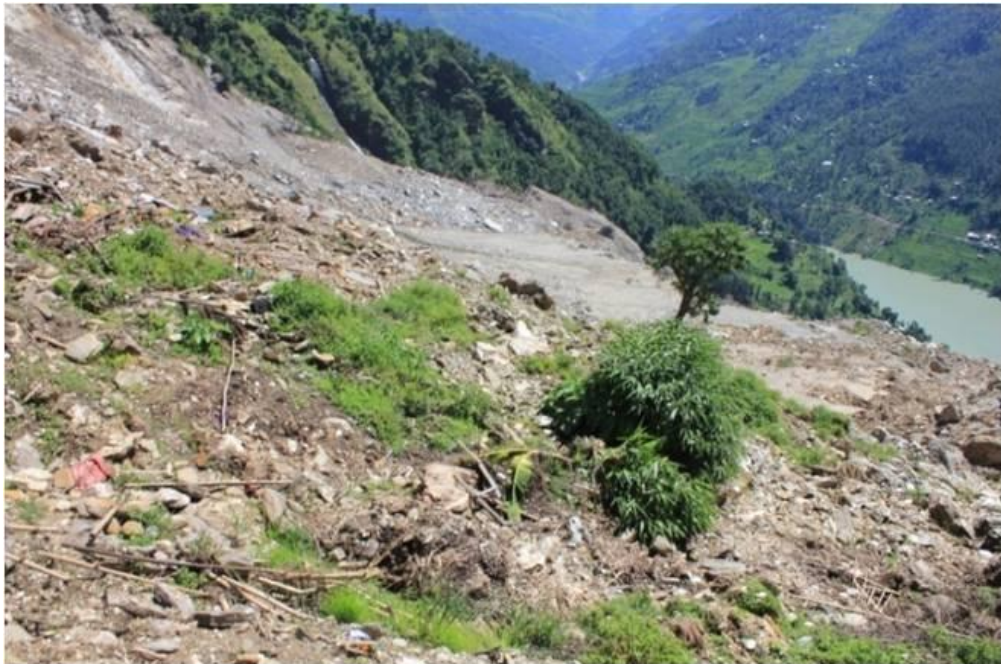
Figure 10: Landslide block moving down near the Iteni Village

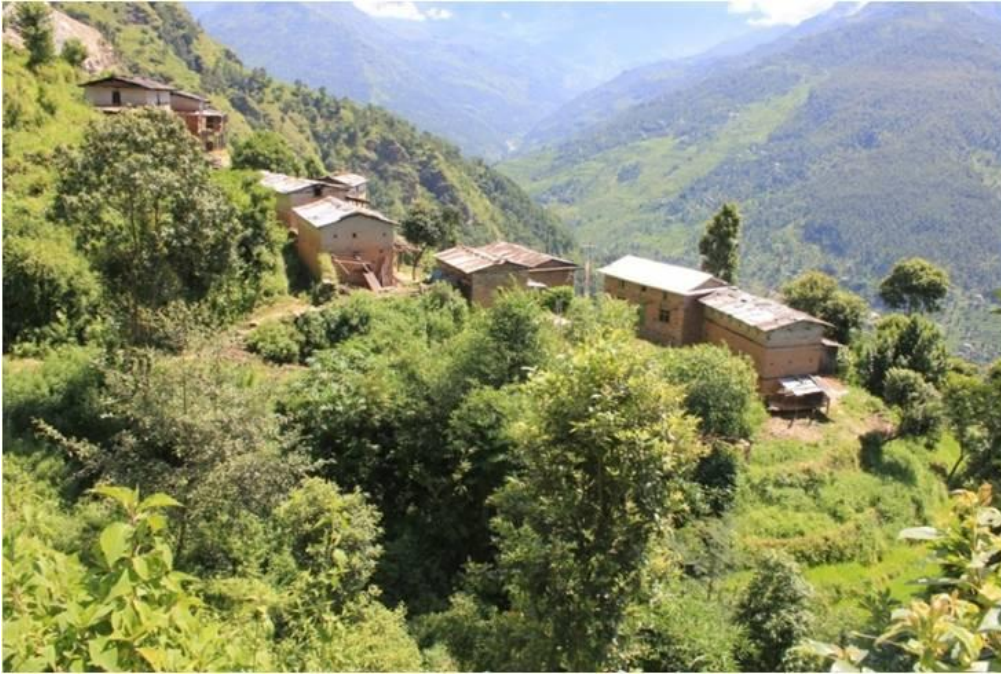
Figure 11: The vulnerable remaining part of the Iteni Village

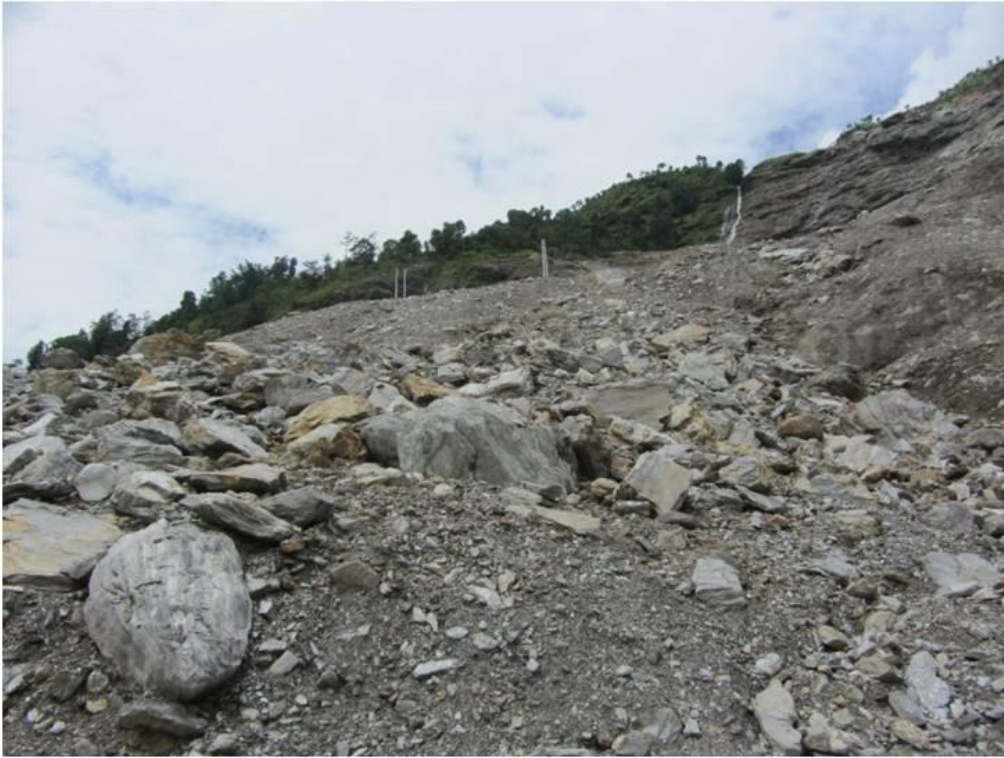
4.5 Toe or debris fan deposit area: This area is the toe part of the Jure landslide. The debris and rock fragments fallen from the upper part are deposited in this area as fan deposit. This area is about 800m width, about 300m high and about 25-50m depth. The temporary road track is excavating from Eastern side of this area. This area is much more vulnerable due the continuous falling of rock fragments and the debris flow. New slope failures, sinking of surfaces and sink hole formations are increasing due the bank cutting along downstream by the Sunkoshi river. The disaster event damaged the houses existed in this area and Jure bazaar completely and damaged two gates of Sunkoshi powerhouse barrage including about 1km long Araniko Highway. At present, some electric poles are installing by Nepal Electricity Authority in this area.

Figure 12: Debris deposited at the toe part of the Landslide

- e) The newly track road is aligned through the toe part of the landslide where the probability of rock falling and debris flow is high. So the protection wall in upper part of the road and scouring by Sunkoshi in the lower part of the road should be protected.
- f) Geophysical and Geotechnical study of the Jure Landslide is recommended. As per the study report the mitigation measures of the landslide should be done.

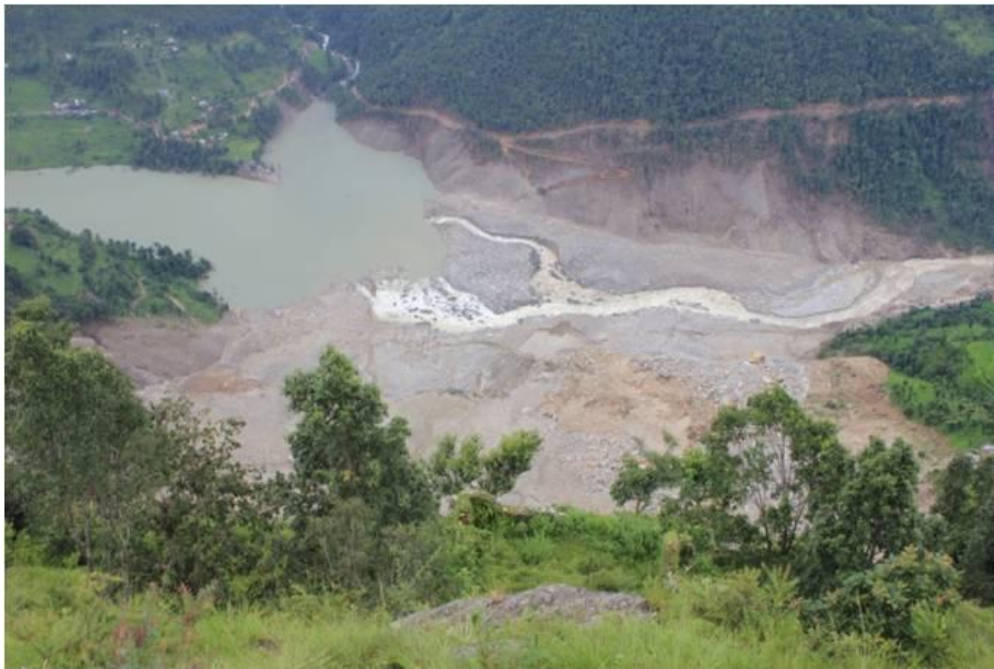
4.6 Landslide Natural Dam in Sunkoshi: The length of the dam across the river was measured about 350m, the width of the dam along the river was measured about 700m and the height of the dam was about 55m. The primary channel for outlet of the trapped river was opened on August 2, 2014 at about 2pm by Nepal Army with the help of experts from Department of Water Induced Disaster Prevention DWIDP. The opening method of the channel was mainly blasting but the rock type of this area is mainly schiest and phyllite, due to which it was felt difficult to progress the deepening of the channel. In this stage the experts and decision makers in the special committee formulated by Ministry of Home Affairs decided to open secondary channel. The experts located the secondary channel at middle part of the dam to open. Thus the secondary channel was opened on August 30, 2014 in the morning at central part of the dam by Nepal Army with blasting and excavation by two numbers excavators. In the same way, Nepal Army excavated the approach road to the dam site. The Nepal Army continued to widen the inlet of the secondary channel upto 52m wide on September 6, 2014. Rainfall in the watershed was occurred in the night of September 6. Due to more widening of the inlet of the secondary channel and occurrence of rainfall in the watershed, the dam was pressurized by water and hit and scour in the weak part of the dam. In the result the dam was breached on

Figure 13: Opening of Secondary Channel in the Landslide Dam

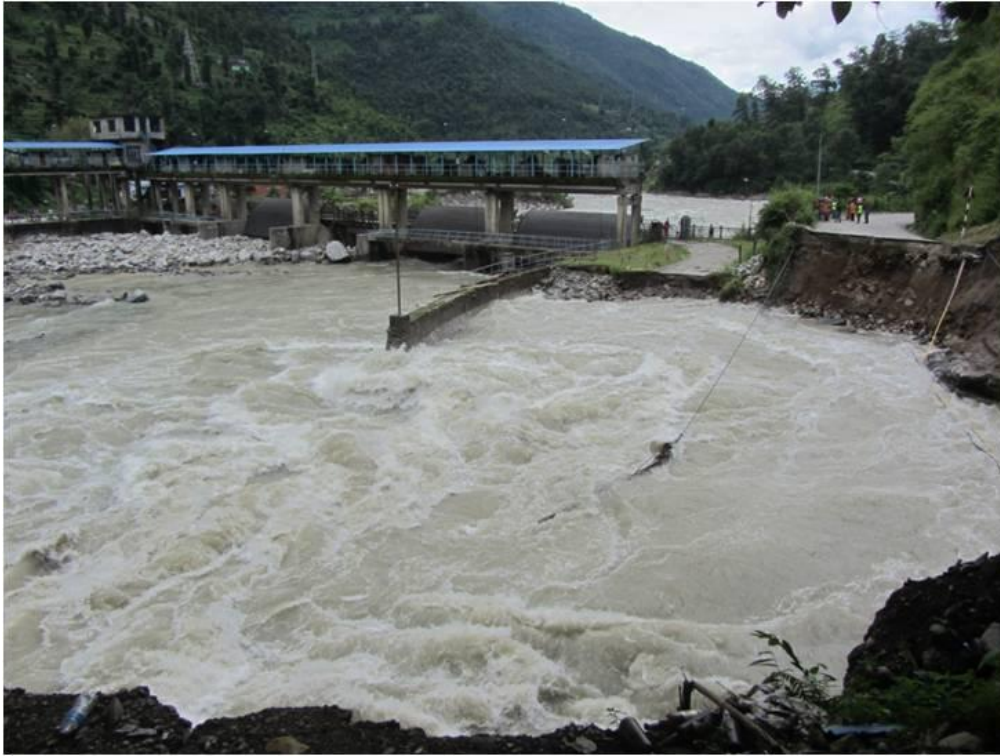
September 7, 2014 at 1am and continued up 4Am (Fig. 13 and 14). Since the breaching occurred slowly and it took about 4hrs, the damages by the breach were nominal and no casualties. The Department of Hydrology and Metrology recorded the discharge during the breaching of the dam at Pachuwaghat real time gauze station which was located at downstream from Khadichaur Bridge. As per the record, the normal flow was 300 cu.m/sec and the maximum discharge was 1350 cu.m/sec and the historic capacity of channel was 1700-1800 cu.m/sec. So the maximum flow was within the capacity. After the breaching of the dam, the water level in the reservoir was decreased by 20m. The study Report of Hazard Mitigation in the Northern Sunkoshi and Bhote Koshi Water Catchment Areas, Nepal (HMWA), 1996 reported that under the Natural dam, the River terrace of sand, clay and gravel boulders were existed.

Figure 14: Damaged Sunkosi Hydropower Headwork and Araniko Highway after breach of the Landslide Dam

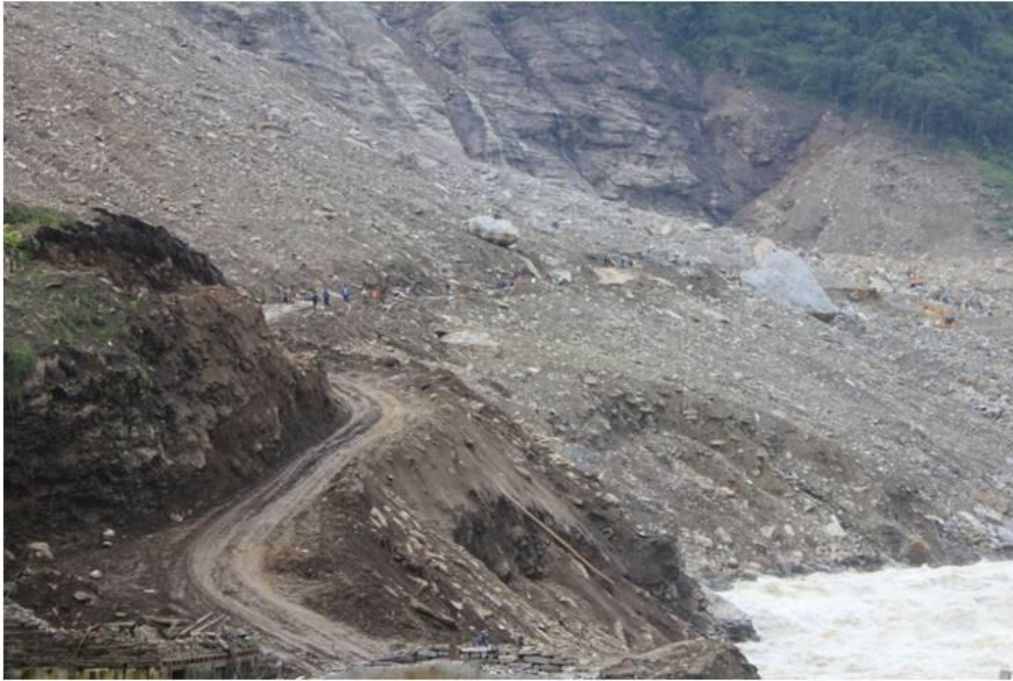
Photo 1: Temporary Araniko Highway track at toe of the Landslide

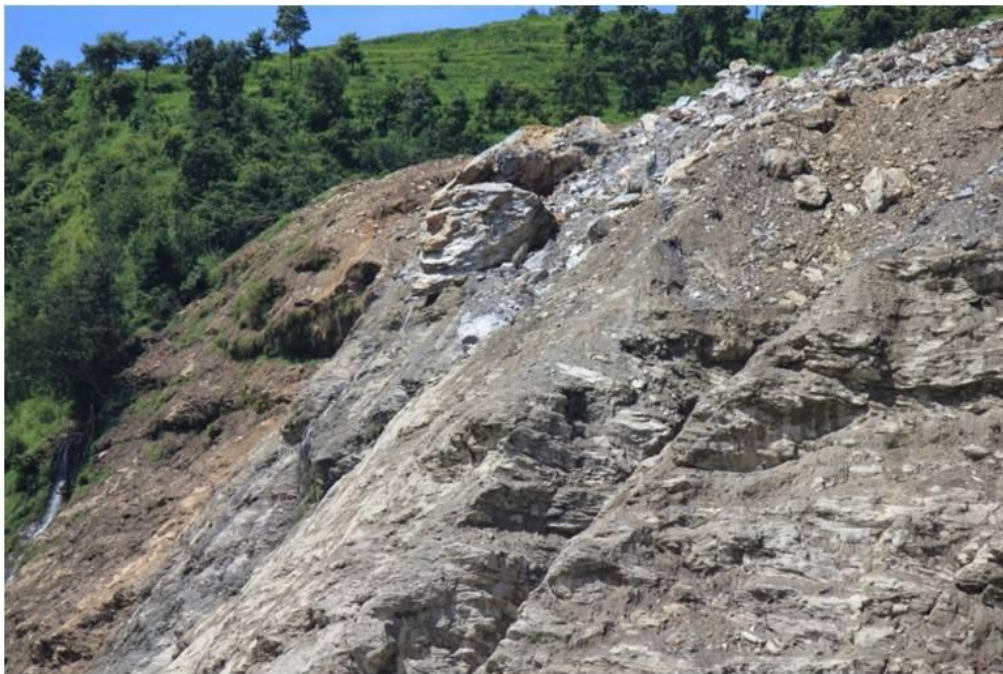
Photo 2: Big rock boulders fallen from the Landslide

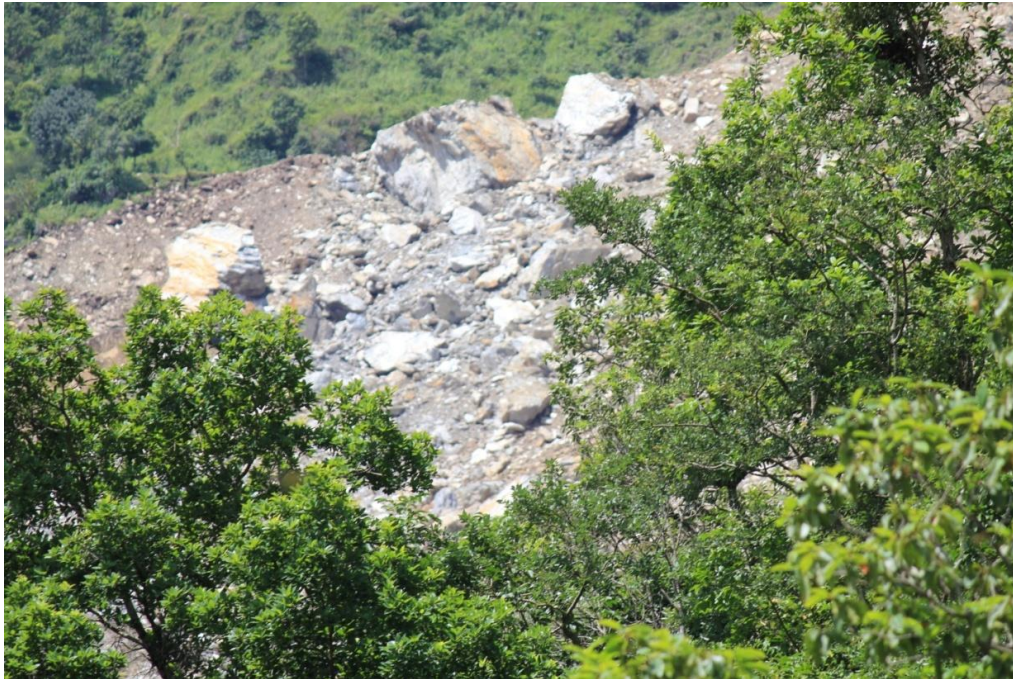
Photo 3: Rock fragments fallen from the Landslide

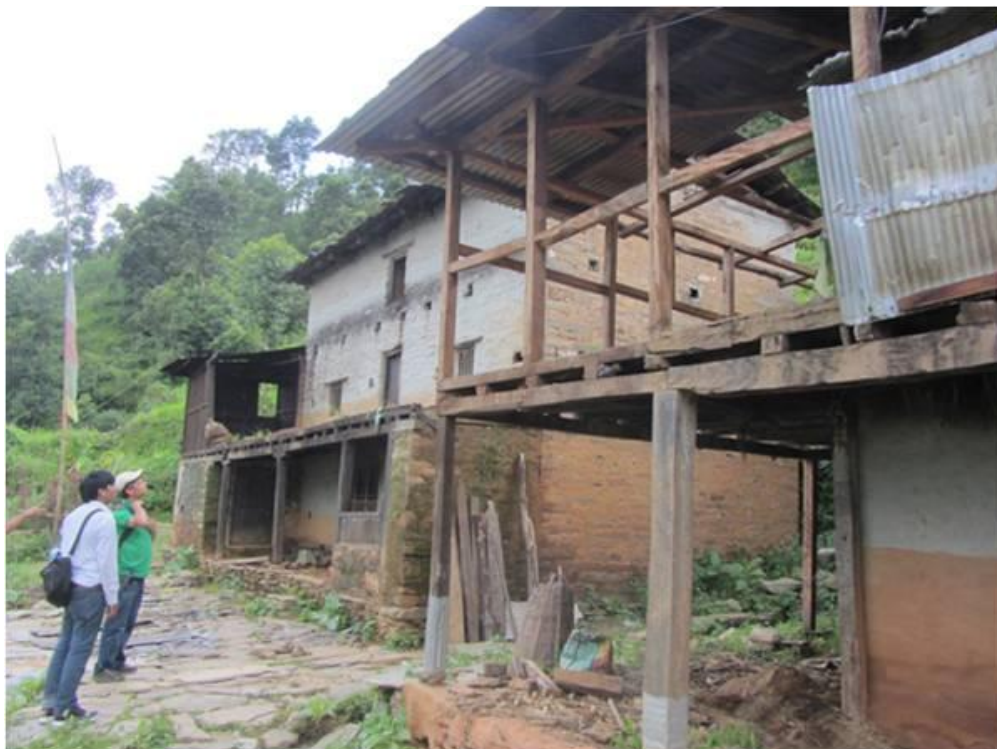
Photo 4: Damaged houses due to the Landslide

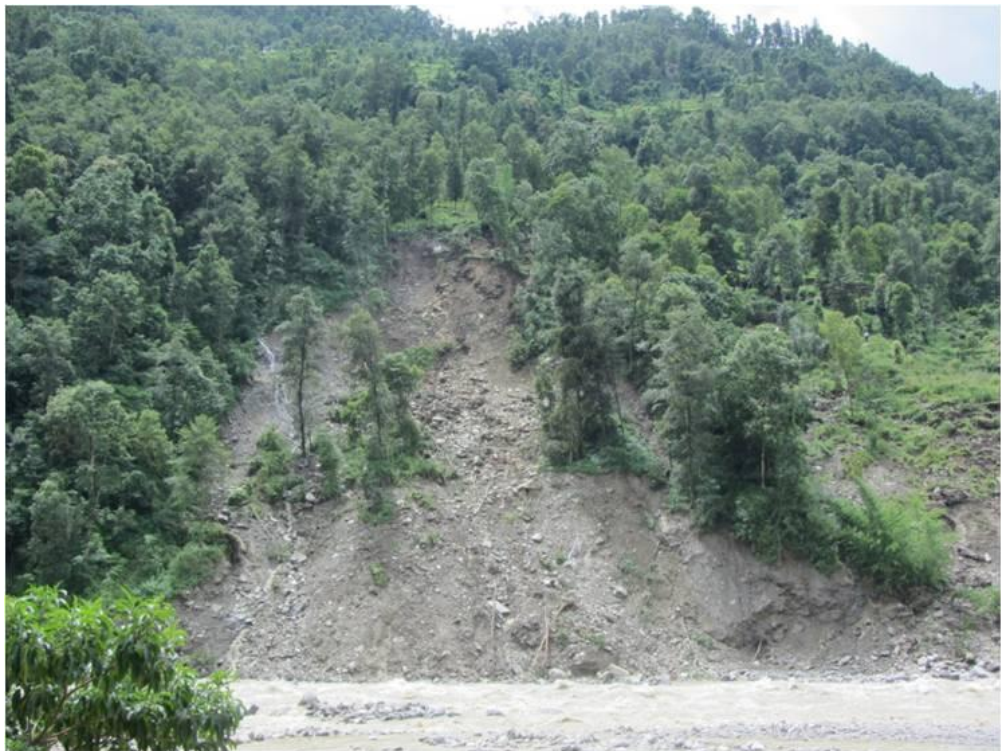
Photo 6: Landslide occurred at left bank of Sunkoshi after breach of Dam
