Assessment of Existing and Potential Landslide Hazards Resulting from the April 25, 2015 Gorkha, Nepal Earthquake Sequence

Open-File Report 2015-1142

By Brian D. Collins and Randall W. Jibson

U.S. Department of the Interior
U.S. Geological Survey

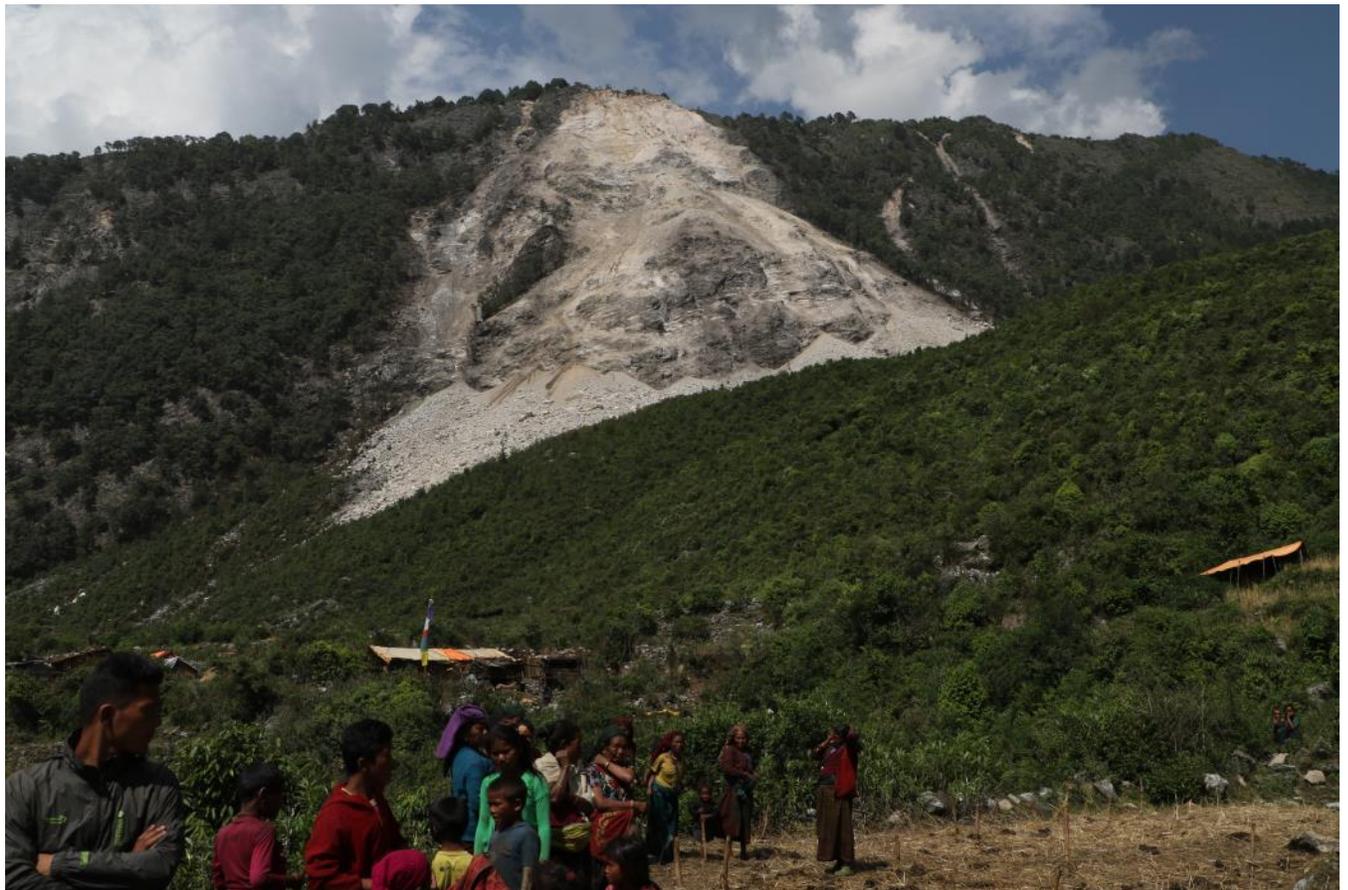
Cover: Villagers in Kerauja below a 500-m-long, 210-m-wide rock slide that resulted in one fatality.

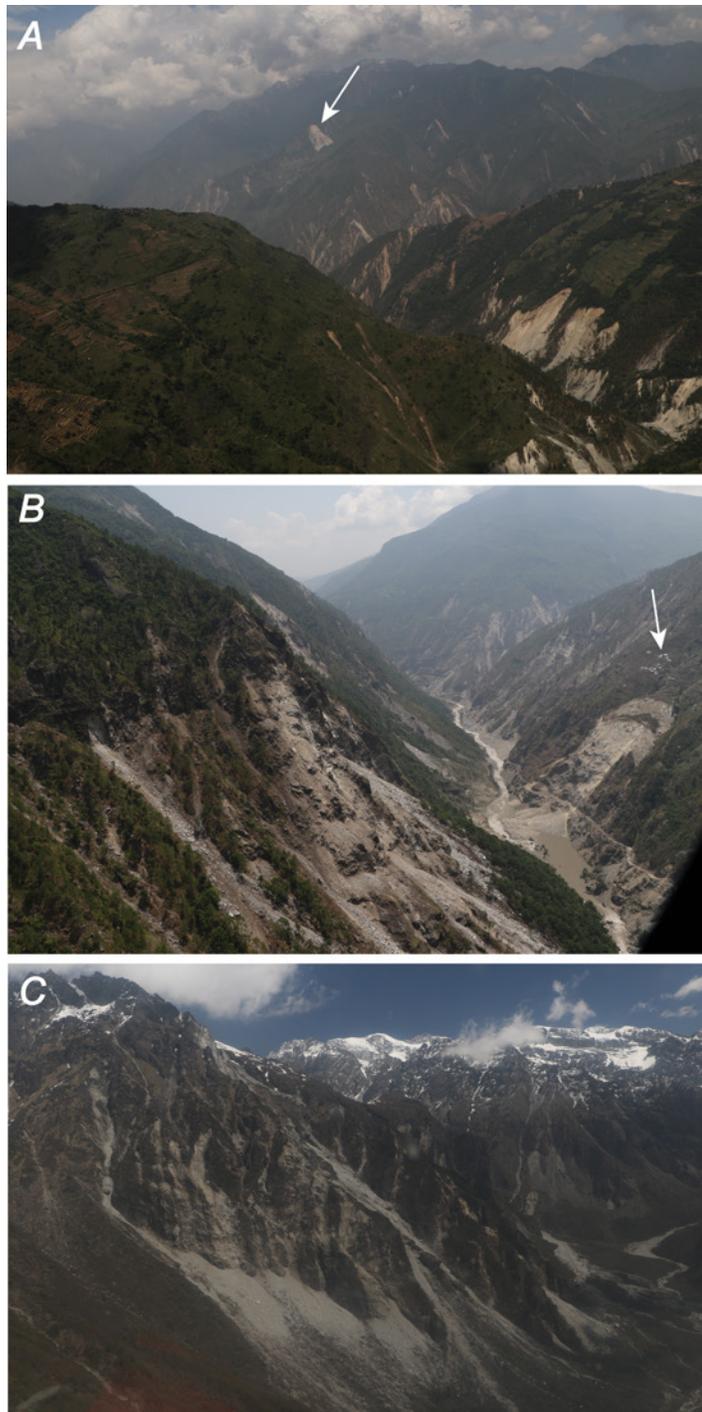
Figure 1. Images showing landslides triggered by the April and May 2015 Gorkha earthquake sequence in central Nepal. *A*, Widespread ridgetop landsliding in Gorkha district. The Kerauja rock slide (see cover image of this report) is wide scar on ridge visible in photograph background (arrow). *B*, Partially breached Gogane landslide dam in Rasuwa district. Top of scarp below village (arrow) is approximately 400 m above river level. *C*, Rock falls in the Urkin Kangari Valley, Sindhupalchok district. Image shows approximately 1,200 m relief between top of foreground cliffs and valley floor.

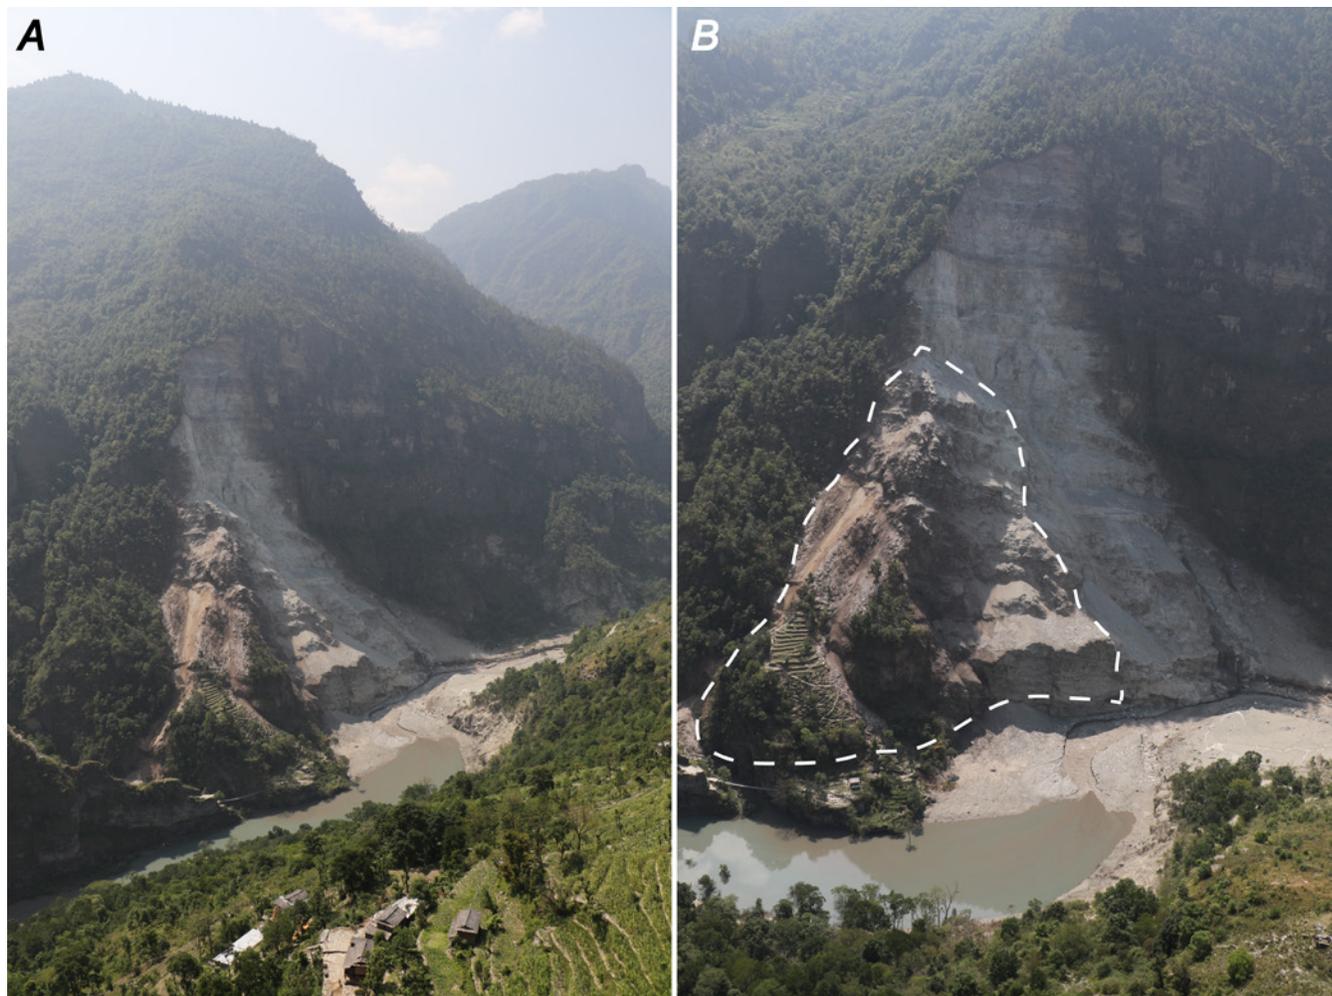
On May 24, 2015, twenty-nine days after the *M*7.8 main shock, a rock slide approximately 350-m-long, 200-m-wide, and 4-m-deep mobilized from a cliff, blocked the Kali Gandaki River in Myagdi district, and buried the village of Baisari (fig. 8) under about 30 m of debris (fig. 12). According to interviews we conducted with Nepal Army personnel on May 29, 2015, cracks had formed in the cliff following the April 2015 *M*7.8 earthquake. The existing cracks widened during the *M*7.3 earthquake on May 12, 2015, and rocks began falling from the cliff 10 days later on May 22. As a result, the Nepal Army evacuated Baisari, and the cliff failed two days later at about 1:00 a.m. on May 24. The landslide destroyed 27 homes and buried the entire village under landslide debris. Damming of the river by the landslide caused upstream flooding and formation of a lake. Using a field-estimated landslide-dam height of 30 m, and using a coarse (Google-Earth-derived) DEM (with estimated horizontal resolution of 30 m) of the area to compute the length of upstream river that 30 m of inundation height would have created, we estimate the maximum inundation length to have been approximately 2.7 km. We estimate the lake width to have been approximately 100 m given the geometry of the upstream gorge. Assuming a simplified geometry for the landslide dam lake and using a maximum depth of the landslide lake of about 30 m indicates that the lake would have impounded ~8,000,000 m³ of water. The lake overtopped the dam 16 hours after it formed and sent a flood-wave down the Kali Gandaki River; water levels reportedly rose temporarily to 2 m above normal monsoon flood stage. Fortunately, communities downstream from the landslide dam had been evacuated, and no loss of life occurred. At the time of our investigation (May 29, 2015), landslide debris still partially blocked the river, and a lake approximately 1,200 m long and 25 m wide still blocked road access upstream (fig. 13).

This landslide probably was in an incipient state of instability prior to the earthquake. Earthquake shaking likely initiated additional movement along or across pre-existing fractures, and this deformation progressed gradually in the days following the earthquake until failure occurred. Few other landslides were triggered in this general area, which suggests that the site of this slide was rendered unstable by oversteepening of the slope by fluvial erosion. The cliff face immediately south of the landslide scar is quite steep (>70°), and although vegetated, it appears to be the site of former rock slides and rock falls. Despite this, interviews with elder villagers conducted on May 29, 2015 indicated that no prior significant landsliding was known to have occurred at this location during their lifetime, nor that of their parents (a period of perhaps 100 yr).

Overall, we judged this area to have high landslide hazard based on both continuing rock fall from the source area (approximately 100 m³ fell during our assessment on May 29, 2015; fig. 14) and also the presence of a large wedge of intact cliff just north of the recent scarp that is surrounded by landslide scars (fig. 12). This wedge, which is about the same volume as the recent rock slide, is bounded by a debris slide to the north and the rock slide scar on the south; these observations indicate that additional landsliding could occur in this area. If this wedge fails entirely, its volume would likely be sufficient to completely block the Kali Gandaki River again.

Figure 12. Photographs showing rock slide along the Kali Gandaki River on May 24, 2015 that buried the village of Baisari and blocked the flow of the river for 16 hours nearly one month following the main earthquake shock (A, B). Progressive failure of the nearly 350-m-tall rock mass through the weathered bedrock profile is thought to have led to its eventual collapse. B, Wedge area of future potential instability is outlined by white dashed line.

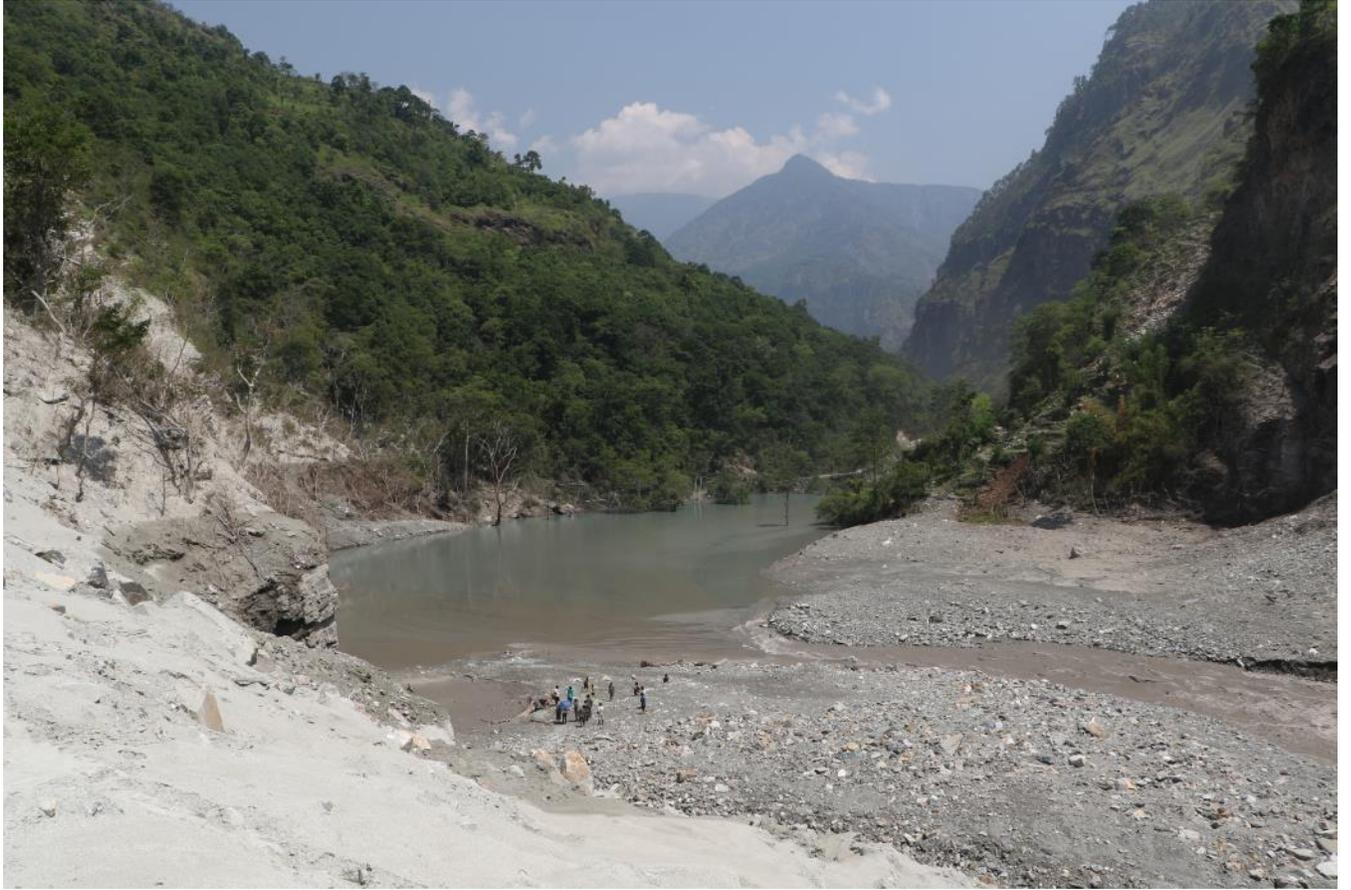
Figure 13. Photograph showing existing lake impoundment formed by May 24, 2015 rock slide at Baisari village. The lake blocks road access to all villages to the north.

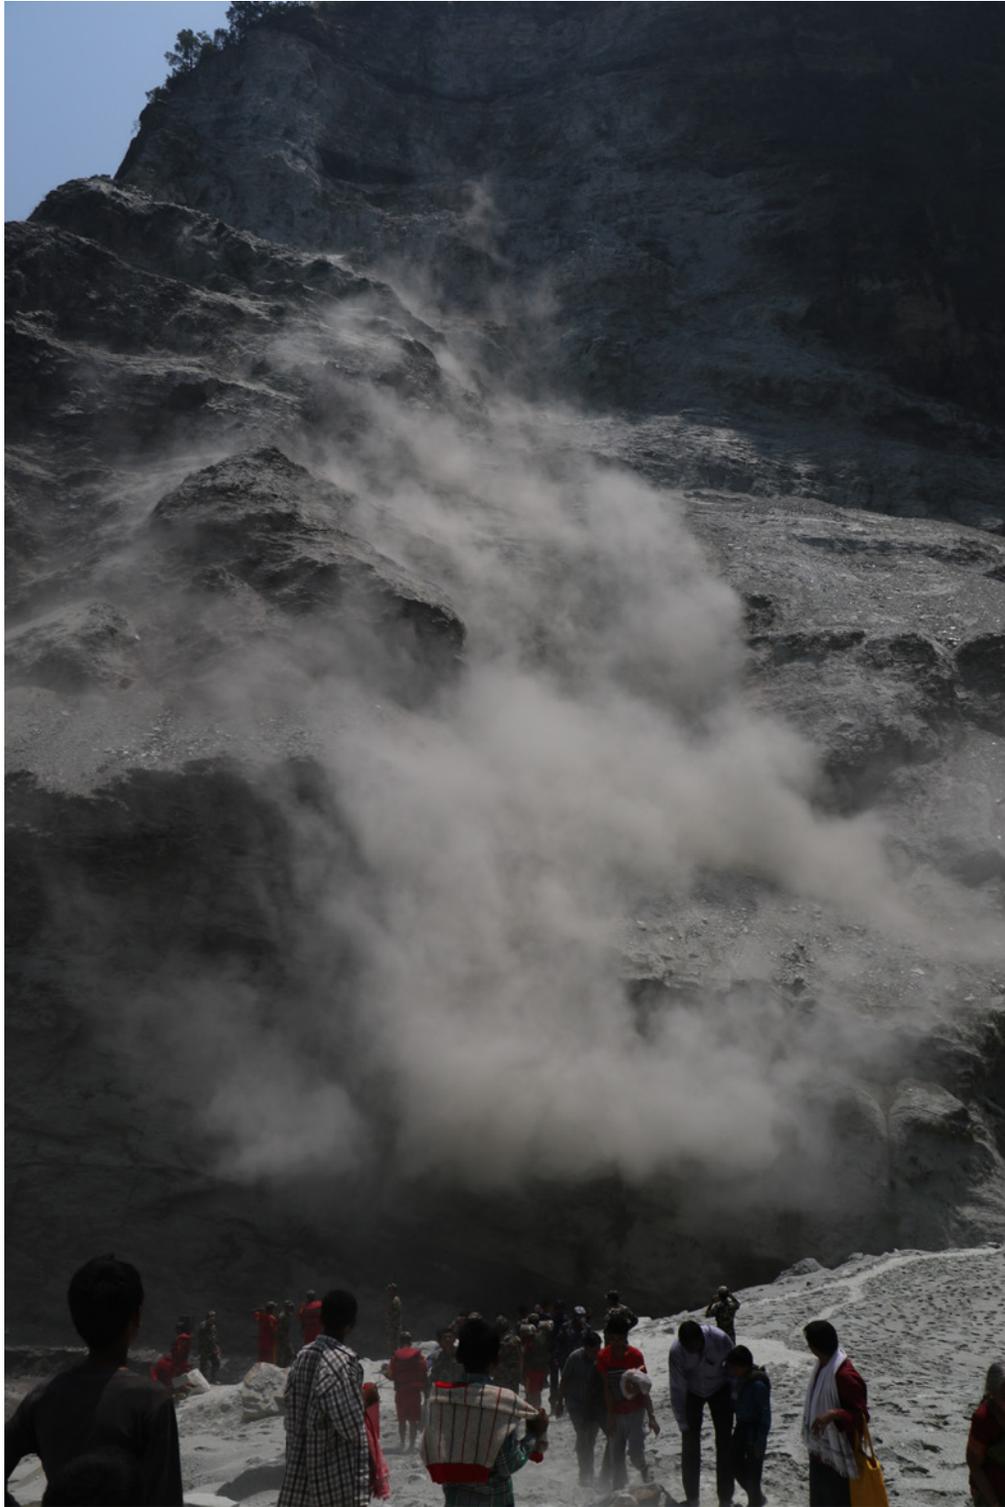
Figure 14. Photograph showing rock fall from landslide scarp (as expressed by dust cloud) five days after the failure, indicates continuing hazard in the Baisari area.

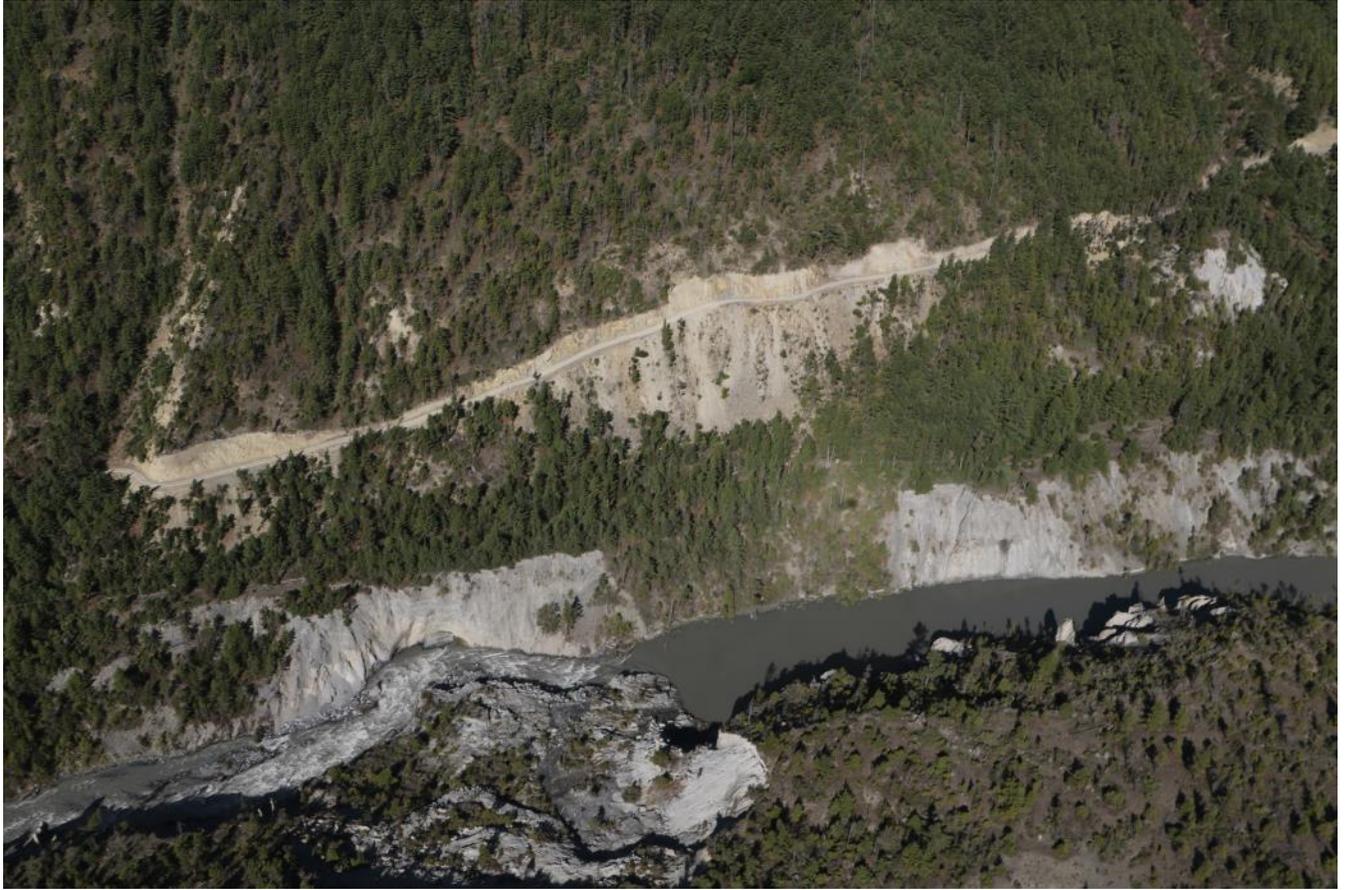
Our estimates of landslide volumes range from 30,000 to 100,000 m³. At the Pisang 1 landslide, partial blockage of the river currently (May 30, 2015) formed a 50-m-long slackwater lake upstream of the constriction. At Pisang 2 (fig. 15), an approximately 350-m-long lake had formed with surface elevation that we estimate from drowned trees to be about 3 m above pre-slide river levels. This landslide is reported to have completely blocked the flow of the river and formed a longer lake that subsequently breached when water spilled over the top of the landslide dam. The river course is now against the south side of the river channel and continues to erode the landslide toe. The Humde 1 landslide (fig. 16A) also likely fully blocked the river's flow. It currently backs up water for approximately 100 m with an estimated river-surface elevation increase of 1 m. Similarly, the Humde 2 landslide (fig. 16B) backs up water for about 200 m with an estimated river-surface elevation increase of 1 m above pre-slide river elevations and also likely temporarily blocked the river's flow.

Based on several existing constrictions in the river from these landslides, we judge the hazard level of these landslides to be moderate and expect that additional landslide deformation will occur from fluvial erosion at the toe of the landslide. If deposits remobilize as flows, they could impound the river again. If the volume of a river-blocking deposit is small, it could be quickly overtopped and eroded away similar to what occurred in the days and weeks following the earthquake. However, if a larger deposit forms, this could impound significant volumes of water, and given the fine grain size of the deposit material, rapid and catastrophic breaching could occur.

Figure 15. Aerial image of the Pisang 2 earth slide along the Marsyangdi River upstream from Pisang village. As of May 30, 2015, this landslide constricted the river with a 350-m-long slackwater lake upstream of the landslide deposit. Maximum width of impoundment in image is approximately 50 m.

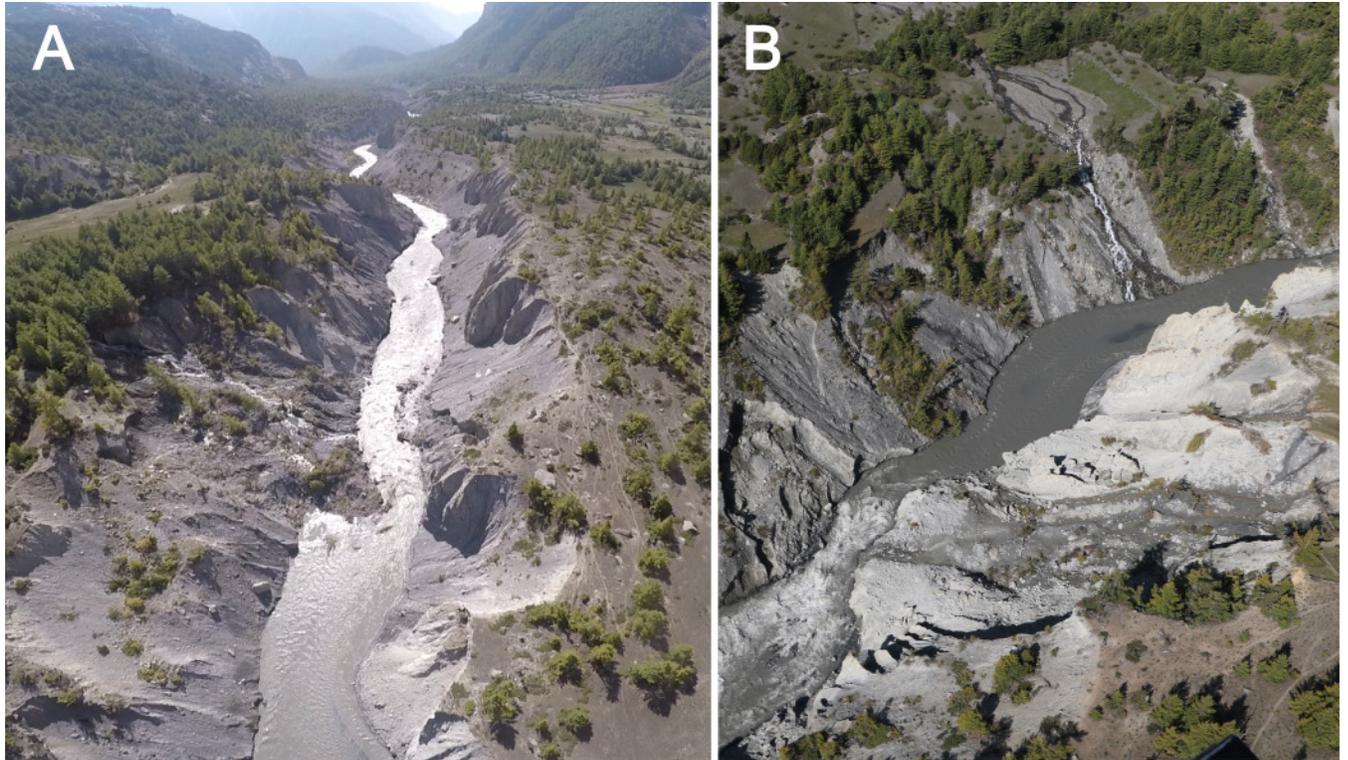
Figure 16. Aerial images of the Humde 1 (A) and Humde 2 (B) earth slides along the Marsyangdi River downstream from Humde village. Both landslides probably temporarily blocked the river's flow and as of May 30, 2015, had constricted the river to form slackwater lakes upstream of the landslides. Maximum width of impoundments shown in A and B is approximately 30 m.

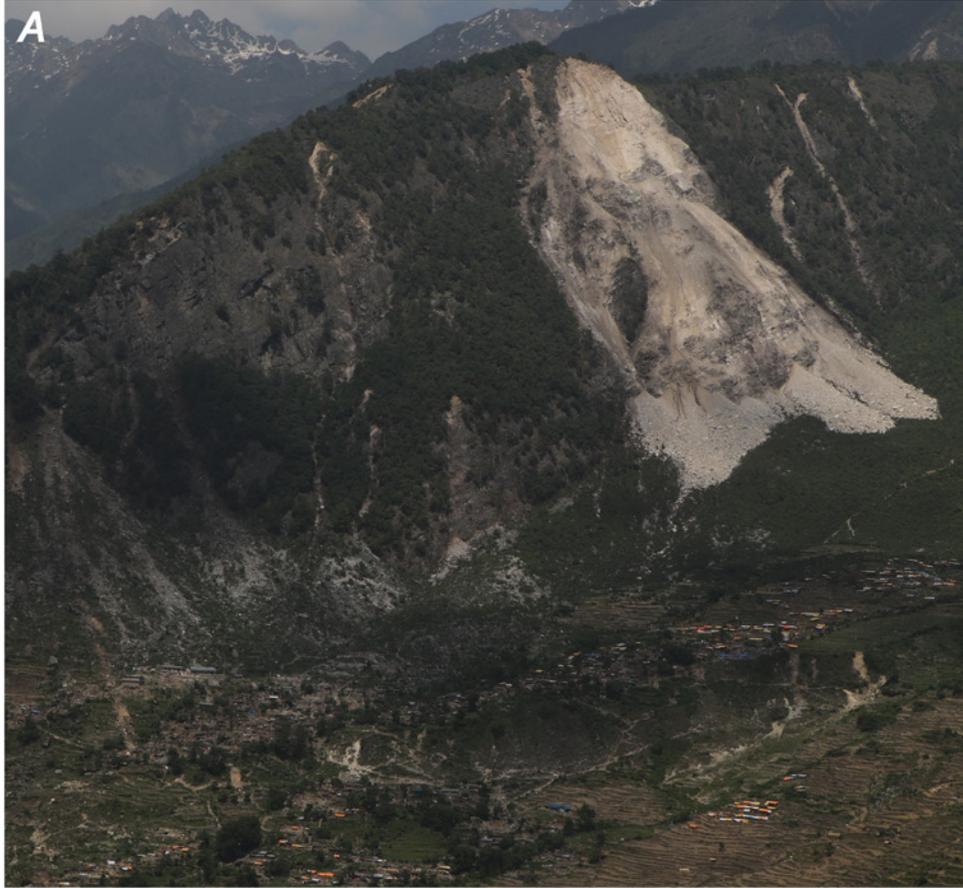
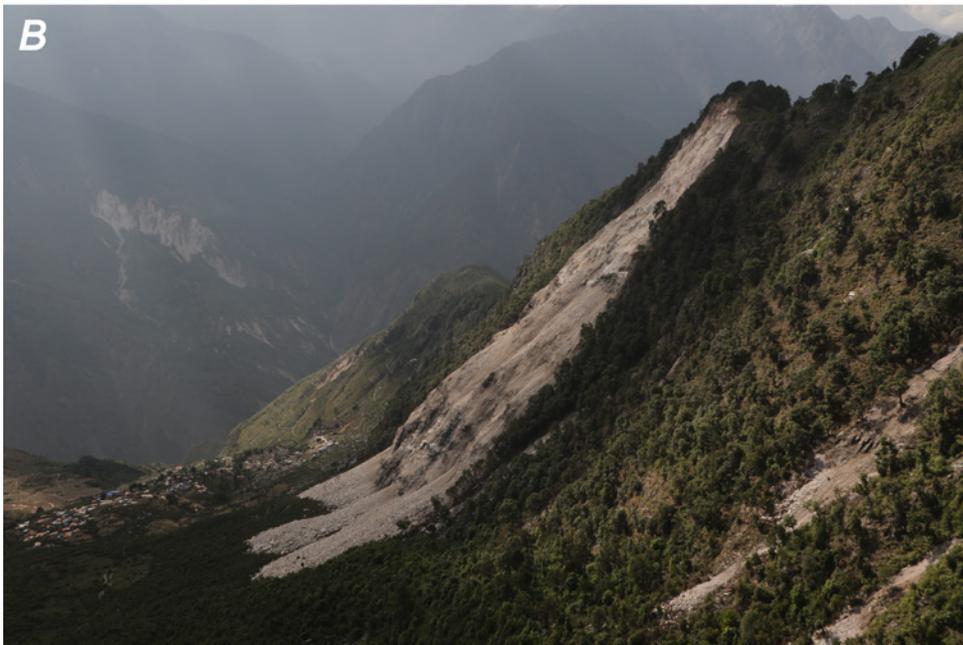
In Gorkha district, we investigated an approximately 500-m-long, 210-m-wide rock slide (fig. 17 and also report cover image) affecting the upper edge of Kerauja village (fig. 8). In this village, 70 percent (~400) of the homes were destroyed, and landslides and structural collapses were responsible for 11 fatalities. The major rock slide above the village killed 1 person and 80 sheep and continued to shed rocks even one month following the main shock. Similar to most other landslides that occurred during and immediately after the earthquakes, this failure appears to have initiated high on the slope (approximate elevation 2,630 m) near the ridge top. Based on indirect measurements made of the talus from available post-earthquake imagery, we estimate the volume of this failure to be 250,000 m³. Given an average scarp length and width of 300 m and 210 m, respectively, we back-calculate the depth of the failure plane to be approximately 4 m. This assessment is consistent with close-up observations of the main scarp, which showed that some vegetation remains on the slope and that the top of the slope has a fairly thin (~3-m-thick) weathering profile. The rock in this area is predominantly quartzite (as interpreted from rocks identified in the village), and although the scarp has a significant degree of fracturing, the rock mass appeared to be fairly competent. According to villagers, this slope was vegetated prior to the earthquake, and no one recalled there having been previous landsliding or significant water seepage from this area.

Overall, we judged this rock slide to have a low hazard related to additional reactivation, other than small rock falls of perhaps hundreds to thousands of cubic meters that might be expected over the next year or more. Small debris flows could also initiate from higher talus slopes, but they are unlikely to reach the village. We saw some evidence of shallow debris flows from near the top of the talus, where presumably minor groundwater seepage mobilized loose, unconsolidated debris remaining on the failure scarp. An additional nearby landslide to the west of the main rock slide resulted in another fatality according to villagers, and our aerial reconnaissance indicated other smaller instabilities on the adjacent slopes. Although we did not observe any evidence of ridge-top cracking during low-level aerial investigation in the immediate areas adjacent to the main rock slide, additional rock falls from these slopes should be expected.

Figure 17. Photographs showing fatal rock slide above Kerauja village in Gorkha district (A, B). Maximum bedrock scarp length is approximately 350 m. Landslides from adjoining slopes to the northwest (left of main rock slide in [A]) resulted in one additional fatality.

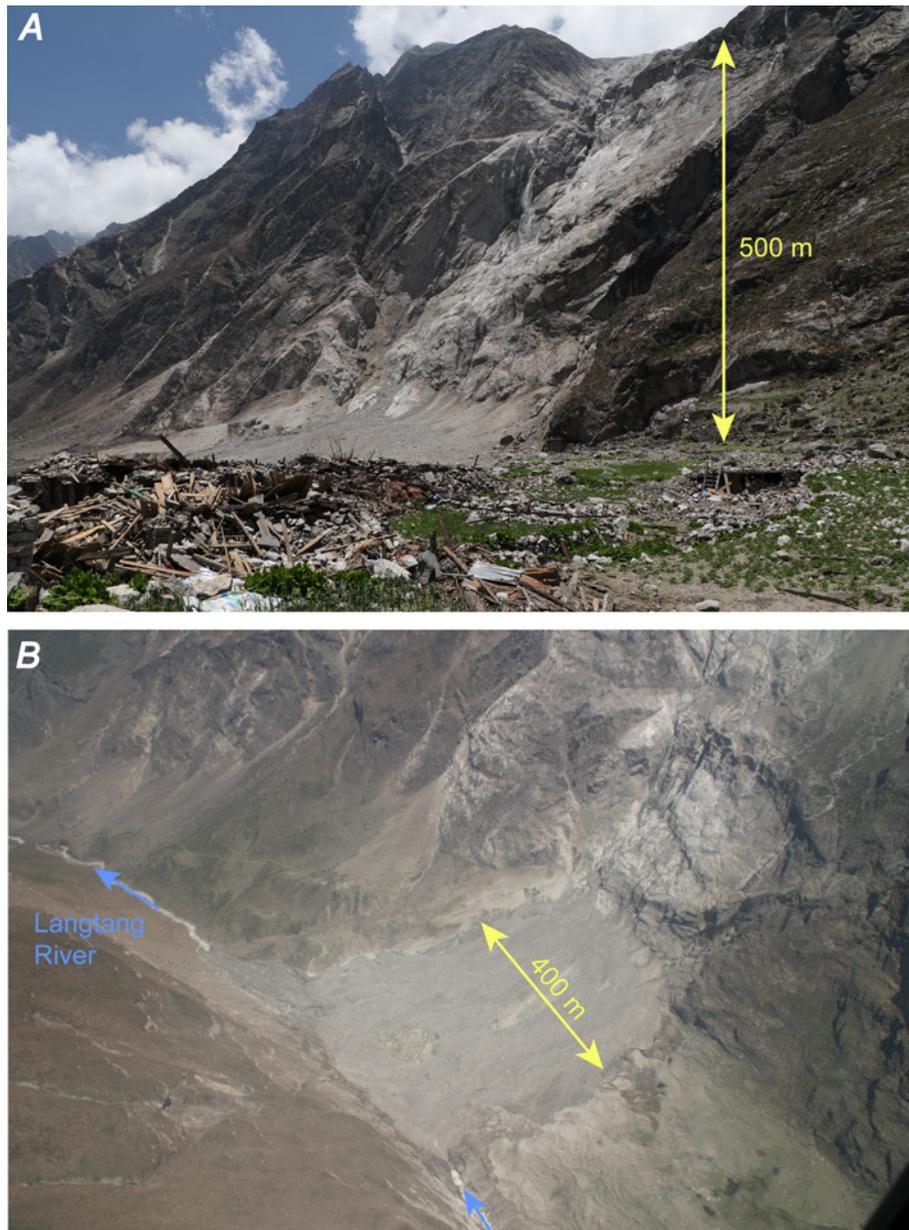
The largest and most destructive landslide triggered by the 2015 earthquakes was a debris avalanche (fig. 18) that destroyed the village of Langtang in the Langtang Valley of Rasuwa district (fig. 8). Although the exact location of the uppermost source is difficult to identify, the landslide appeared to initiate at an elevation above 5,000 m on the flank of Langtang Lirung, a 7,227-m-high peak on the north wall of the valley (fig. 19). Large masses of glacial ice broke loose from multiple source areas during the earthquake shaking, and as the ice rapidly descended the steep slopes above the valley it entrained a mixture of rock and soil from the ground surface and surrounding valley walls. The mixture of ice, rock, and soil accelerated down an approximately 35° slope and then became at least partially airborne at a point 500 m above the valley floor where the slope steepens to about 50°–55°.

Figure 18. Photographs showing the Langtang debris avalanche, which destroyed the entire village of Langtang either through direct deposition or by consequent air blast. An estimated 200 people were killed in this single event. *A*, Oblique northwest view of deposit with cliff in which the debris became airborne. Homes in foreground were pushed over by the ensuing airblast. *B*, Aerial view of deposit showing location of the Langtang River tunnel through ice and debris (fig. 21).

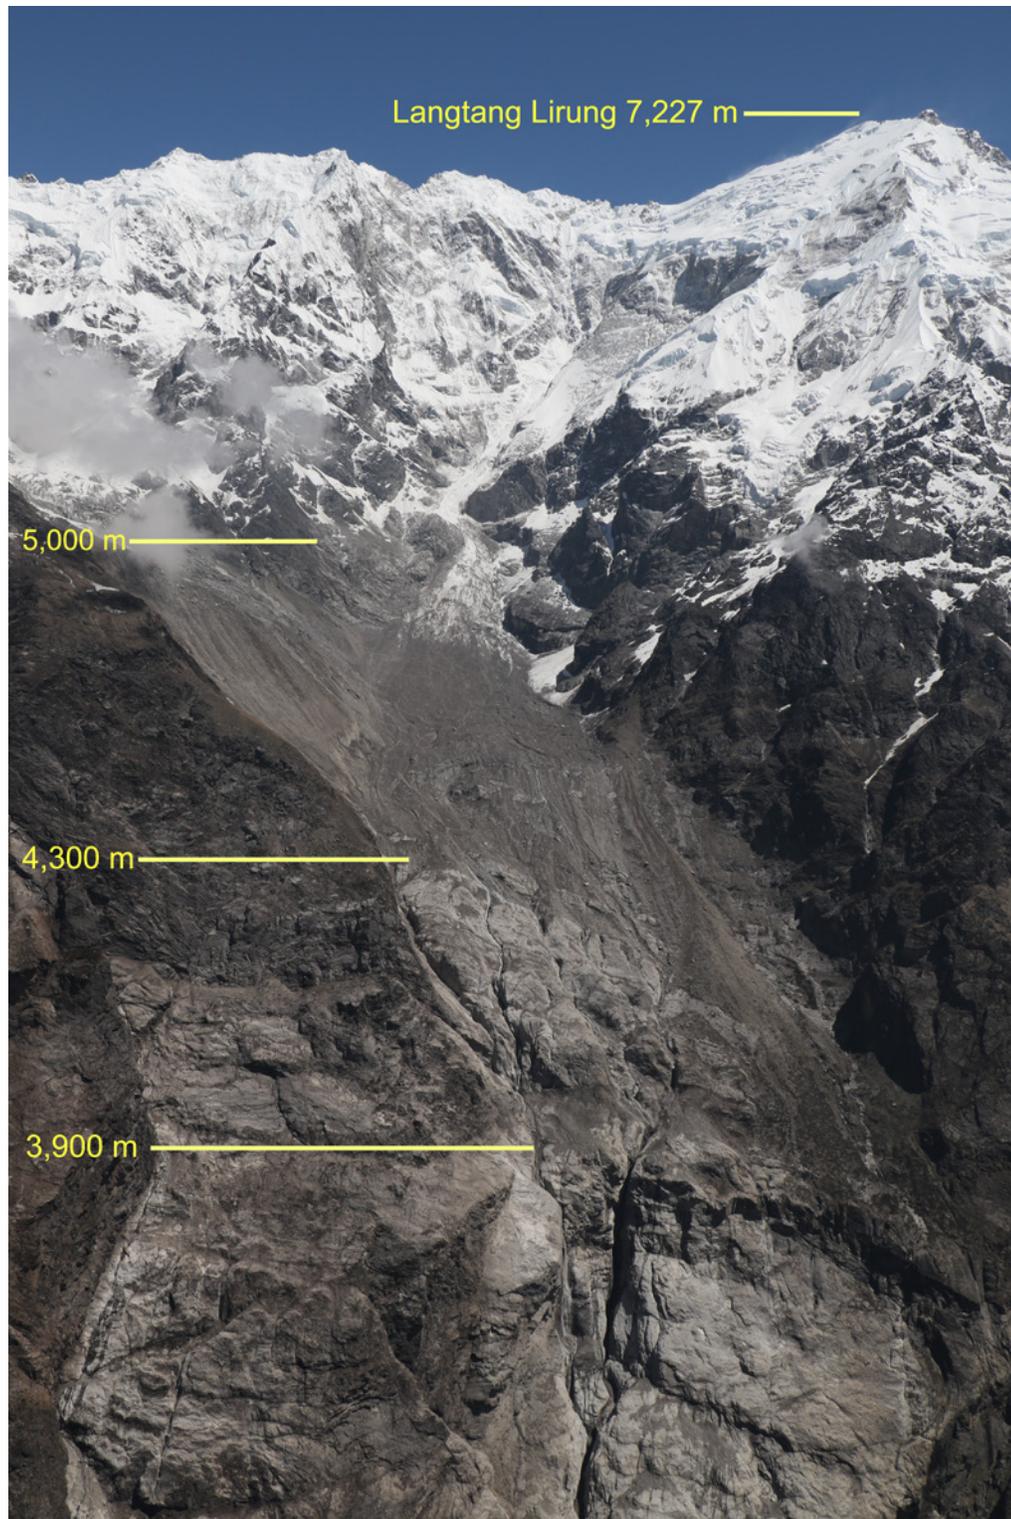
Figure 19. Photograph showing source area of Langtang debris avalanche was in ice slopes above 5,000 m elevation. Transition from debris to rock cliff is at approximately 4,300 m elevation. Bottom of photo is at approximately 3,600 m elevation. The debris avalanche likely became airborne at about 3,900 m elevation and fell 500 m to the Langtang Valley below located at 3,400 m elevation.

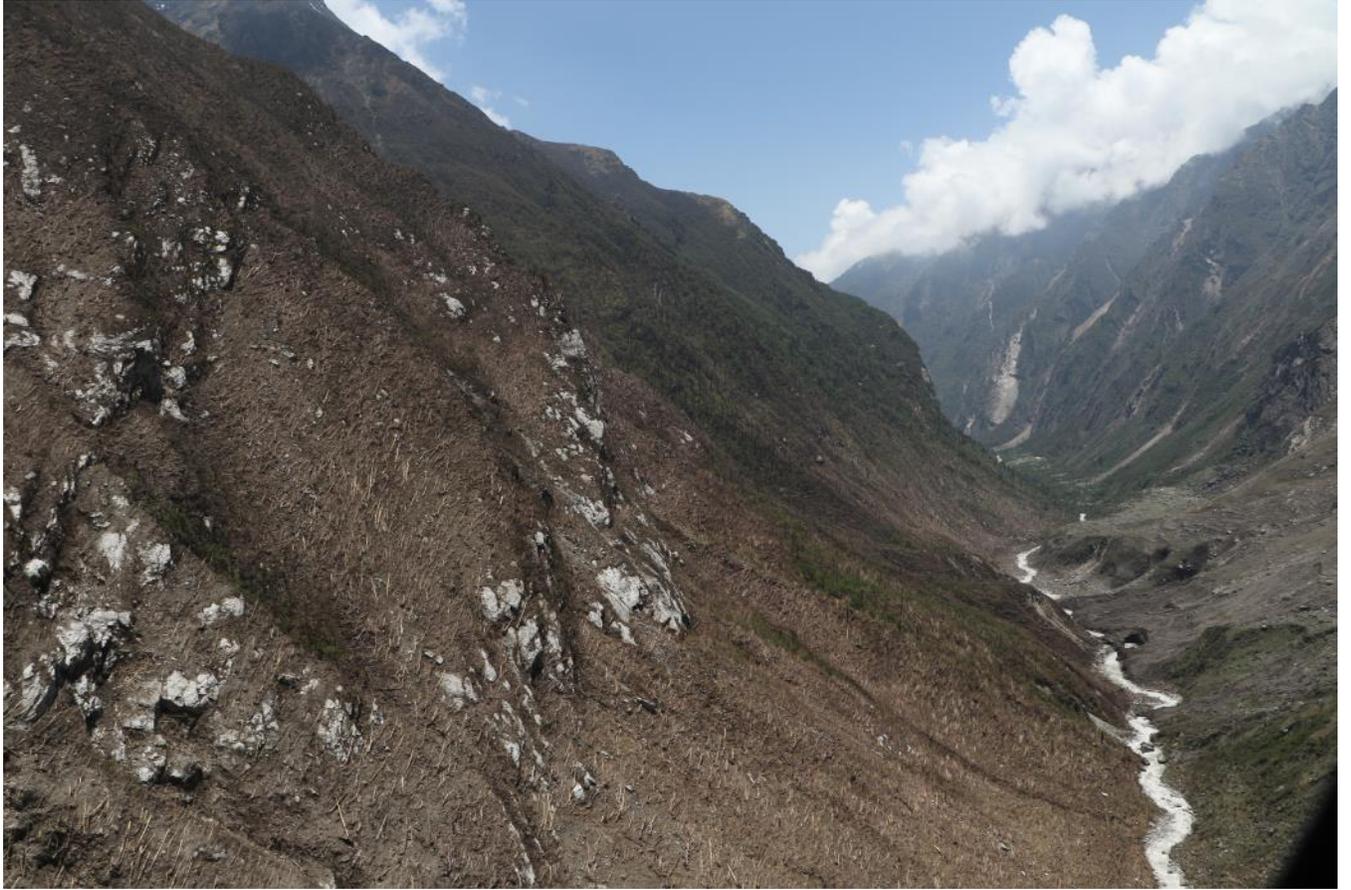
Figure 20. Photograph showing blown down trees caused by rapid emplacement of the Langtang debris avalanche deposit and resulting radial air blast. The air blast flattened all parts of the village not originally buried by debris and caused blowdown of trees in all directions for a distance of approximately 1 km. View is down-valley to the west and shows approximately 1,000 m of vertical relief between river and foreground mountain.

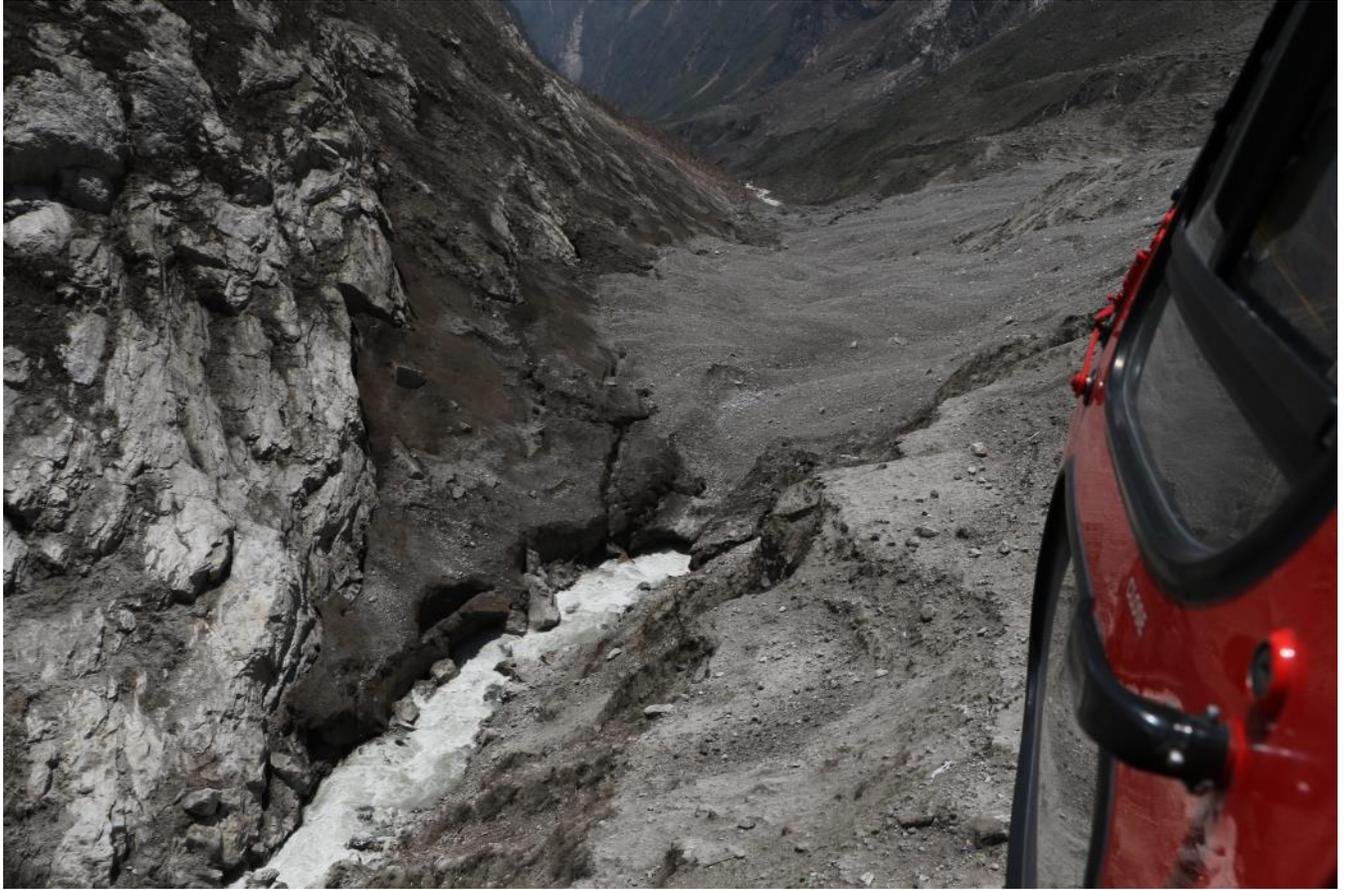
Figure 21. Photograph showing the Langtang debris avalanche deposit temporarily blocking the flow of the Langtang River, which subsequently formed a tunnel through the ice in which the river was flowing through in May 2015. River in foreground is approximately 10 m wide. Tunnel through ice and debris is approximately 650 m long.

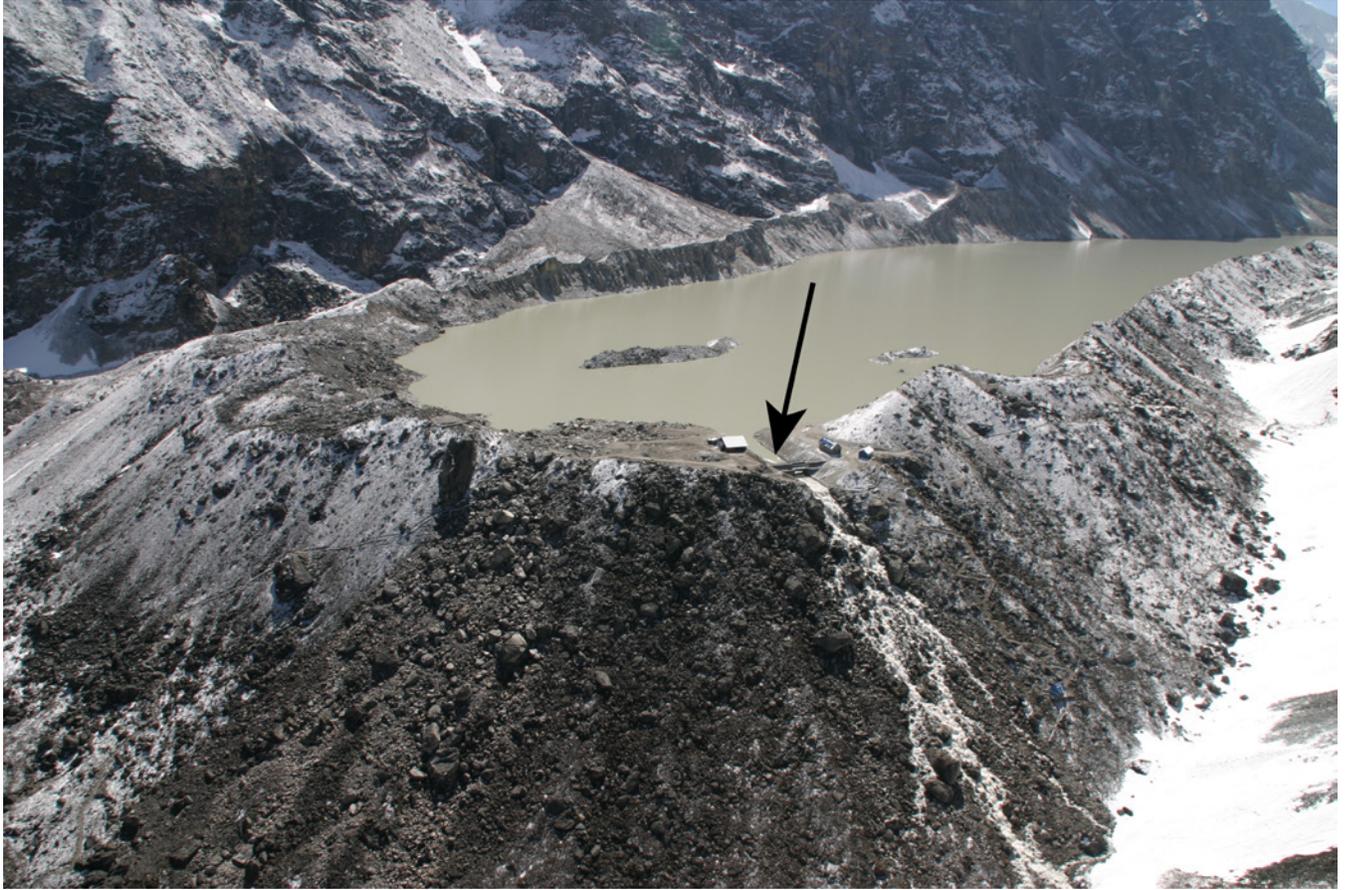
We also inspected the entire impounding moraine from the terminal moraine all the way eastward to the glacier from the air and saw no cracks or other evidence that the natural dam was damaged by the earthquake or that the stability of the lake was in danger. Due to the high altitude and abundance of steep rock cliffs adjacent to the lake, we were not able to ascertain whether incipient landslides formed on these slopes as a result of the earthquakes or whether any landslides could pose additional hazards to lake-tsunami generation.

Figure 22. Photograph showing eastward view of the terminal moraine forming Tsho Rolpa glacial lake. The engineering outlet works (fig. 23) are indicated by an arrow.

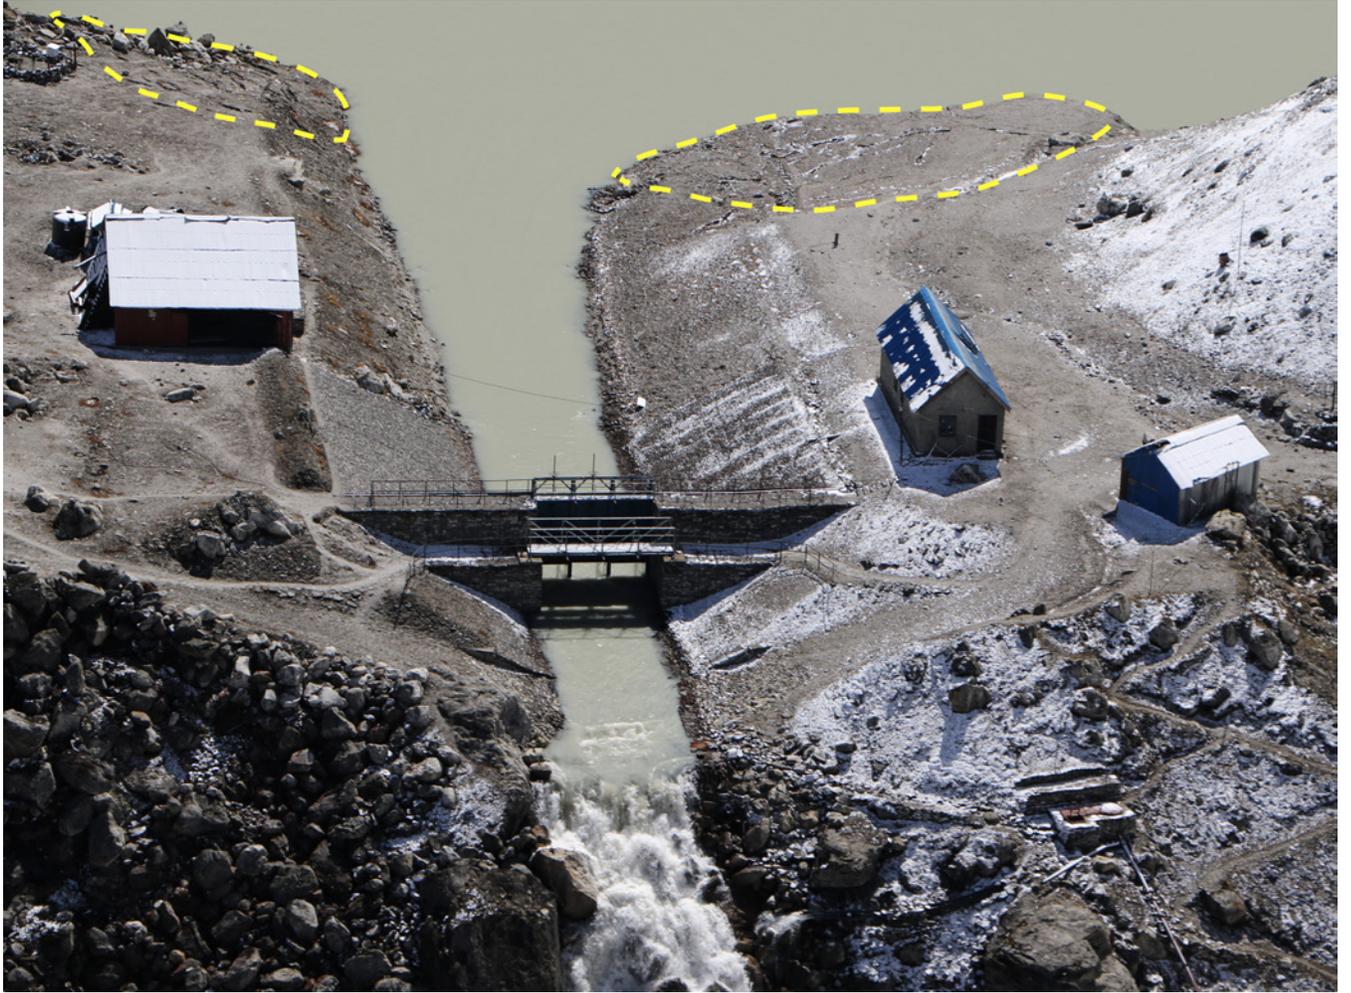
Figure 23. Photograph showing the sluice gates used to control the lake elevation at Tsho Rolpa. Areas of lateral spreading (fig. 24) are visible at the lake end of the channel (dashed yellow lines).
