Assessment of Existing and Potential Landslide Hazards Resulting from the April 25, 2015 Gorkha, Nepal Earthquake Sequence

Open-File Report 2015-1142

By Brian D. Collins and Randall W. Jibson

U.S. Department of the Interior
U.S. Geological Survey

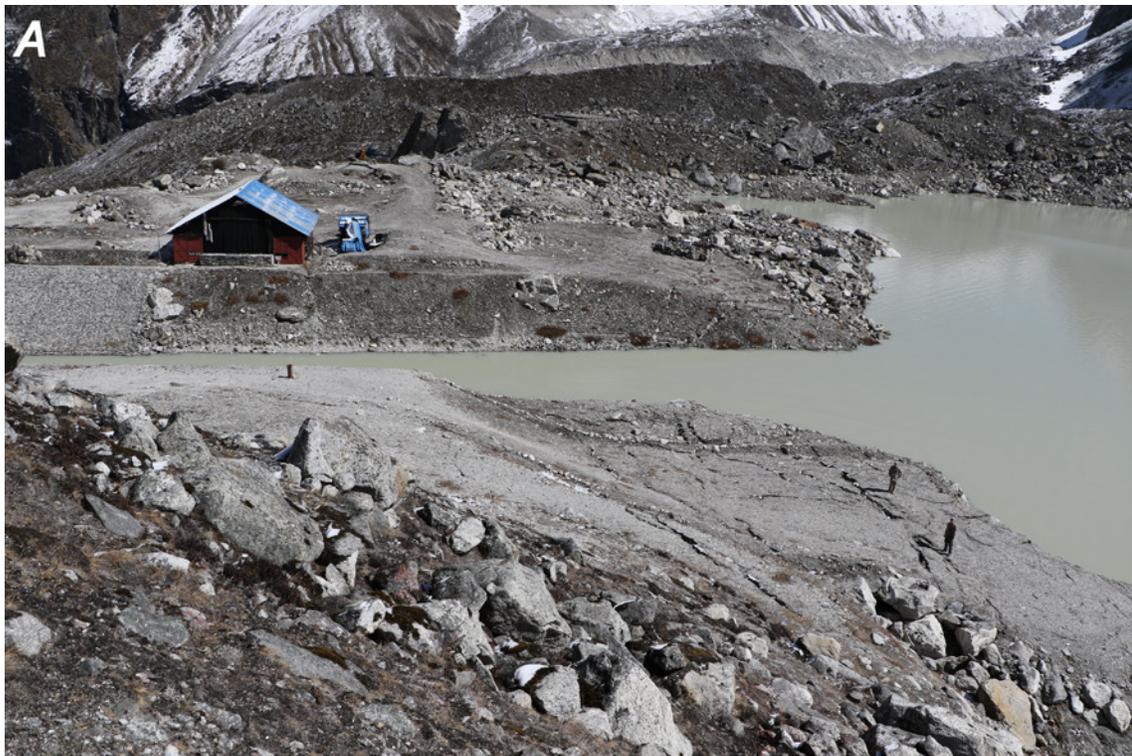
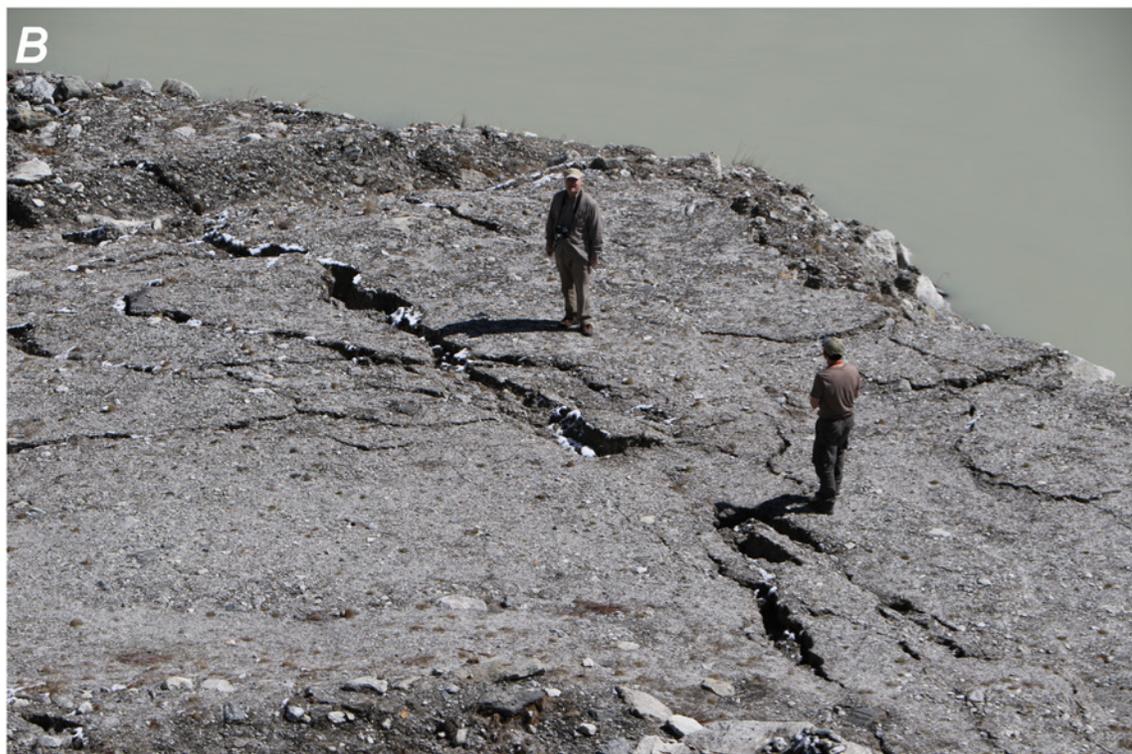
Figure 24. Photographs showing lateral spreading at the inlet to the Tsho Rolpa engineered drainage channel (A, B). Approximately 1.0–1.5 m of horizontal displacement (toward the lake) and 0.5 m of downward displacement on the eastern side of the channel did not appear to compromise the stability of the moraine dam or engineered outlet.
