講演会(ヒマラヤ周辺における水・土砂災害への取り組みについて—ネパールとブータンの最近の事例—)における資料

ネパールにおける水・土砂災害対応の現状

ブータンにおける氷河湖決壊洪水危険性調査と氷河湖排水工事の状況

Water Induced Disaster Status in Nepal

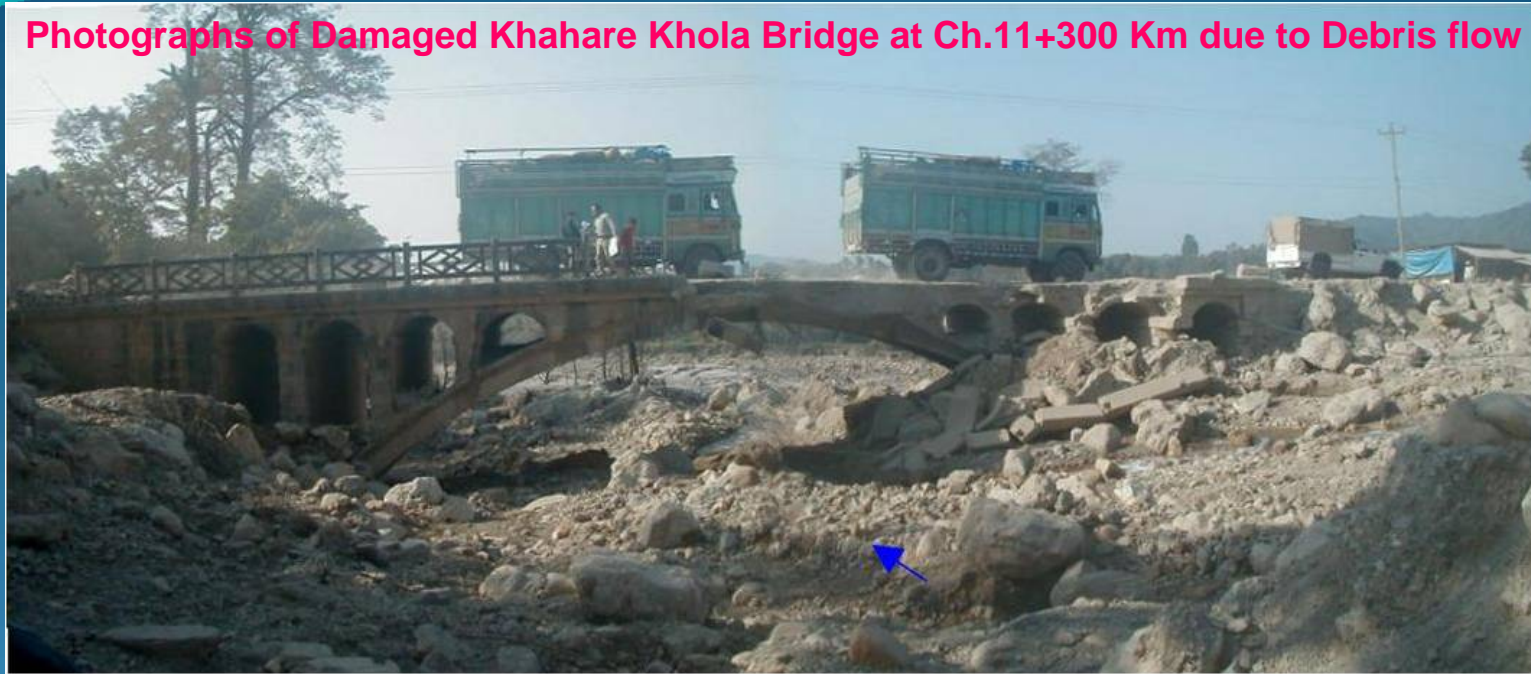
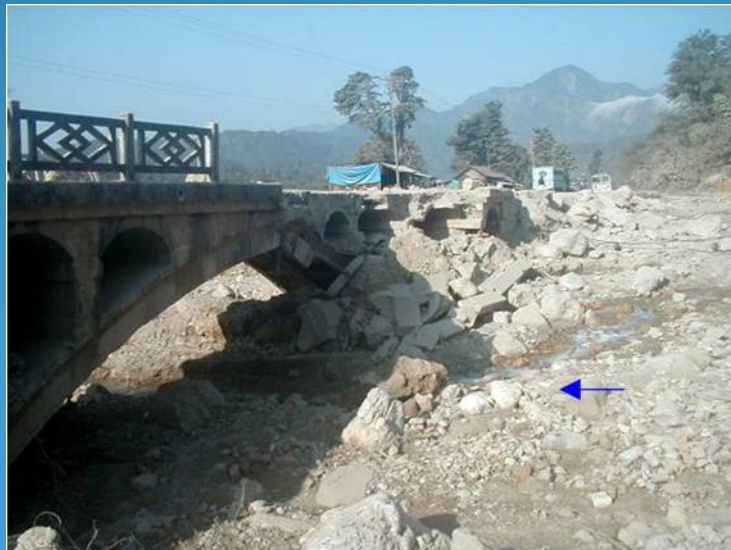
Photographs of Damaged Khahare Khola Bridge at Ch.11+300 Km due to Debris flow

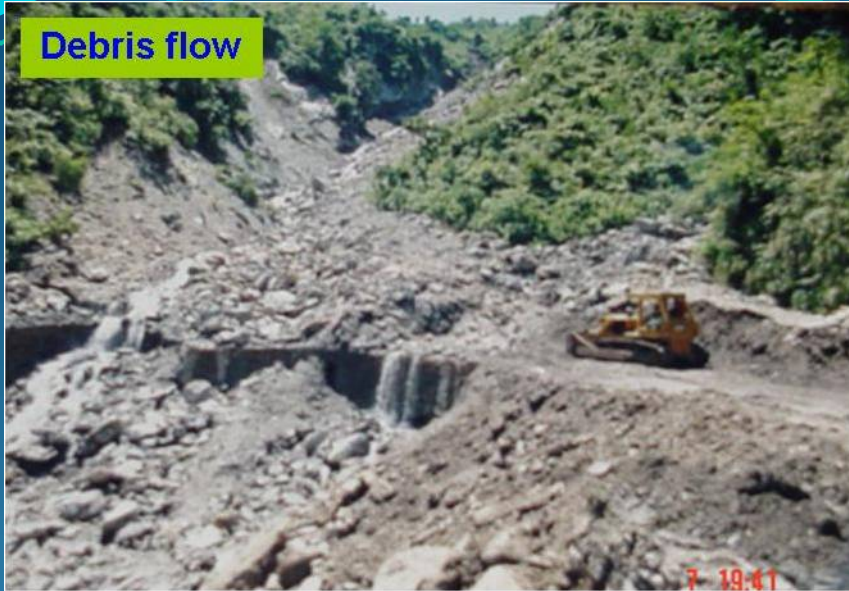
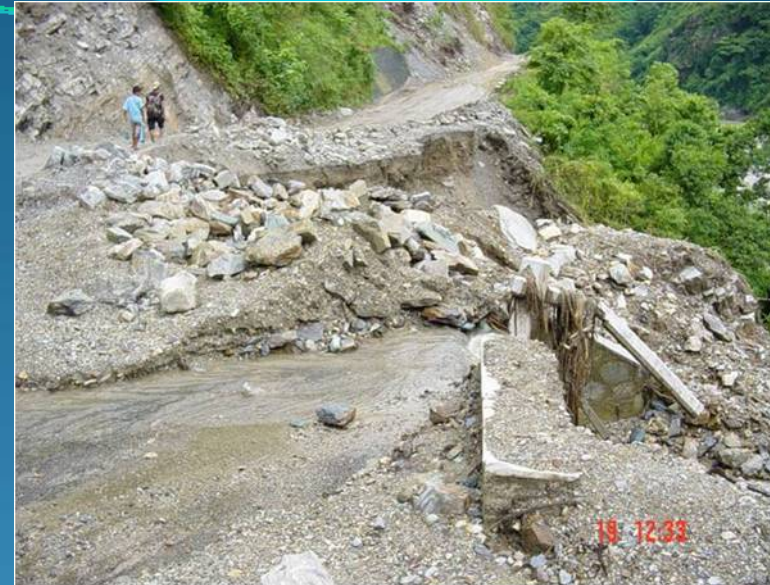
Debris Flow at Ch. 31+950km

Debris flow

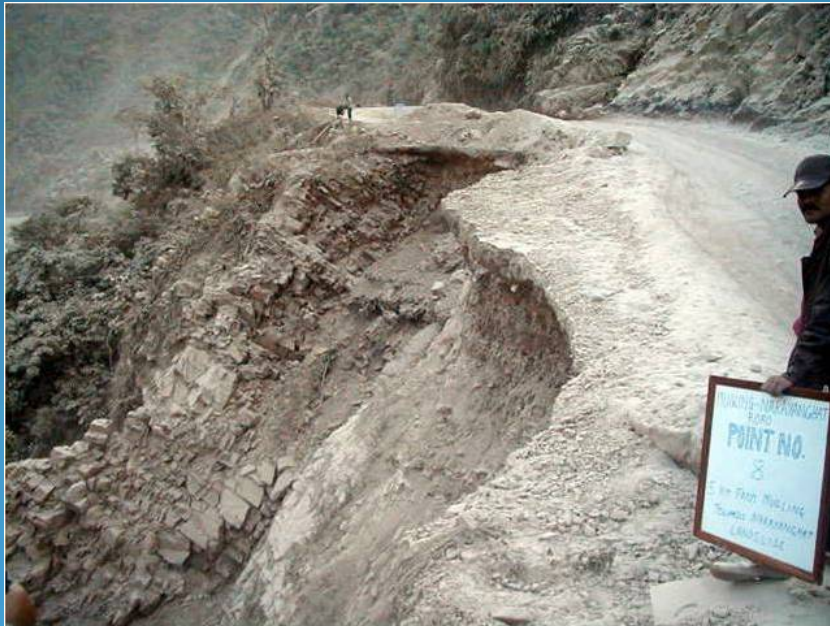
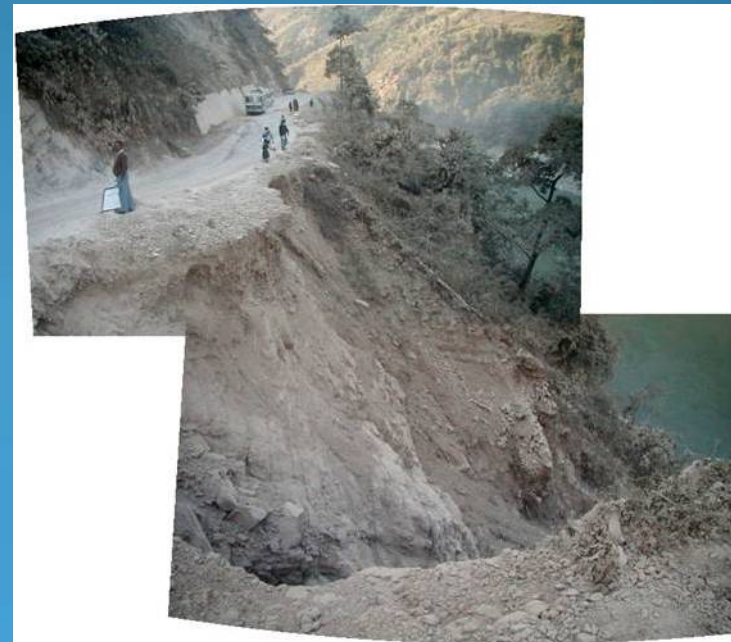
Broken retaining wall and road shoulder at Ch.33+000

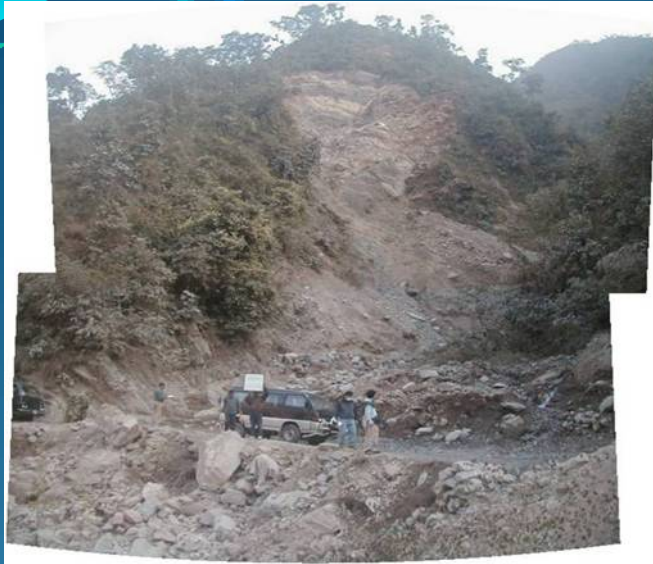
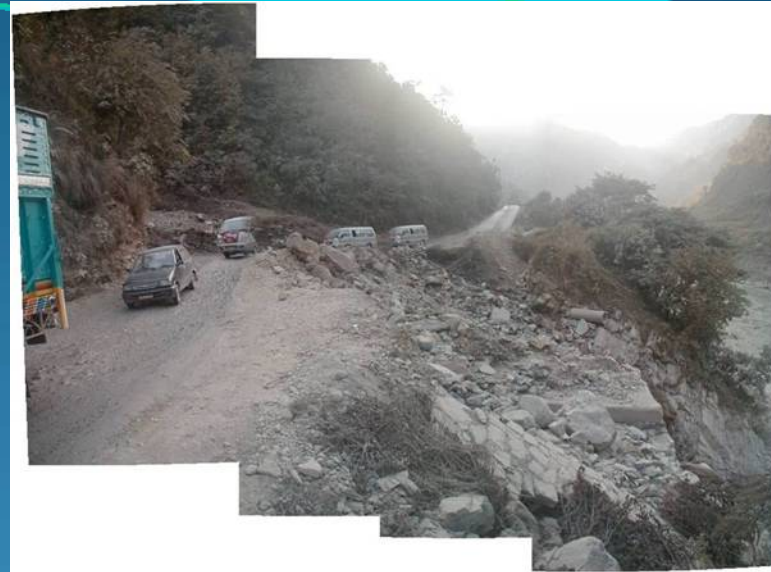
Slope failure and broken road shoulder at Ch.31+000

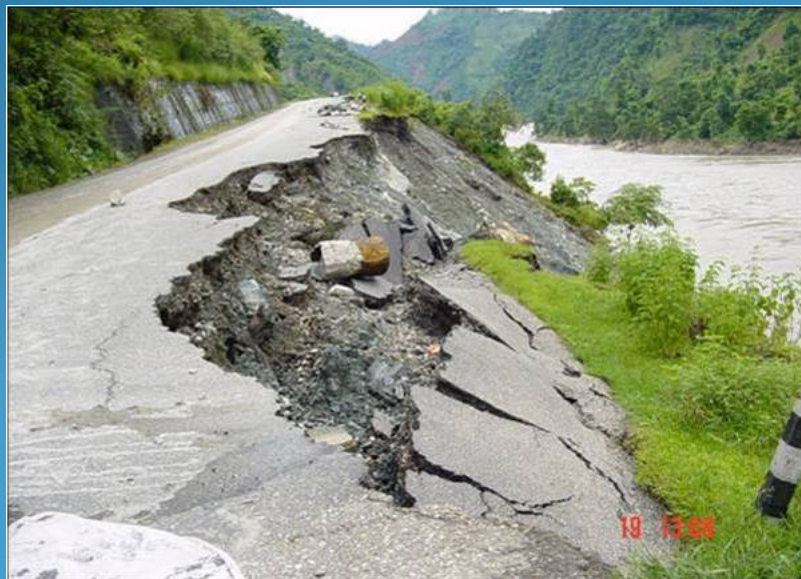
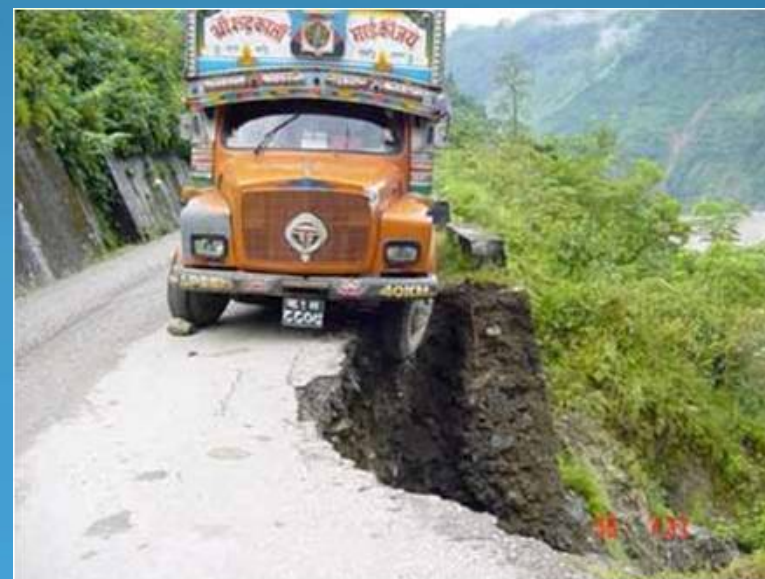
Condition of Road Foundation Failure

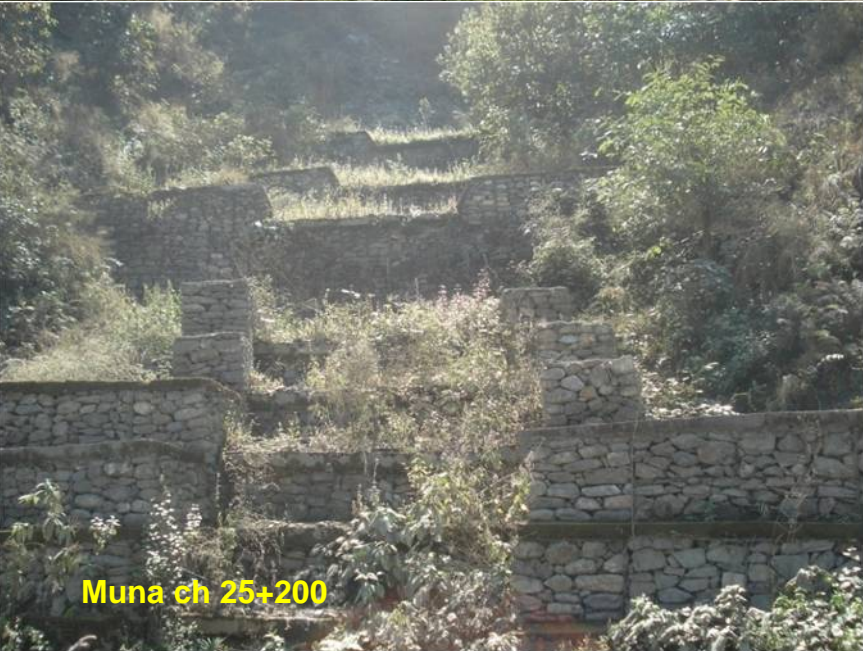
Muna ch 25+200

Stable structures

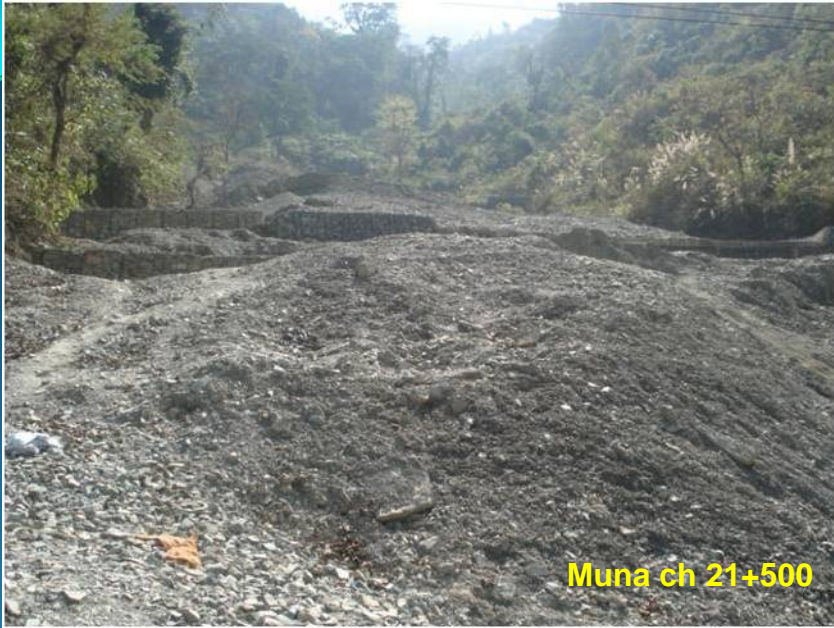
Muna ch 21+500

Stable structures with debris flow

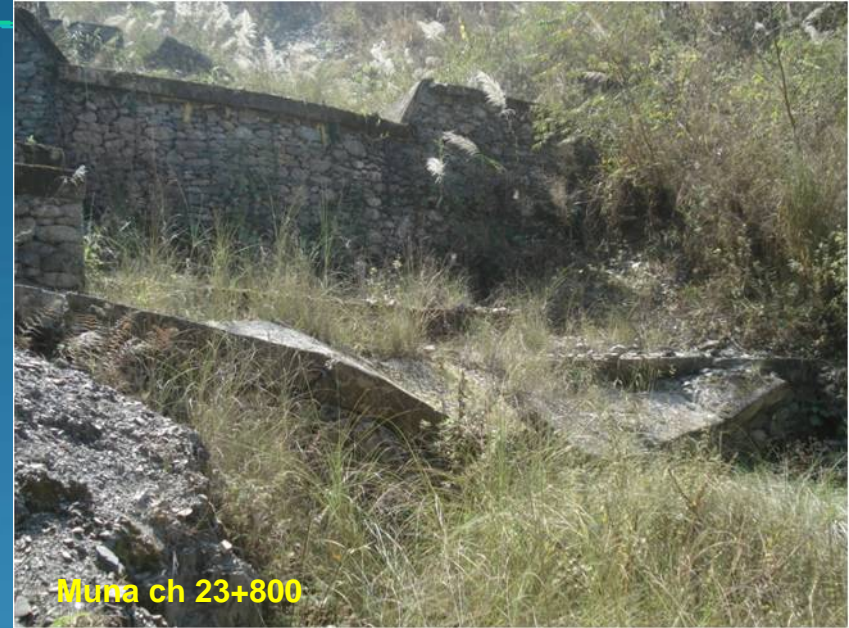
Structures needed to be maintained

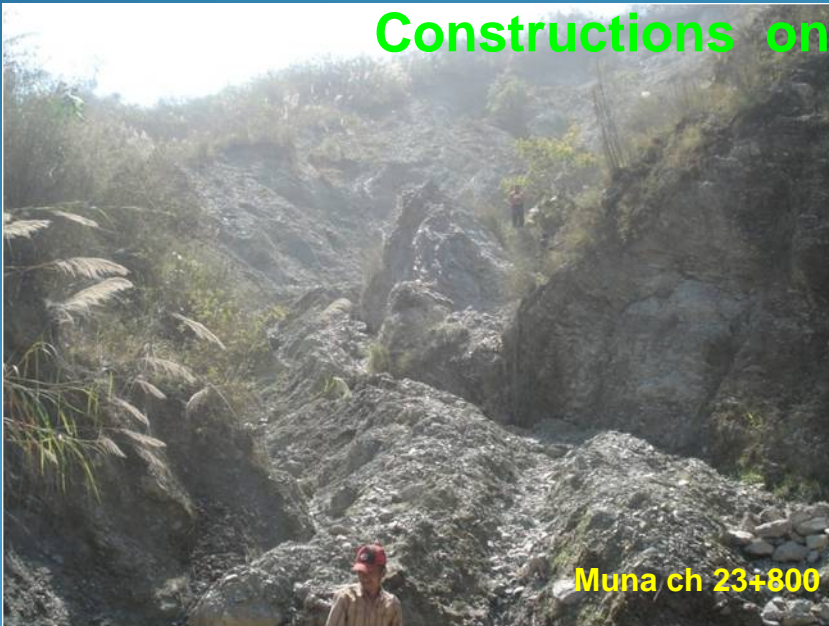
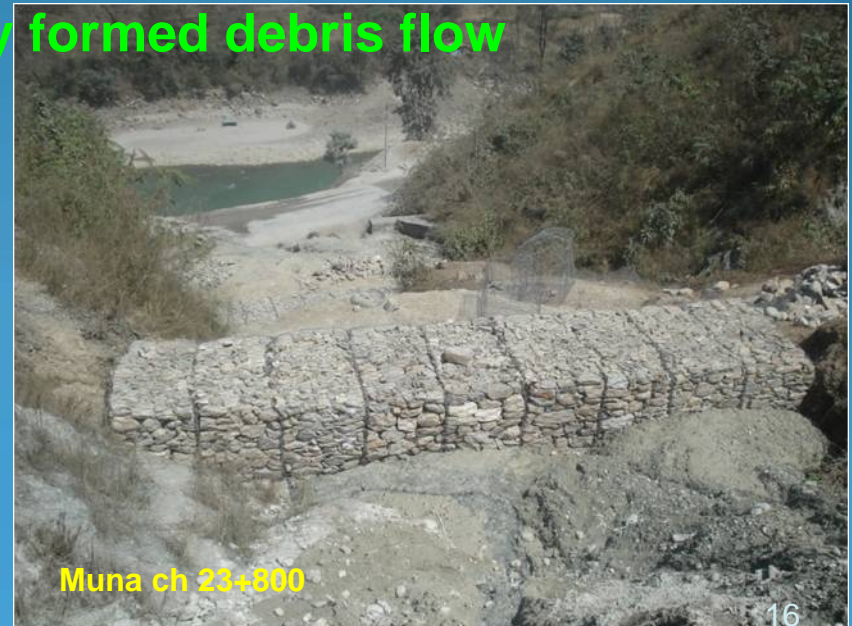
Constructions on newly formed debris flow

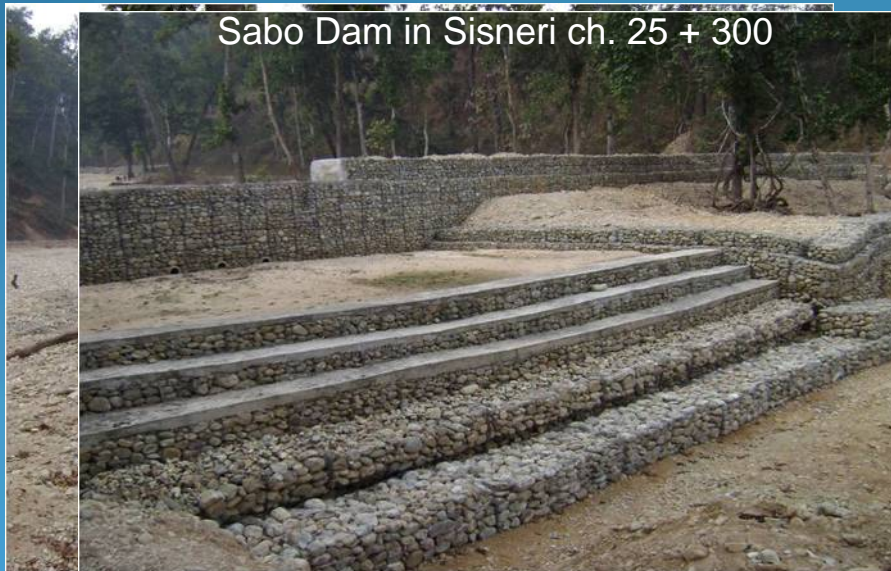
Embankment Protection work in Sisneri ch. 25 + 300

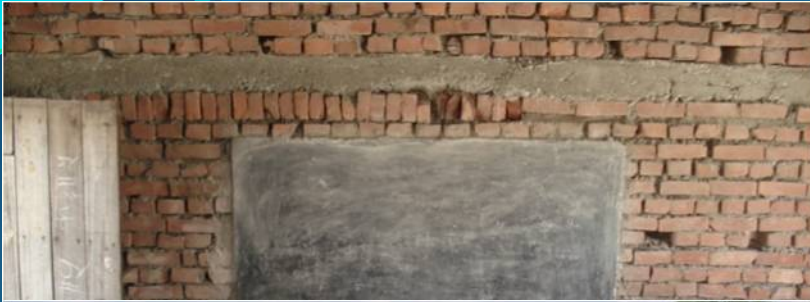
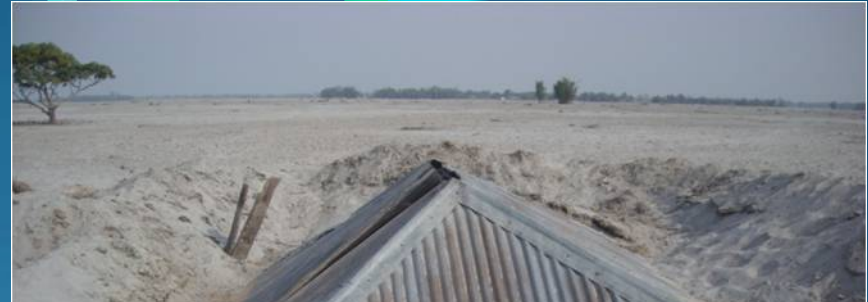
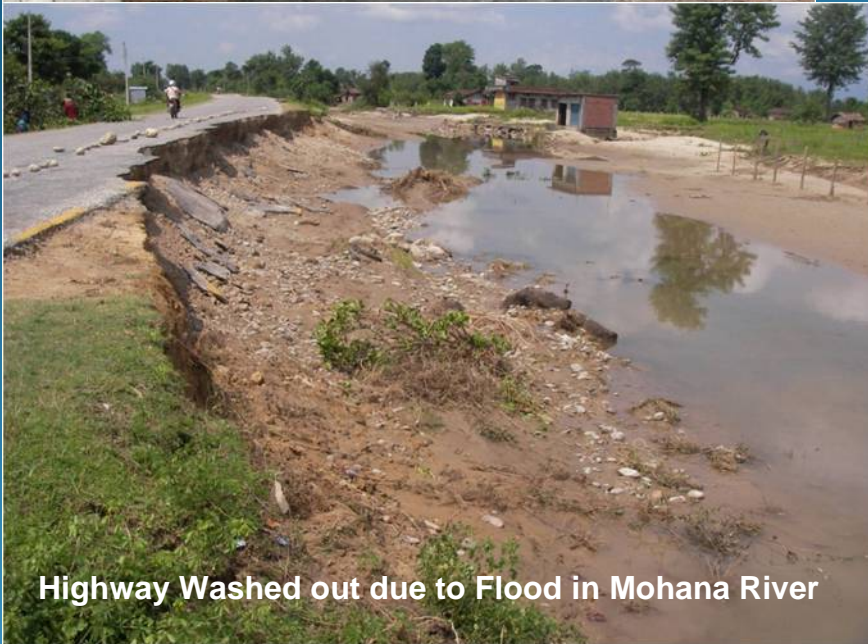
Infrastructures Damaged by Flood

Highway Washed out due to Flood in Mohana River

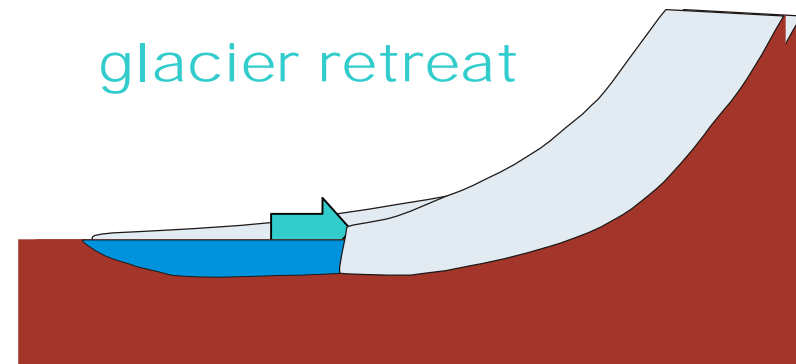
Glacier Lake Formation

Melting process
as vertical thinning of glacier

Glacier retreat
as horizontal expansion of lake

1. Increased melt rate (due to global warming?) → increase water volume → increased hydrostatic pressure on moraine dams
2. Weakening of moraine dams due to erosion and melting of ice (for ice-cored moraine dams).
3. This “fragile” system can be disturbed by external forces such as:
 - Earthquakes
 - Rock or ice avalanches
 - Outburst from adjacent glacial lakes
 - Landslide and debris flow

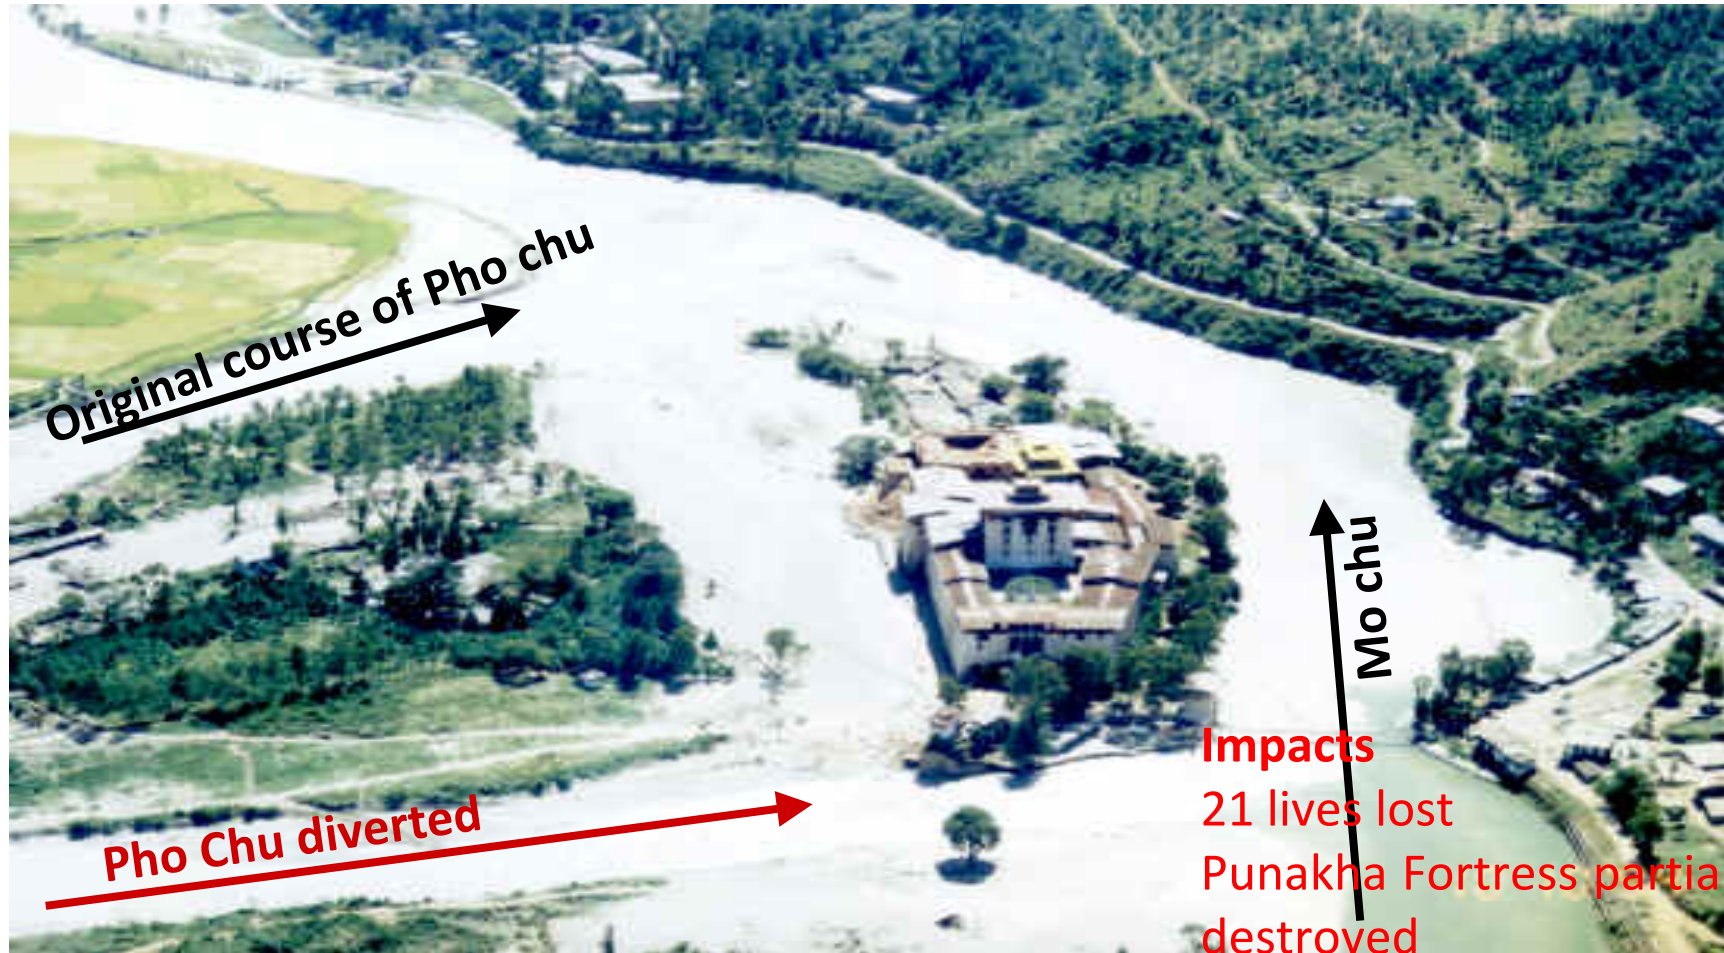
Downstream Punakha Dzong Affected

Impacts
21 lives lost
Punakha Fortress partially destroyed
91 households affected
12 houses damaged

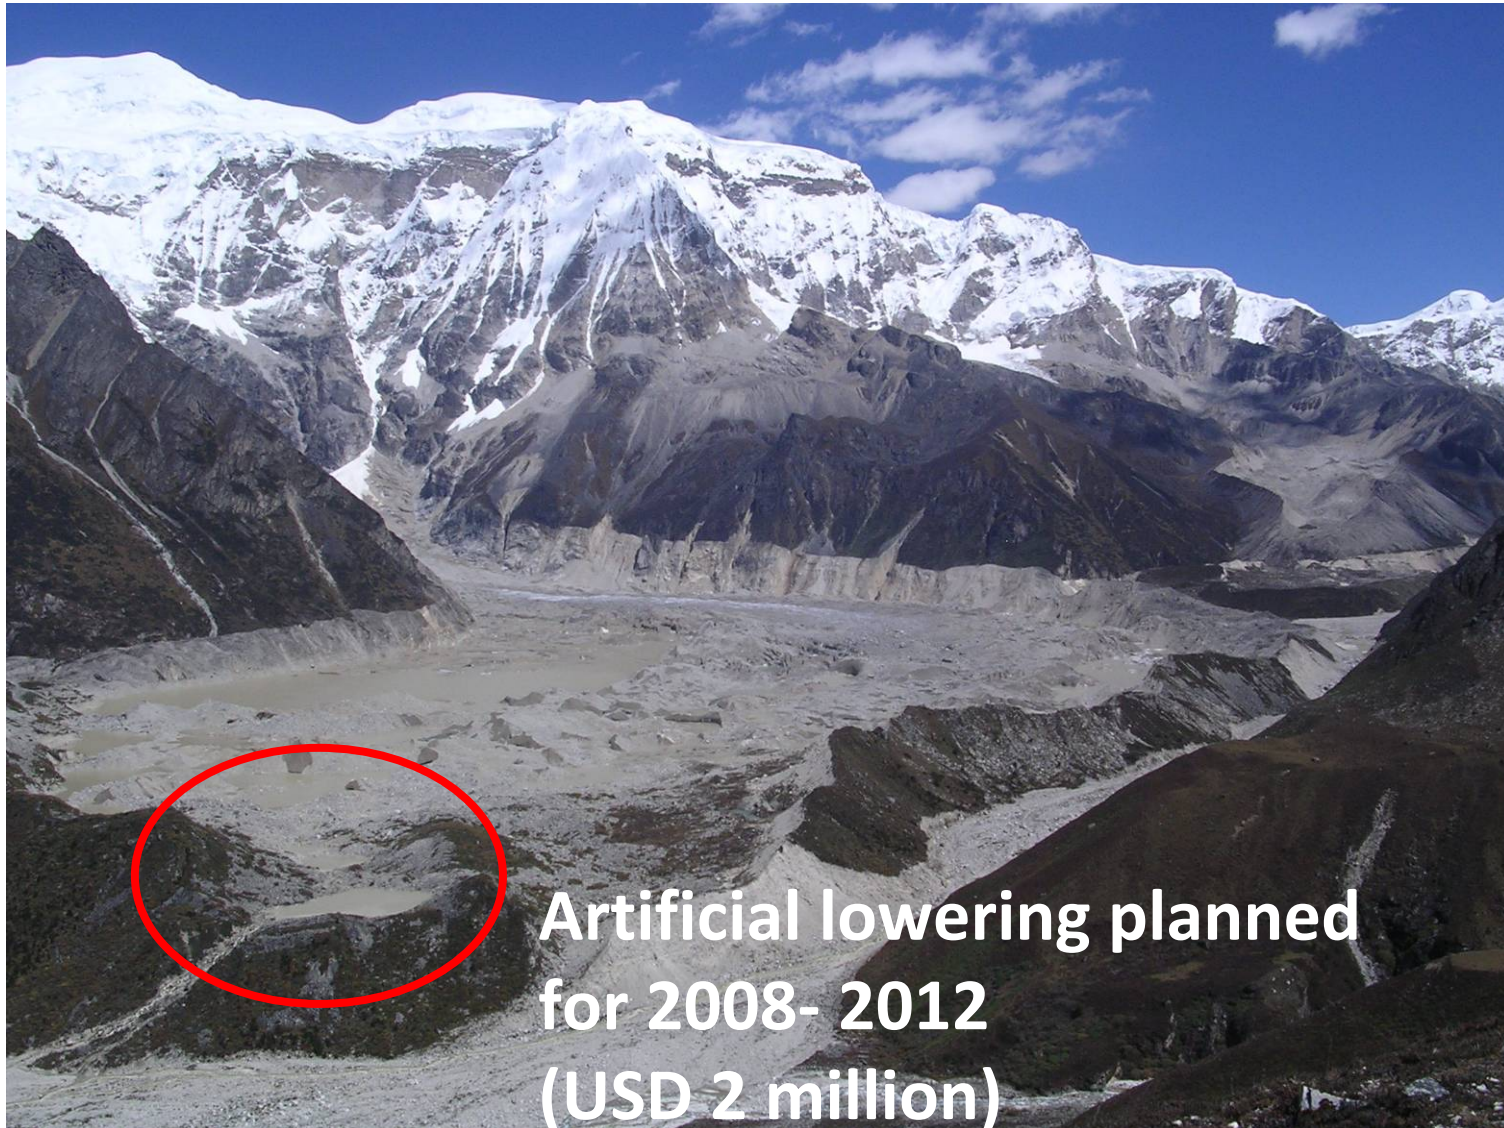
Thorthormi mitigation

- 1998- Joint Bhutan – Japan Project for risk assessment of GLOF.
- 1999-2001- Joint Bhutan-Austria Project for risk assessment of glaciers and glacial lakes.
- 2002-2004 – Regular monitoring of glaciers and glacial lakes by DGM
- 2005-2007 - Detailed topographic survey by DGM.
- 2007-2008 – Monitoring of glacial lakes in Lunana
- 2009-2012 – Study of Glaciers and Glacial Lakes at the Head Waters of Mangdechu, by DGM/JST/JICA , through funding from JST and JICA.
- 2008 – 2012 – Artificial lowering of Thorthormi
-- Installation of Early Warning System

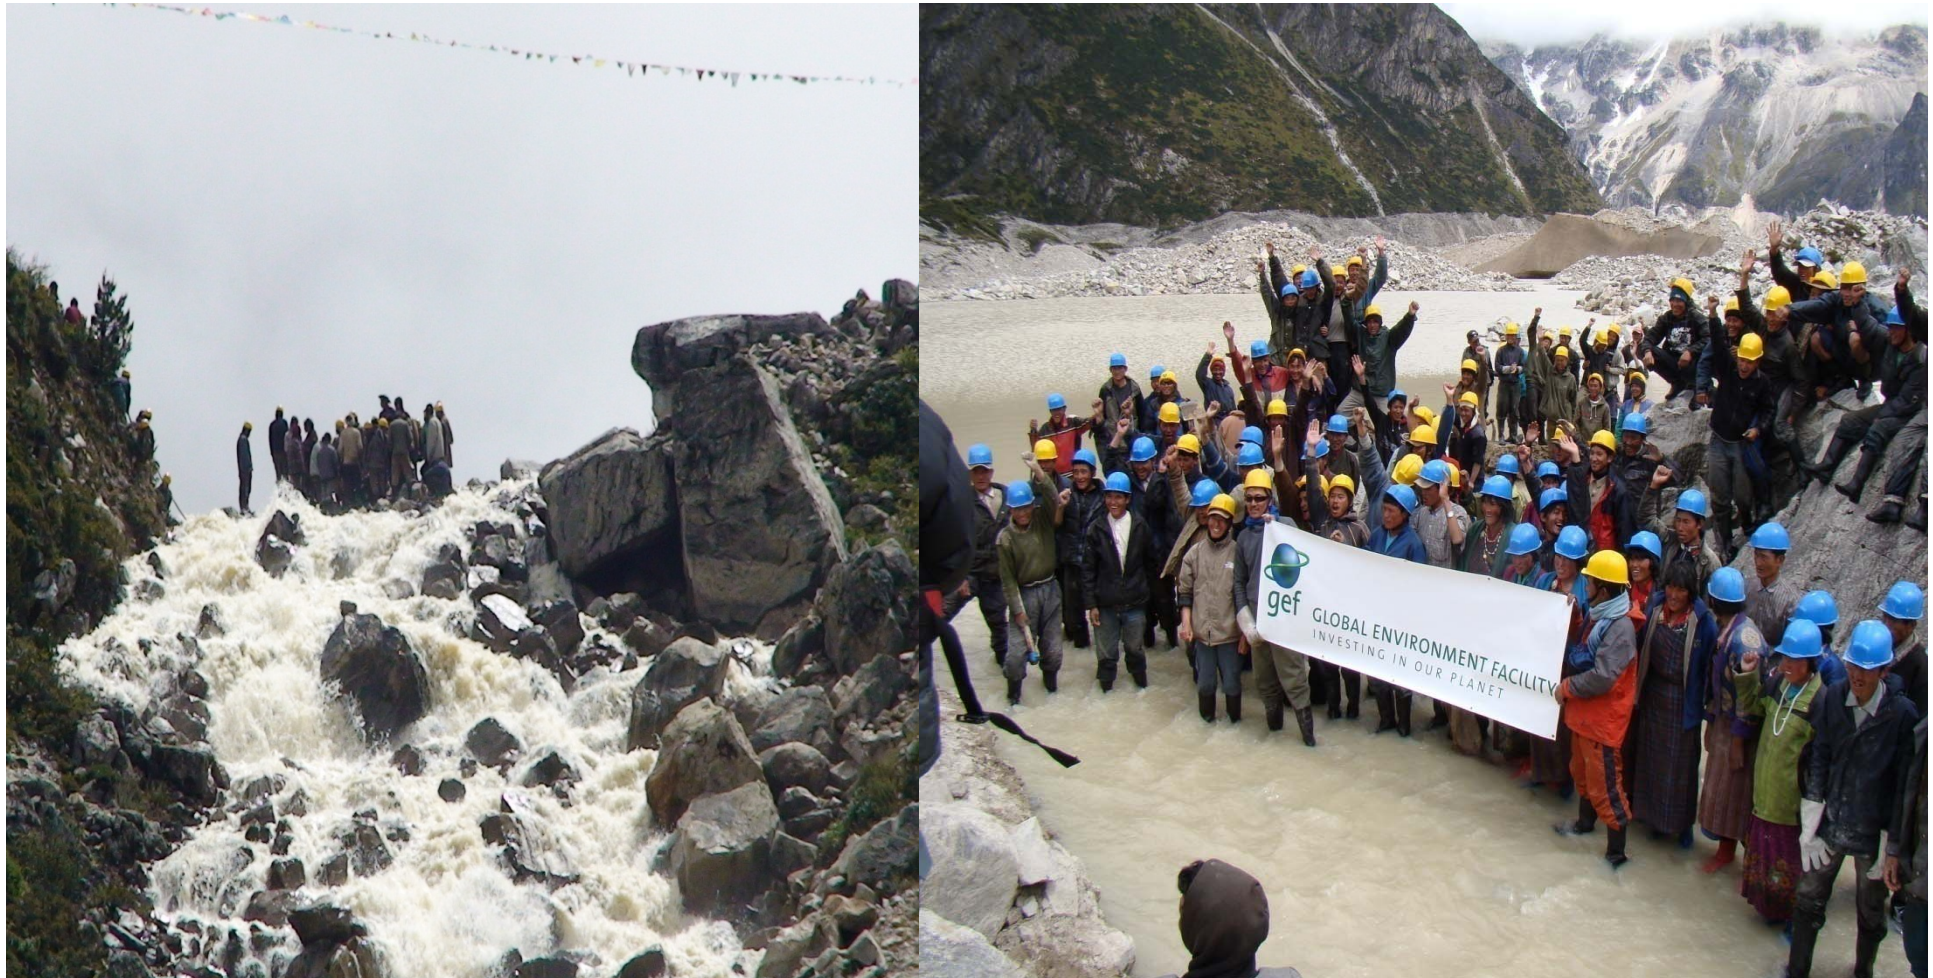
Mitigation of Thorthormi Lake through Global Environmental Facility (GEF)

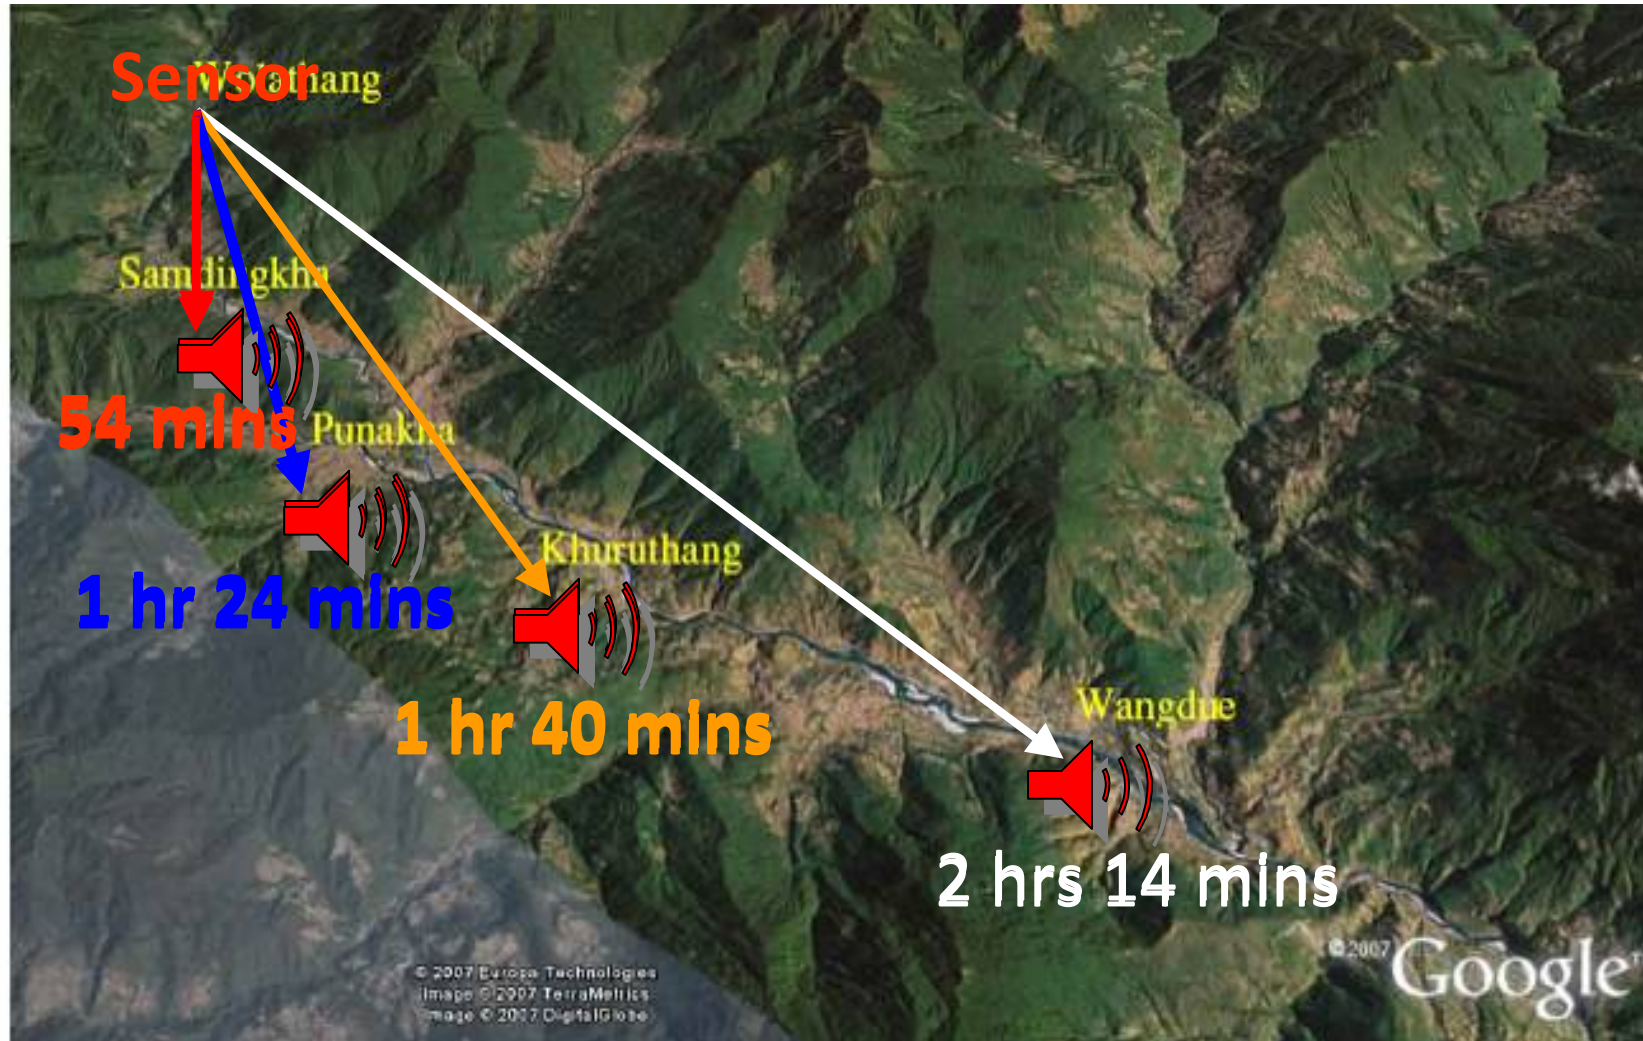
Early Warning

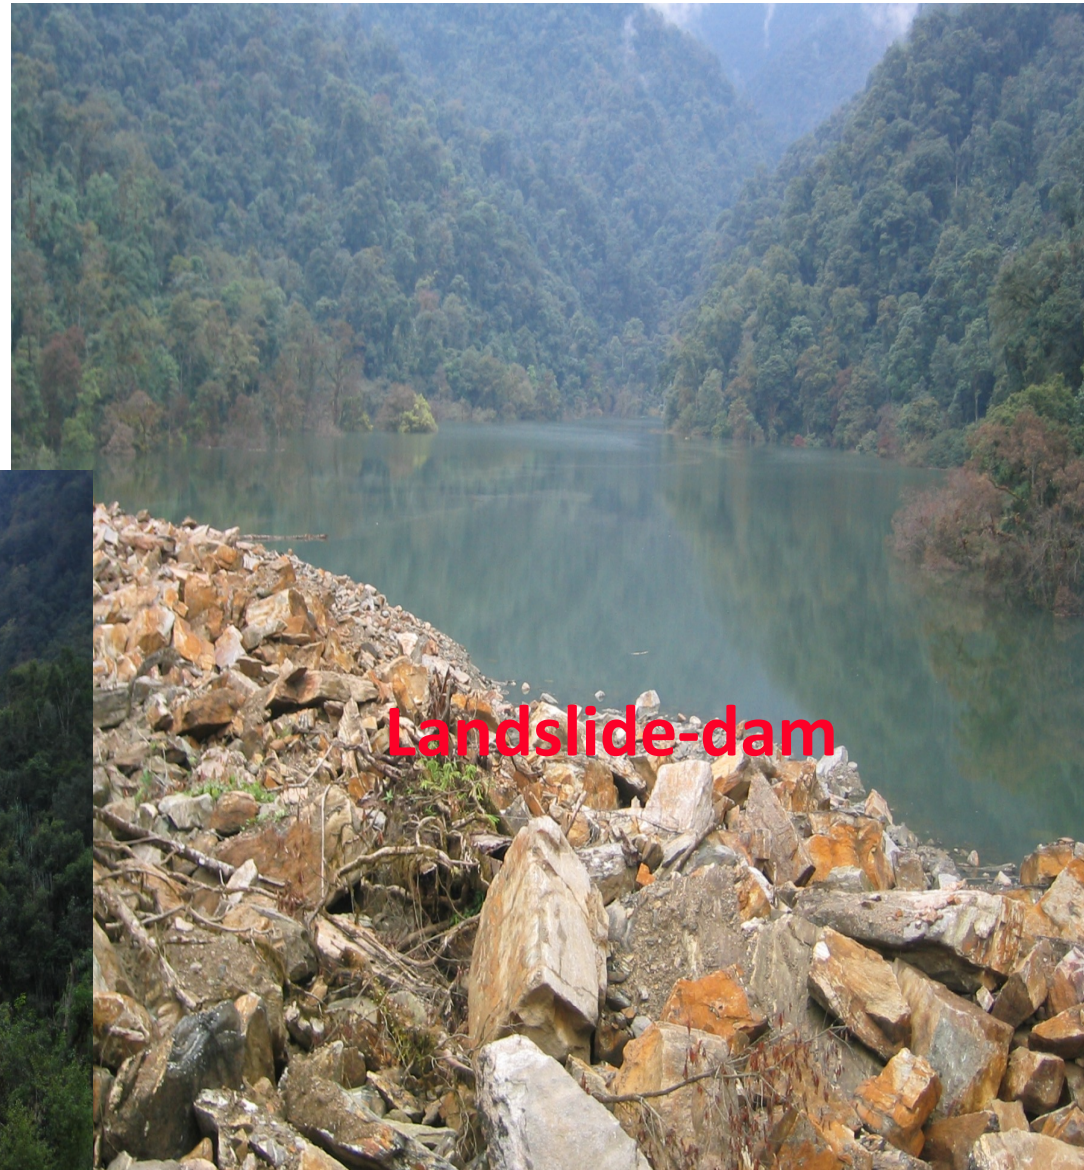
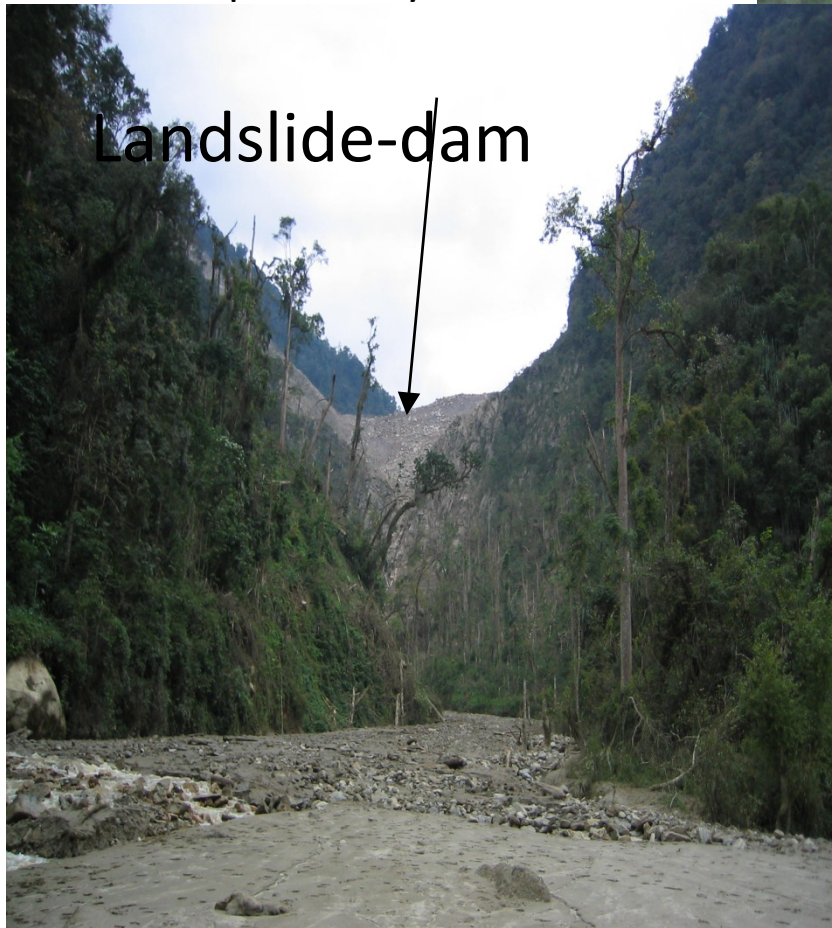
Landslide damming lake

One of the common threat in Bhutan is damming of the river system by the landslide and create havoc downstream (a typical example Tsateychu in Eastern

Landslide-dam

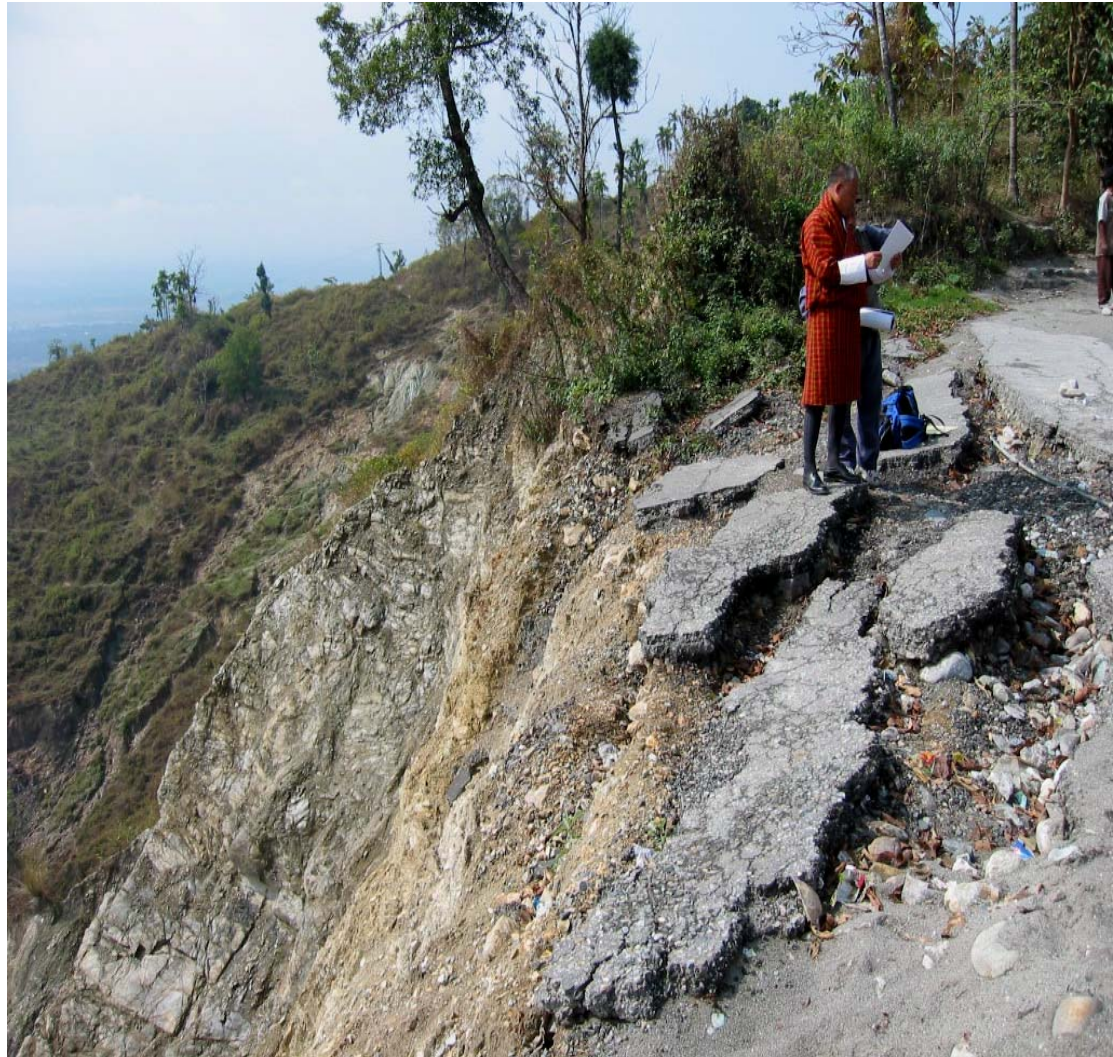
- This landslide is older than 15 years
- Construction of check dams (gabions) in 1999
- Effect of the 2000 monsoon
- Destruction of the road and checkpost
- New road under construction

Jumjha Slides (Rock Slide)

- The short term mitigation measures including careful scaling of the rock mass, wire mesh on the slope to retain the unstable rock masses from loosening and falling down to the road should be carried out. Flexible wire mesh fences should be constructed on the slope to capture the moving rock blocks.

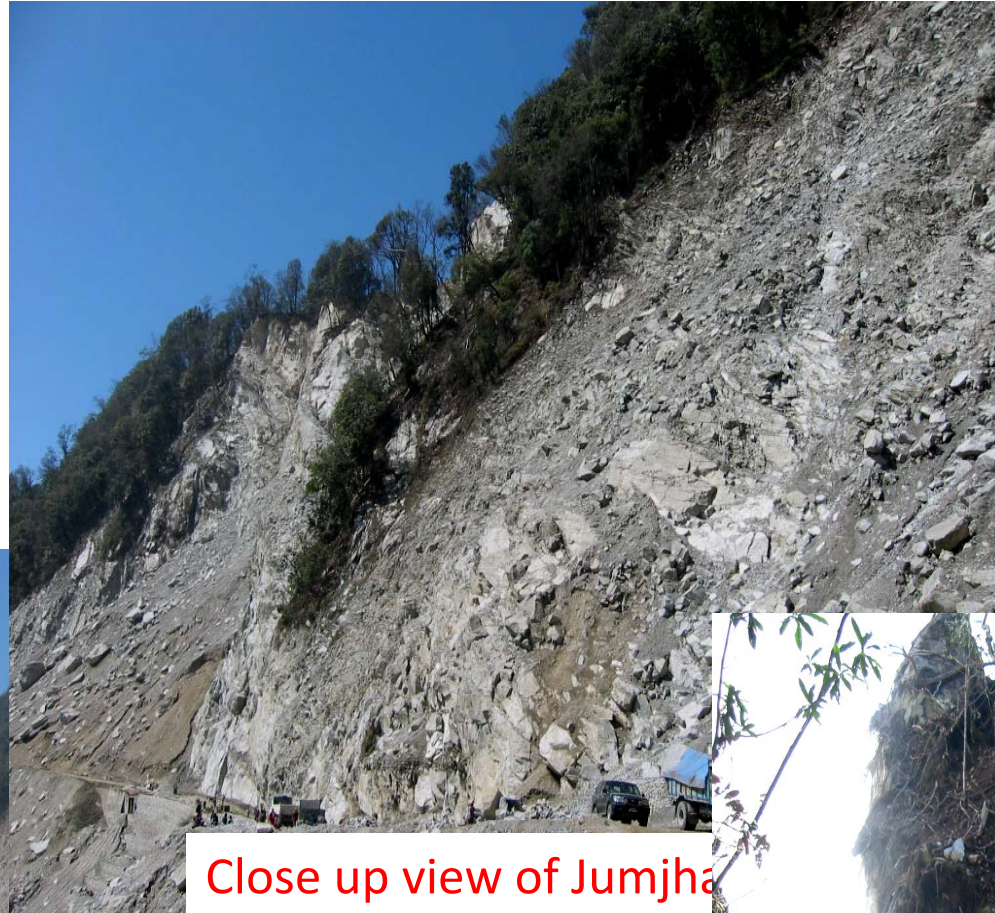
Close up view of Jumjha
