Survey Report on the Seti River Flood,Nepal (May 5, 2012)

November 2012

The Japanese Disaster Survey Team for the
Seti River Flood

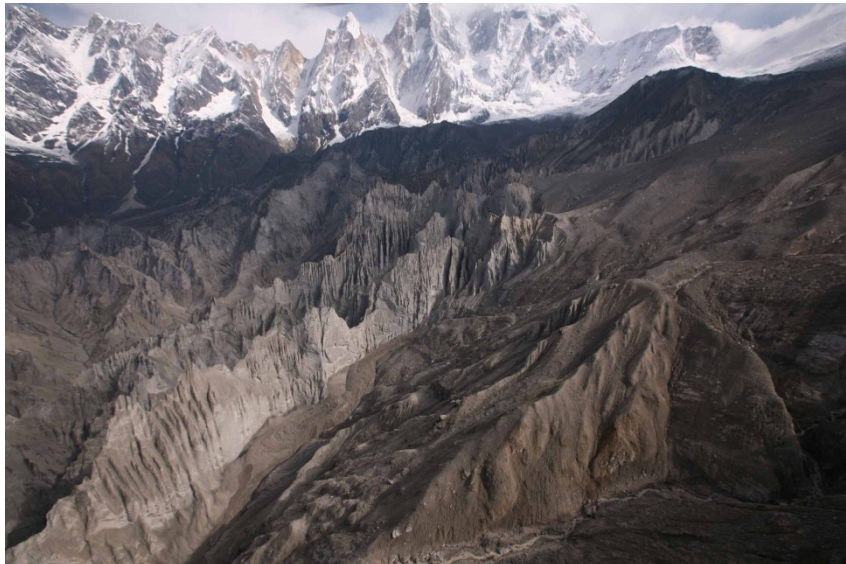
**Earth pillars of lacustrine deposits
(Rounded slopes appear in the right section.)**

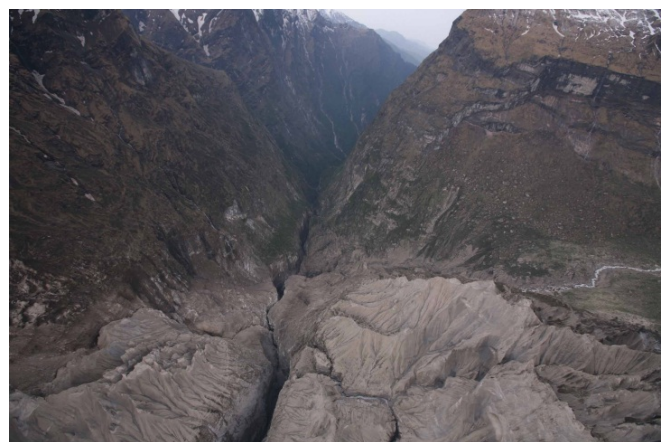
**The Seti Gorge formed in limestone
(Mud originating from the rock avalanche can be seen at the lower part.)**

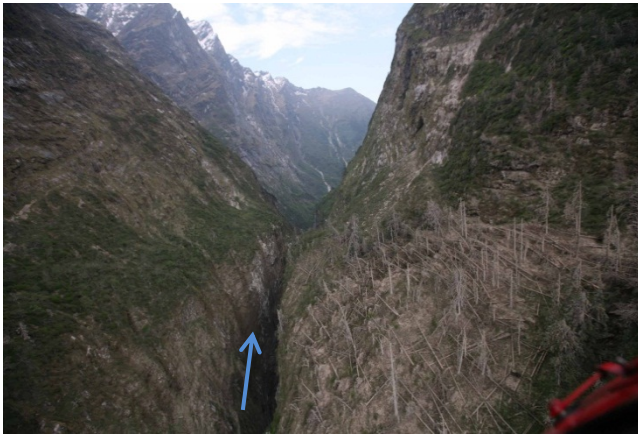
Trees falling toward downstream (There is mud clinging to them.)

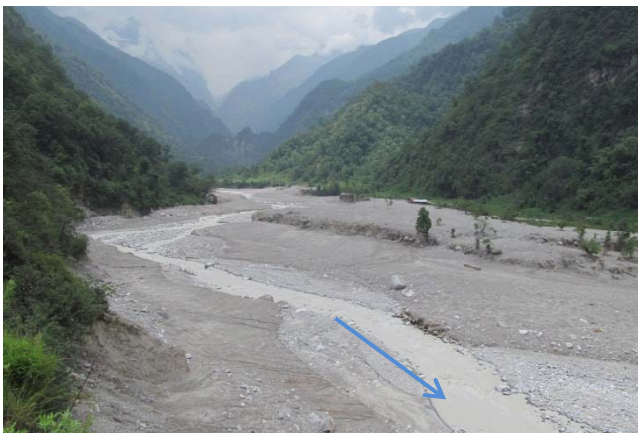
Temporary damming-up area near Kapuche (Two houses remain on the lower terrace at Yomo.)

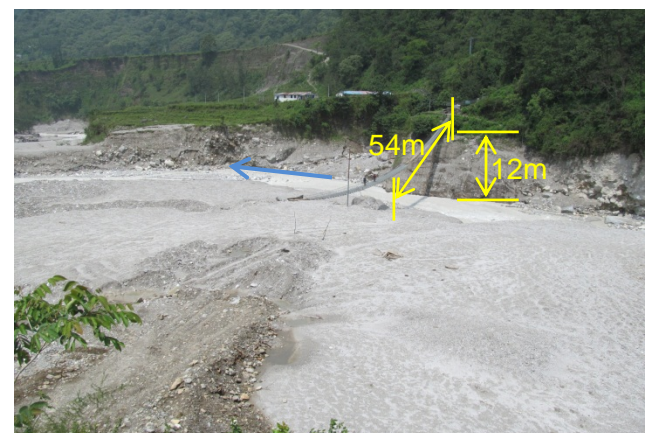
Disaster area around the suspension bridge at Karapani

(The flood overtopped the left-bank river terrace due to the momentary river blockage.)

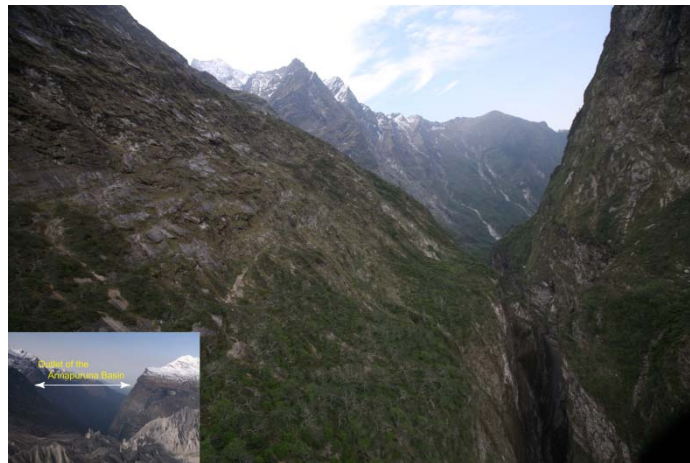
Image 6.2.1 Outlet of the Annapurna Basin

At the southeastern corner of the basin, a U-shaped valley develops as an outlet of the basin. The Seti River incises through the U-shaped valley,

The present stream of the Seti River deeply incises the bottom of the U-shaped valley of the Last Glacial Age and formed a narrow gorge (**Image 6.2.1**). The marl distributed inside the Annapurna Basin is also cut deeply into its base. Furthermore, downward incision onto the Nirgili formation of the Ordovician period overlain by the marl has progressed, forming a slit-like karstic ravine of 200 m in depth (**Image 6.2.3**).

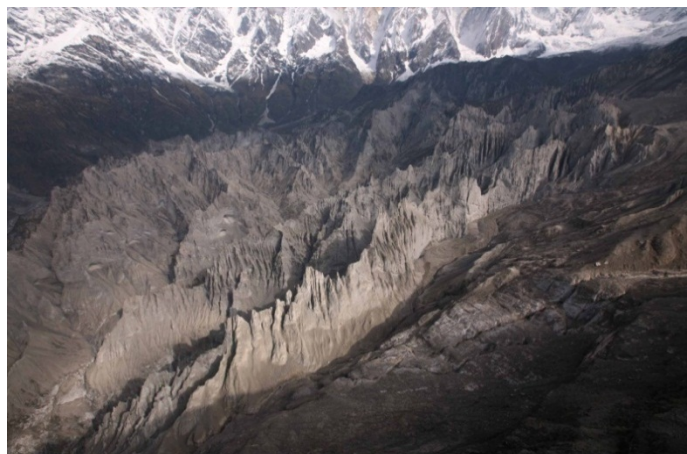
Image 6.2.1 The earth pillars and earth screen-ridge in the Annapurna Basin

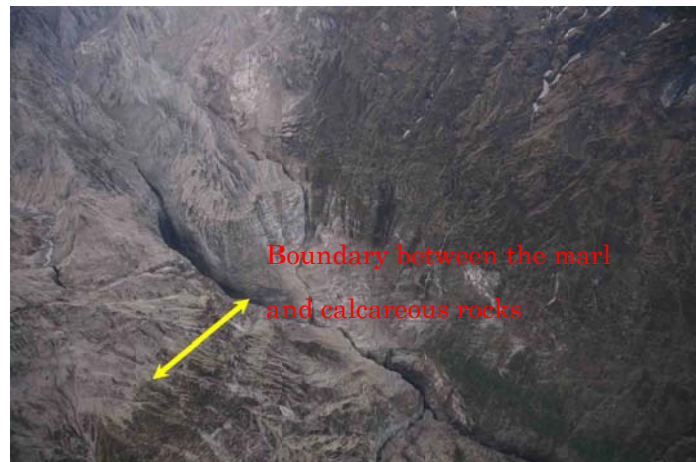
Image 6.2.2 Deep, a slit-like karstic ravine, incising calcareous sedimentary rocks called Niriglu formation

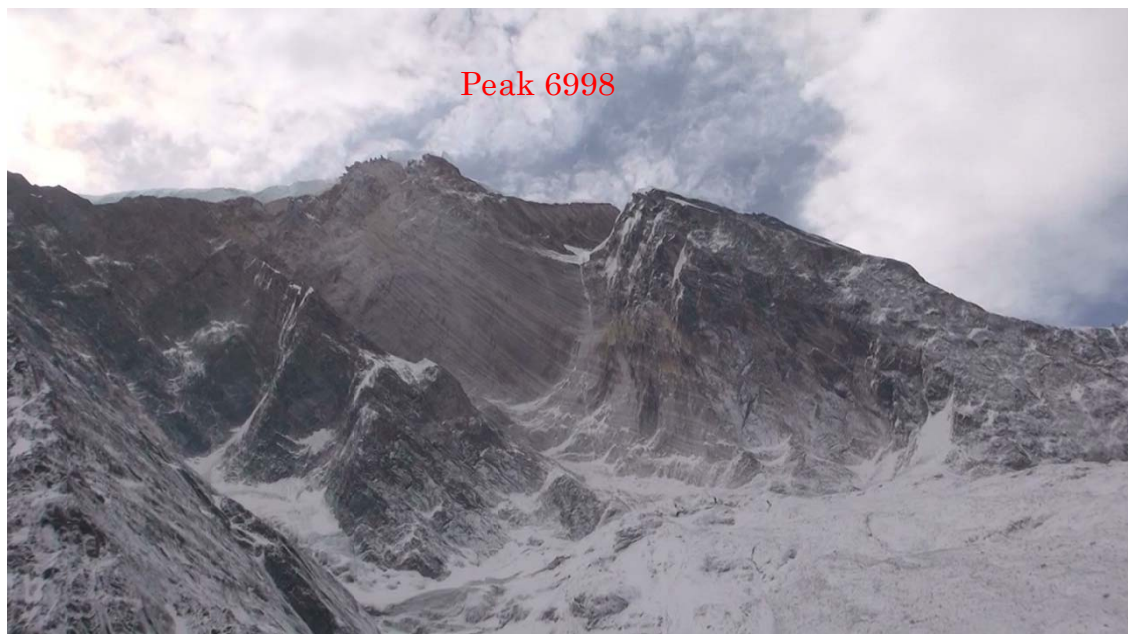
Image 6.2.4 Source area of rock failure just below the ridge top around Peak 6998

Light grey part is the source area of the rockslide.

The rock wall facing west just below the ridge between Annapurna IV and its southern sub-peak 6998 collapsed suddenly on 5th May, 2012 (**Image 6.2.4**). The maximum width and relative height of the rockslide are 500m and 1000m respectively. Blocks of the rockslide fractured at the foot of the wall and scattered on the glacier and subsequent rock avalanches run off on the glacier and the marl area (**Image 6.2.5**).

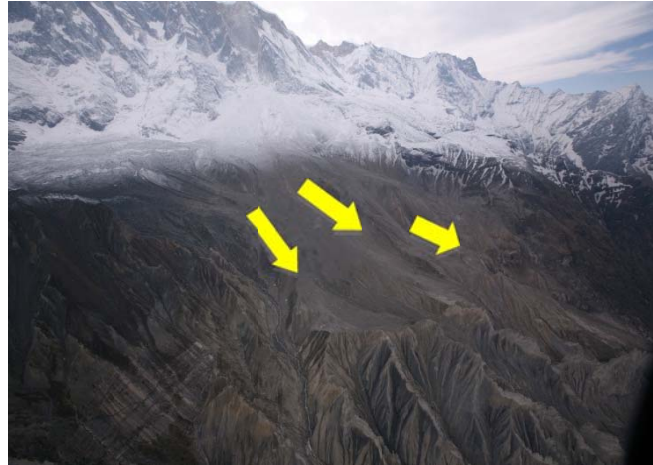
Image 6.2.5 Passage area of the rock avalanches

Coincidentally, there was a big cloud of rock flour rolling. The average slope gradient from the foot of the wall to the inlet of the gorge is about 14 degrees. There is no gentle slope to reduce the speed of the rock-debris avalanches. The passage of high speed rock avalanches must have induced severe erosion on the glacier ice and the marl, because the surface of the glacier, the earth pillars and the rough-edged screen-ridges along the passage route of the rock avalanches looked rounded (**Images 6.2.6 & 6.2.7**). The height of the destructive blowing wind that caused severe erosion must have been up to 100m because a few rows of the earth pillars and screen-ridges in the eastern side were only rounded due to erosion, implying that they blocked the passage of the rock avalanches to the west by themselves.

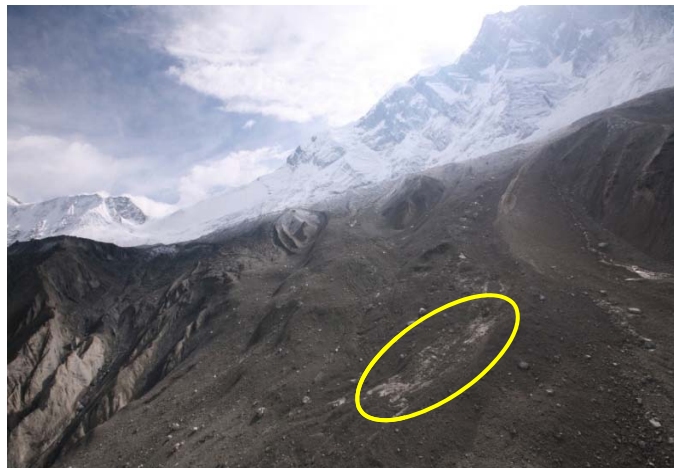
Image 6.2.6 Eroded glacier surface

Note the glaring ice inside the yellow oval.

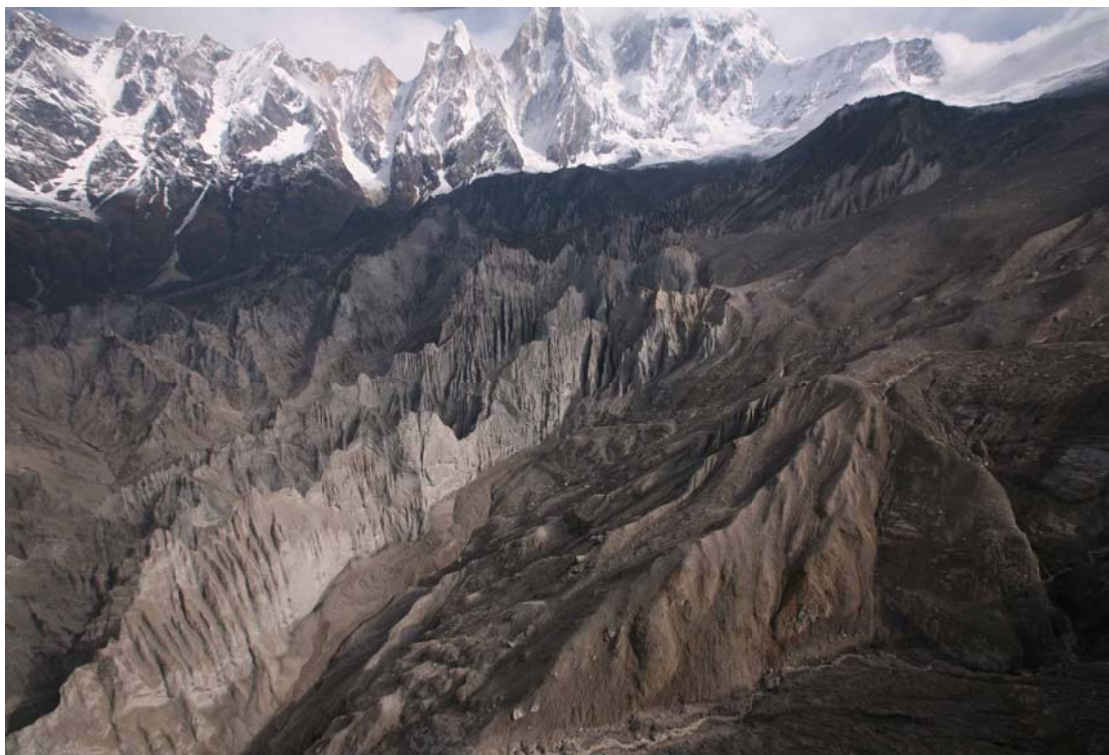
Image 6.2.7 Rounded earth pillars and screen-ridge due to passage of the rock-debris avalanches
Sticky mud flow lobes are also recognized along the stream floor.

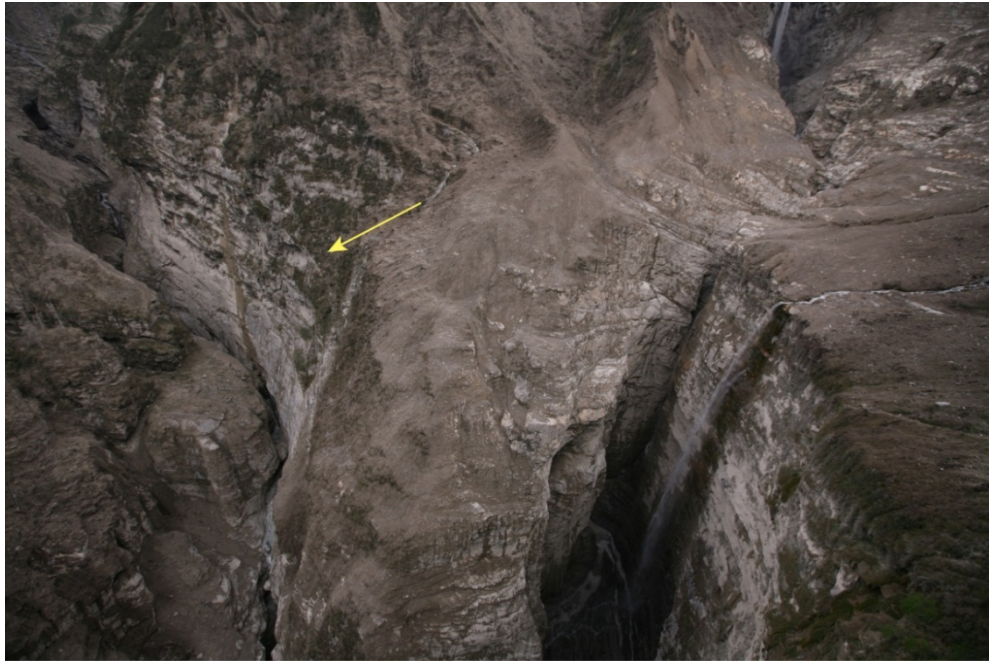
Image 6.2.9 Rock-debris avalanches impact site just beside the Seti Gorge

Most of trees on the ridge were swept away by the main body of the debris avalanches and some of those distributed in its marginal parts were blasted out by the strong wind.

Yellow arrow indicates the direction of blasted trees.

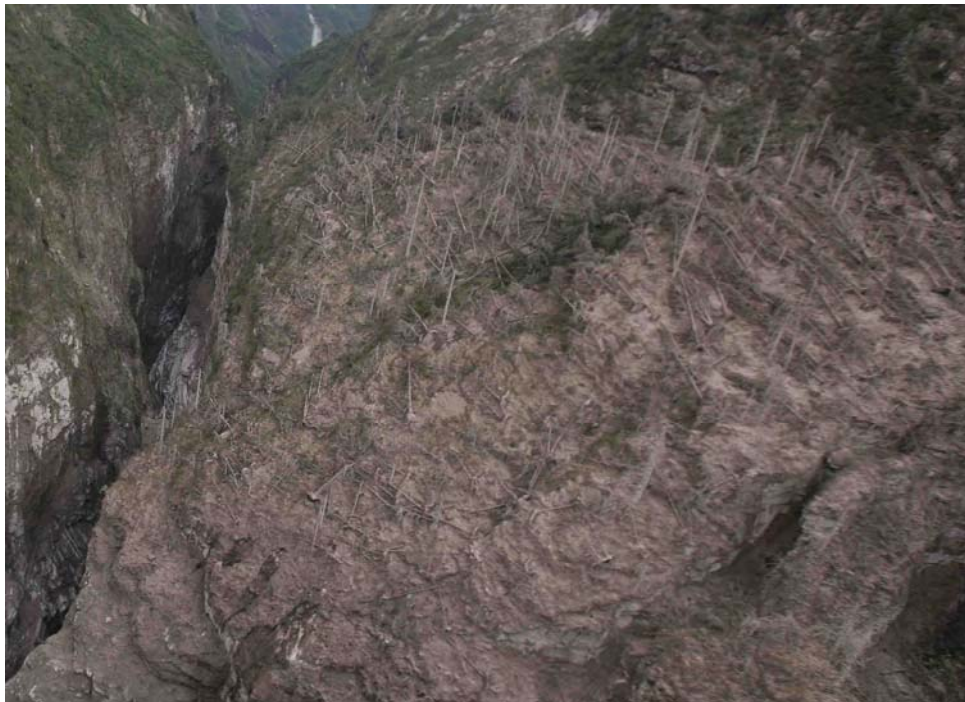
Image 6.2.10 Coniferous trees blasted out by the accompanying strong wind with the debris avalanches on the right bank of the Seti gorge

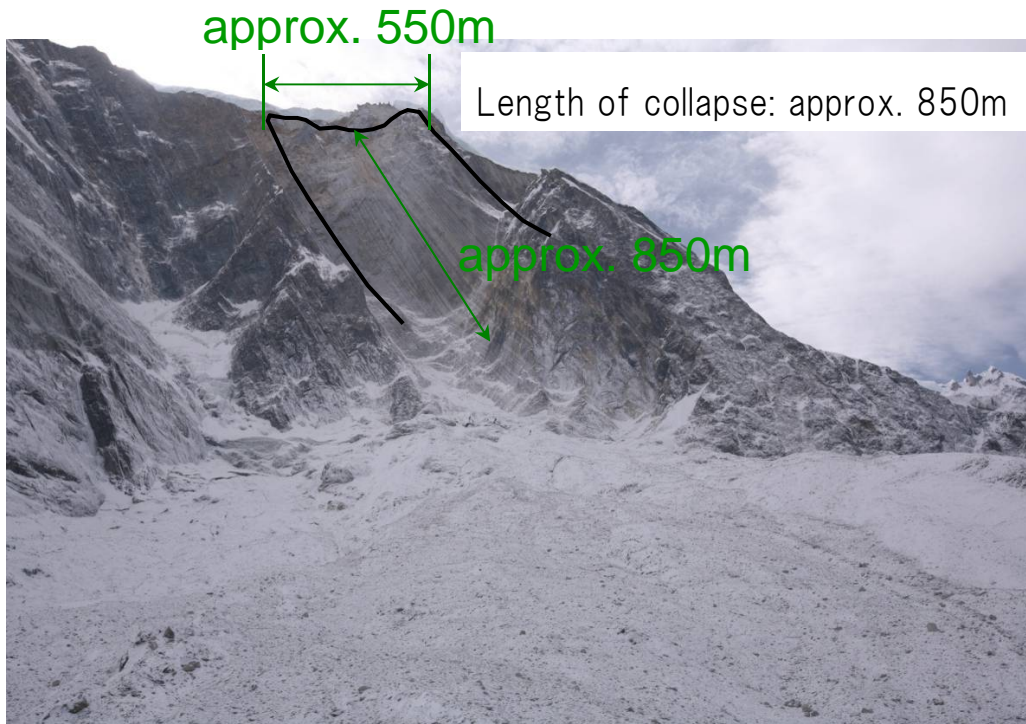
Image 6.2.13 Estimate of scale from the photos taken from helicopter investigation (04/06/2012)

Estimated from the helicopter photographs based on the breadth of 550m established above (**Image 6.2.13**).

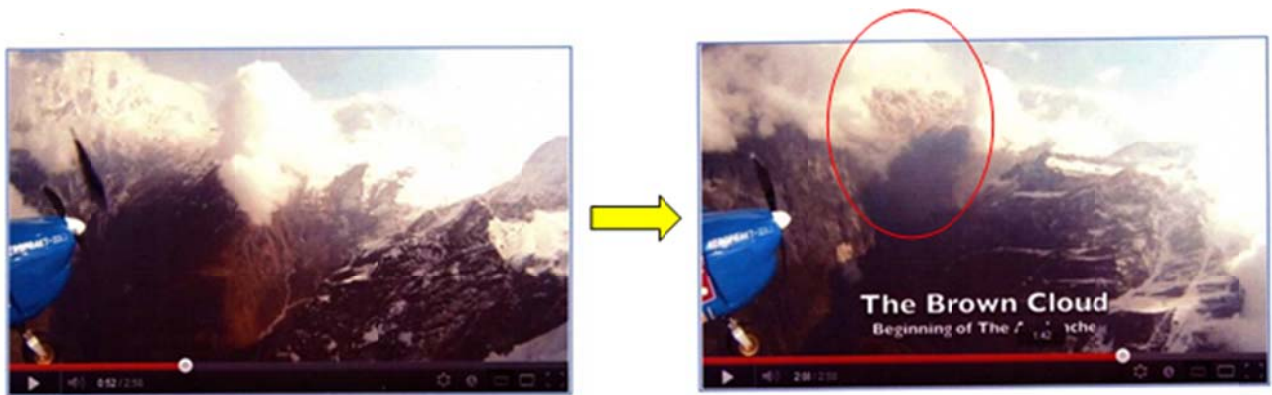
Image 6.3.1 Two video scenes taken by A. Maximov (Avia Club Nepal)

The videos shot by A. Maximov, the pilot of an Avia Club Nepal light plane, have occasionally indicated the time of rockslide occurrence on the west-facing cliff of Annapurna peak (Petley, 2012c). A big change was found among two video scenes with a shot time gap of 76 seconds (**Image 6.3.1**). Extreme dust smoke covering the southwest slopes of Annapurna which was not seen in the former scene (left) appeared in the latter (right). S. G. Eksrom, a Columbia University geoscientist suggested that the local earthquake around this area indicates the occurrence of a landslide, and that the time was 9:09:56 AM (Nepal Local Time) on May 5 (Petley, 2012).

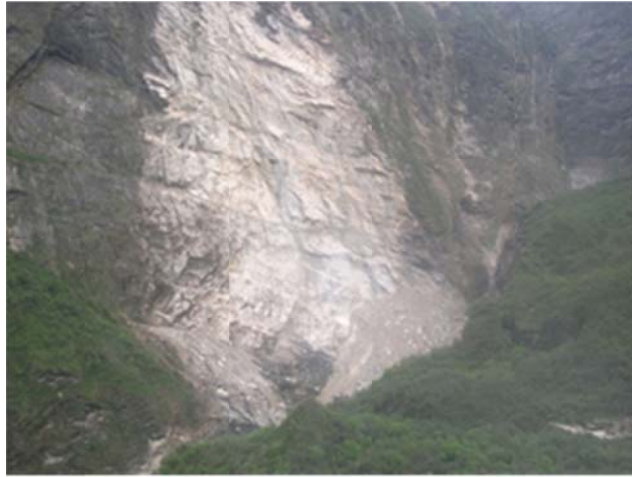
Image 6.4.1 Rock slide on the right bank slope of the Seti River

Rock flour with a large amount of mud originating from both eroded marl deposits and the dust of rock fracturing due to the rock slide and rock avalanche was carried into the Seti Gorge and mixed with river water. Dust was often reported during the rock avalanche (Bandari and Kumar, 2000; Wieczorek, et al., 2000), and it was widely observed on the foot slopes of the rock slide area in the Landsat image taken on 6 May (Stark and Petley, 2012). Downstream from the fresh rock collapse, which was formerly believed to form the Seti River blockage (ICIMOD, 2012) (**Image 6.4.1**), continuous devastation of the forest along the river was observed, and the main process of transporting debris was by river water. The outer river bank of the two bending points of the Seti River just upstream of the narrow gorges was eroded up to 30m above the riverbed and some slope failures occurred (**Image 6.4.2**).

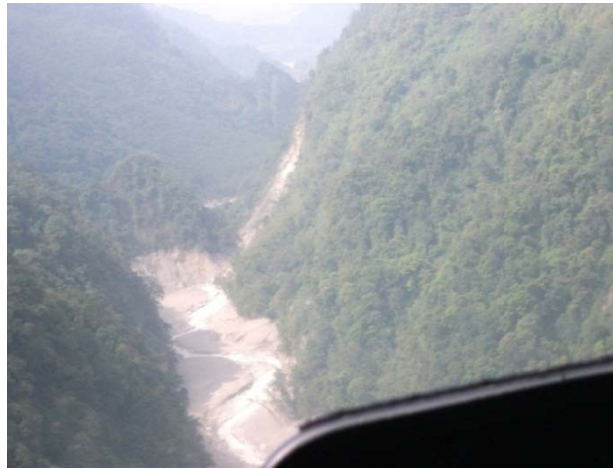
Image 6.4.2 River bank erosion and slope failure at the narrow bend of the Seti River

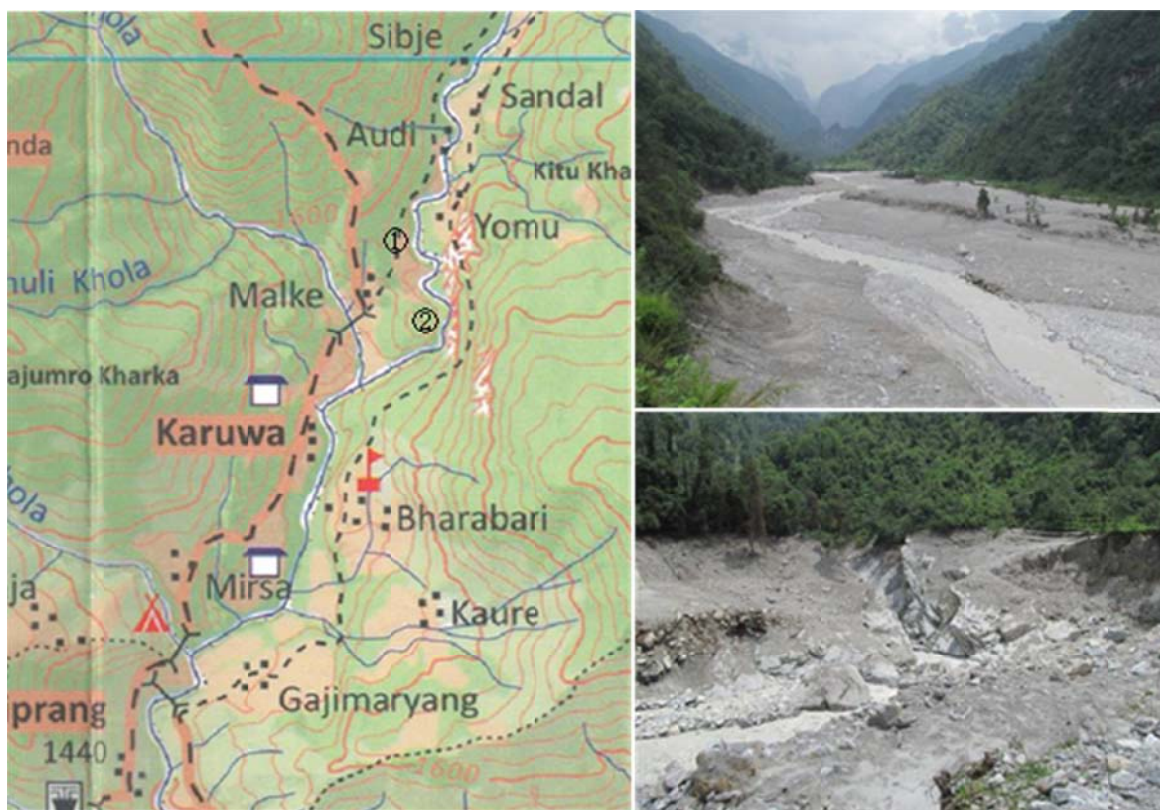
Fig 6.4.1 Riverbed conditions around and upstream of the third bending point

Since the riverbed gradient is about 5 degrees up to 1km downstream from the third bending point, breached materials from the temporary damming seem to have moved as a debris flow. The surge soon reached the Kharapani Bridge.

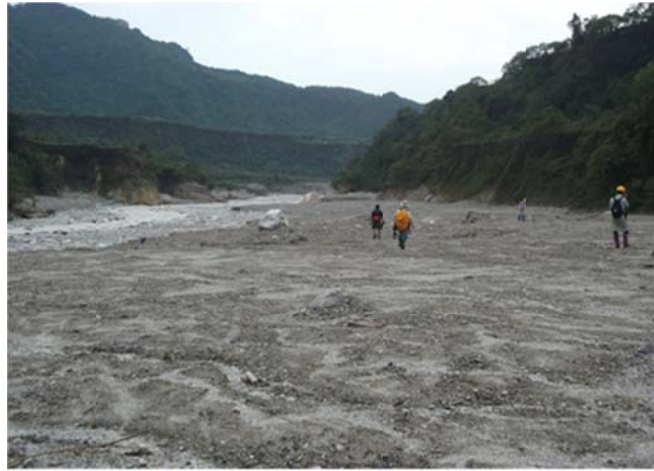
Image 6.4.4 Mud and gravel covering the lower river terrace (Baraudi)

In the flood deposits on the lower terrace, fine materials of less than 20cm in diameter such as gravels with mud, are dominant (**Image 6.4.4**). Gneiss and round gravels were not observed frequently. The main source of sediment was Tethys sediments and marl. The mud flow reached Kharapani at 9:38 (Dahal, 2012), so the travel time of the flood must have been around 30 minutes, indicating that the average speed from the origin to Kharapani was 60km/h. The high velocity surge was due to the gorge being strait and narrow with steep riverbeds from the reaching point of rock avalanche to the first river bending point. The large amount of logs which formed temporary dams at narrow or steep bends originated from the thick riparian forests along Seti Khola due to rare human intervention.

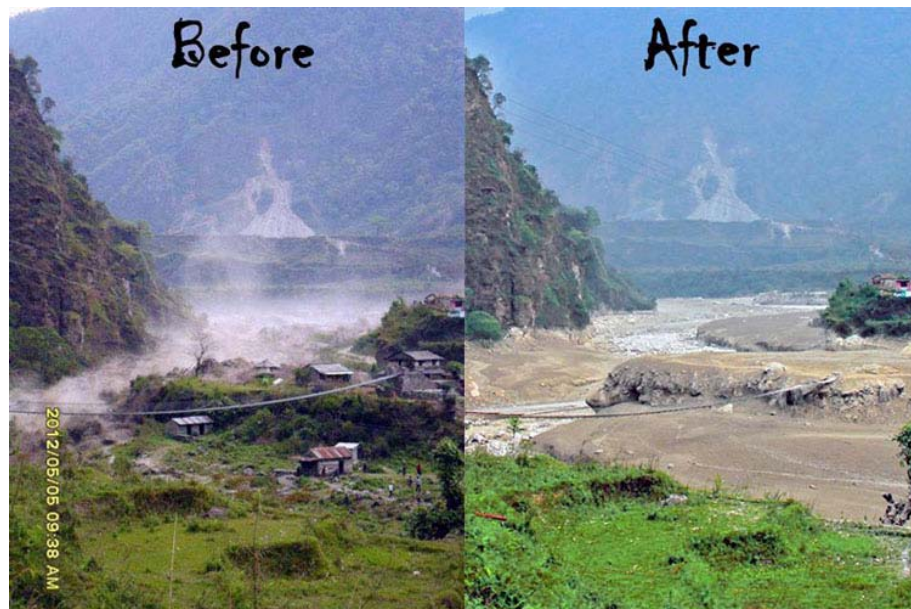
Image 6.5.3 Status before and after the flood at Kharapani (Dahal, 2012)

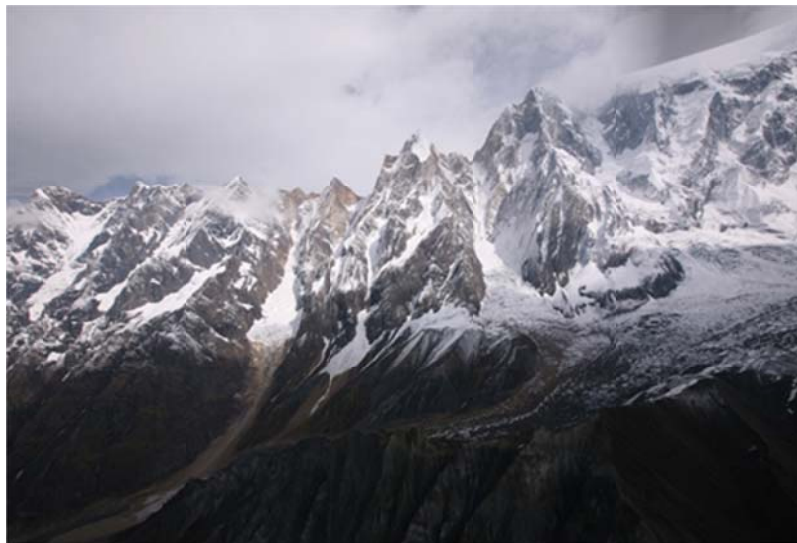
Image 6.7.1 Evidence of recent rockslides on the east-facing slopes at the south of Annapurna III peak (Light brown part in the center)

Though the timing and location of similar flash flood disasters can hardly be forecasted, fine materials such as paleo-lake deposits, glacial deposits beneath the high steep slopes, or unstable large-scale landslide slopes that are actively dissected by torrents or rivers are prone to similar types of flash floods. In particular areas where there is less chance of humans being nearby like the uppermost basin of Seti Khola, should be monitored aerially or by special survey. Evidence of another recent rock collapse could even be observed on the steep slopes around the Annapurna Basin (**Image 6.7.1**).

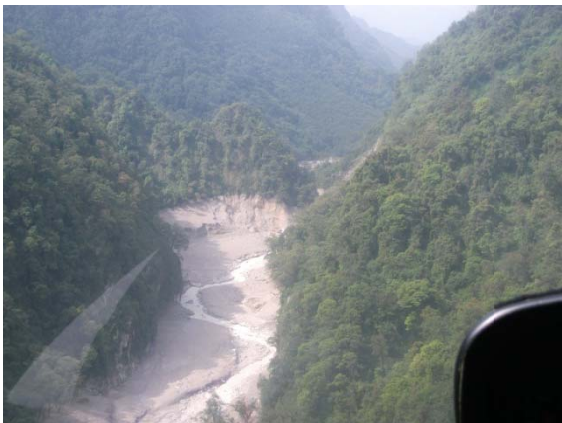
Bank erosion up to 30 m in height at the second bending point of the Seti River

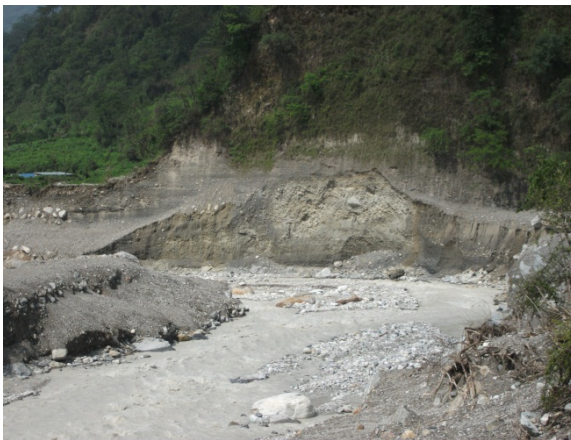
Strong bank erosion of consolidated gravel deposits by the mud flow (Baraudi)

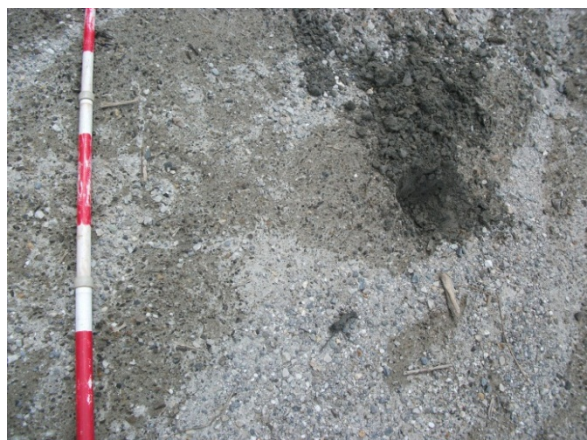
Flood deposits of fine materials (Baraudi)

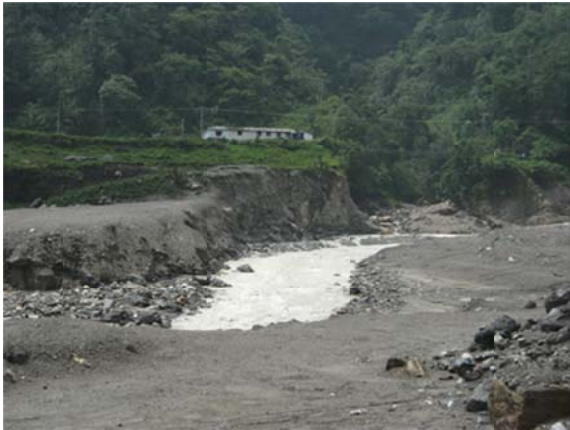
Coverage of mud flow deposits of fine materials on the lower river terrace (Kharapani)
