Status of Early Information System and Support of DWIDP to Community DRR

Department of Water Induced Disaster Prevention (DWIDP)

December 2014

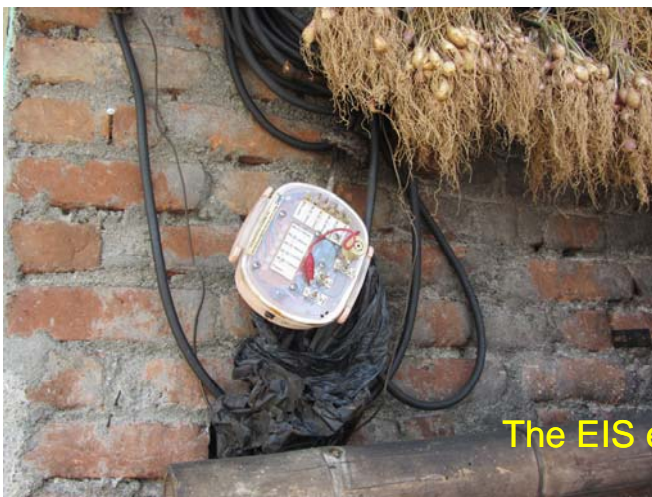
The EIS rain gauze installing

- **The EIS installed on roof terrace of the house of Mr Kedar Tamang. (consists of Solar panel, battery, warning system and rain gauze)**

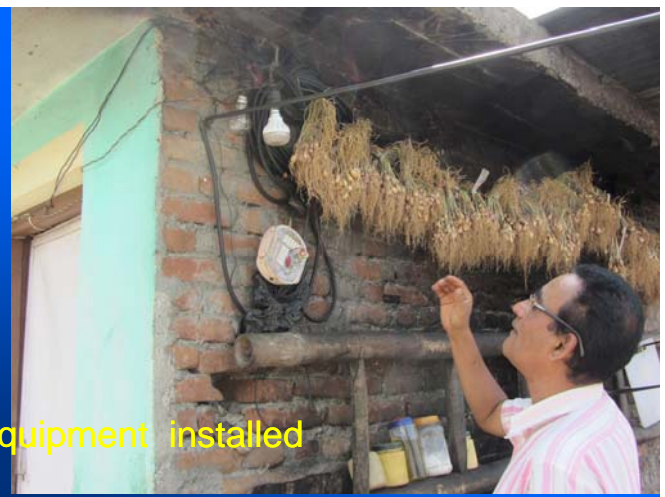
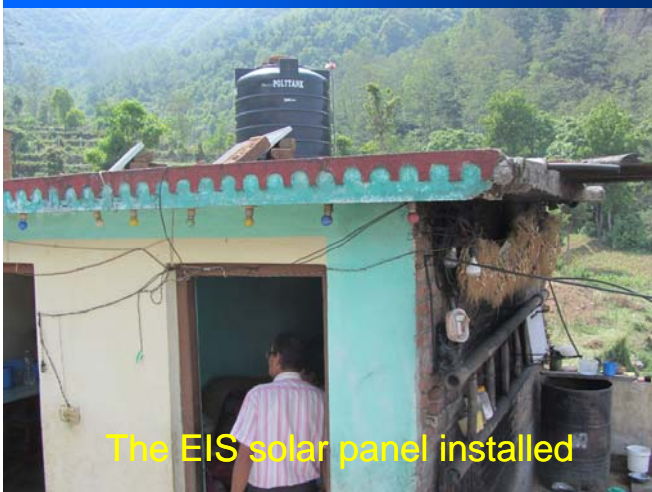
The EIS equipment installed

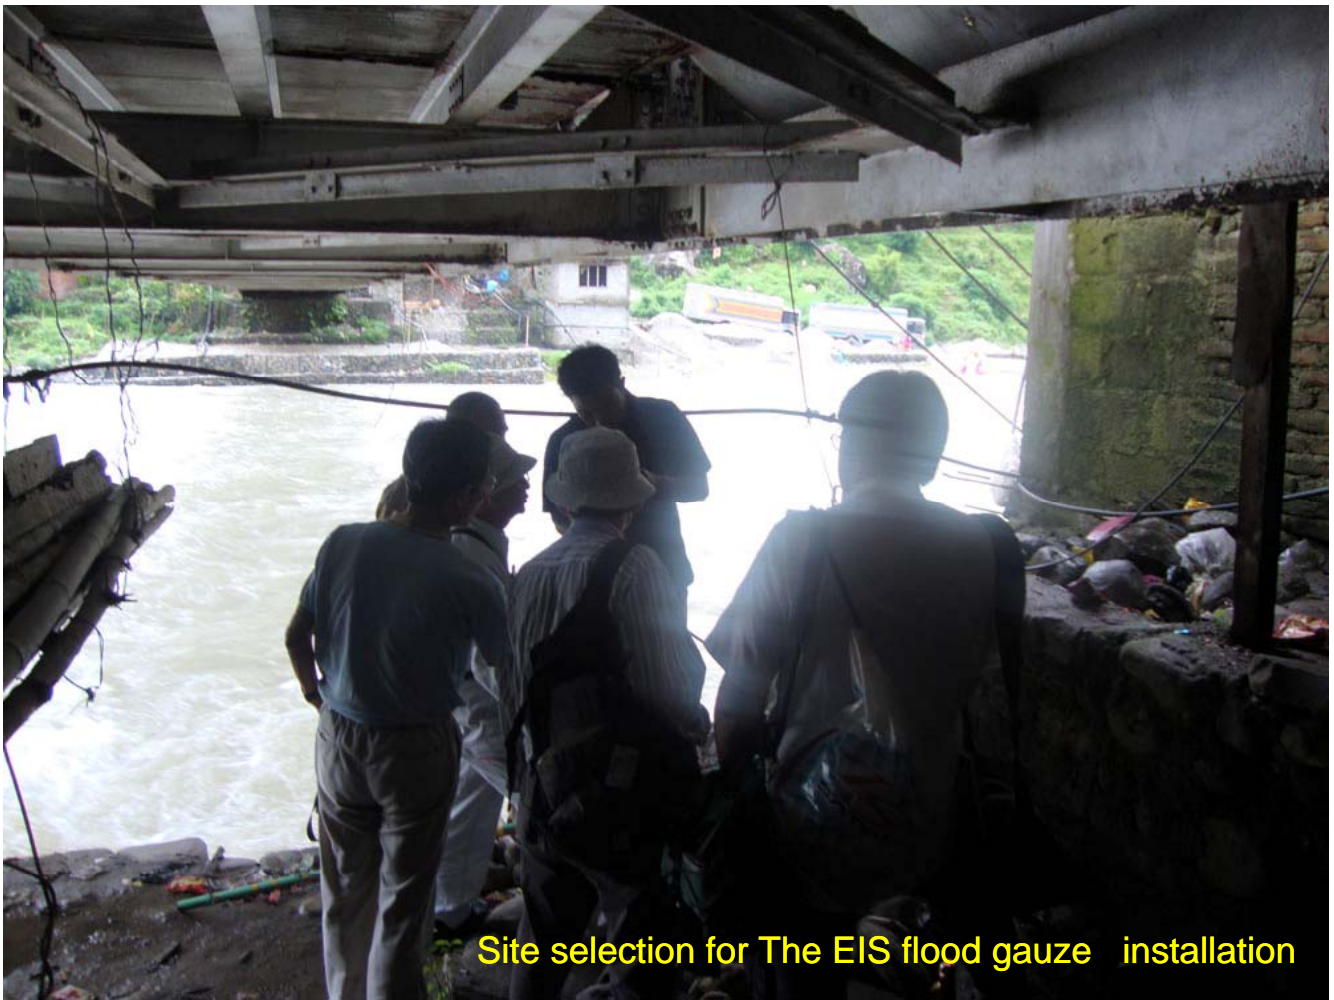
Khadichaur Flood gauze Station for Flood warning

- **The EIS installed at right bank of Sunkoshi River, below the bridge (Khadichaur-Jiri road). The equipments were installed in the house of Mr Padam/Bhim/Hira Tamang. (consists of Solar panel, battery, warning system and flood gauze)**

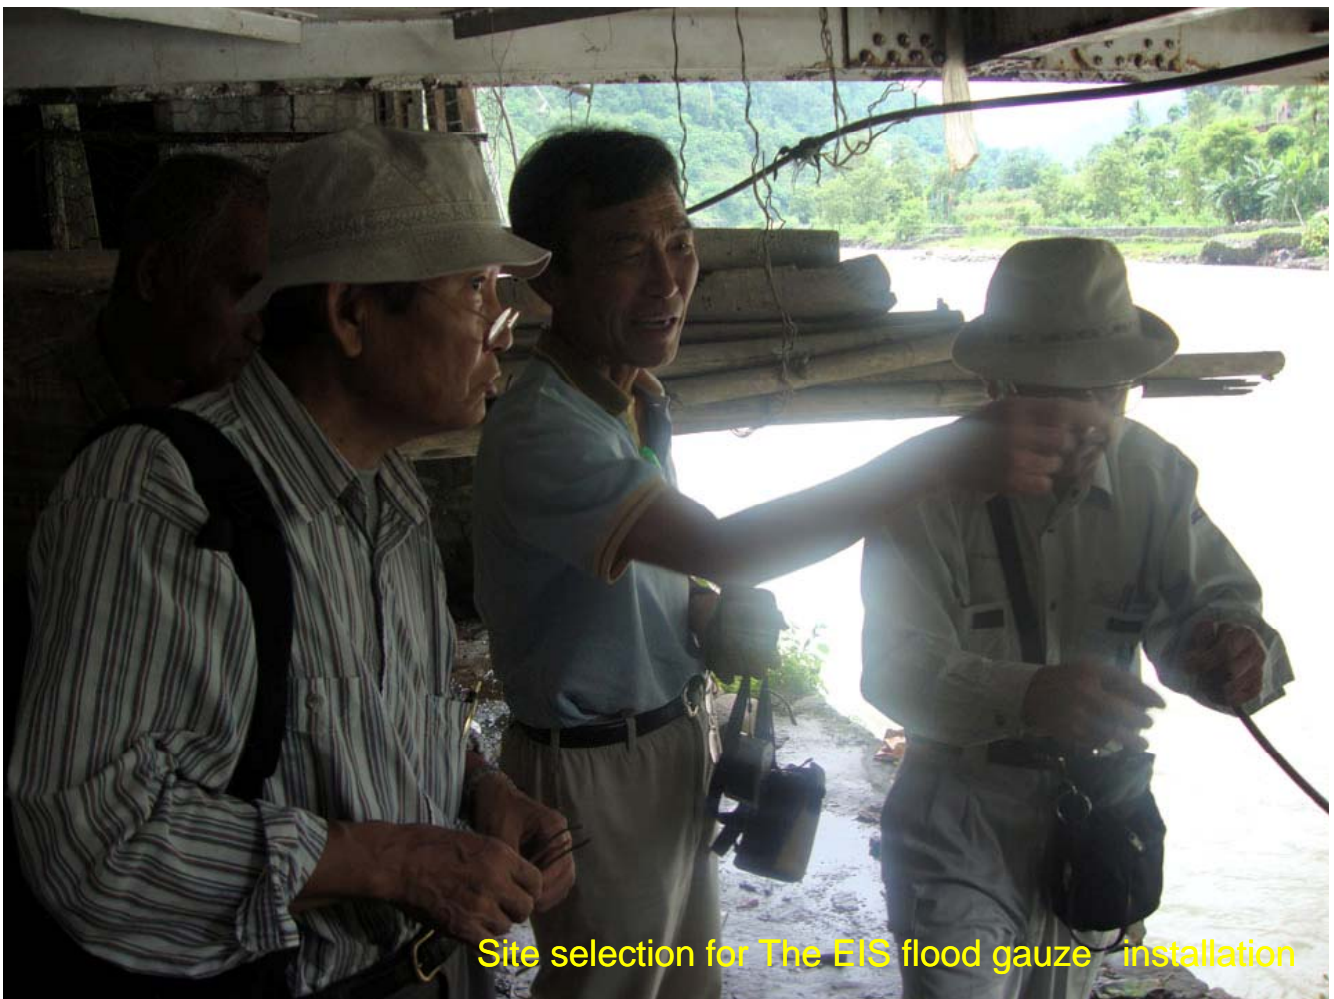
Site selection for The EIS flood gauge installation

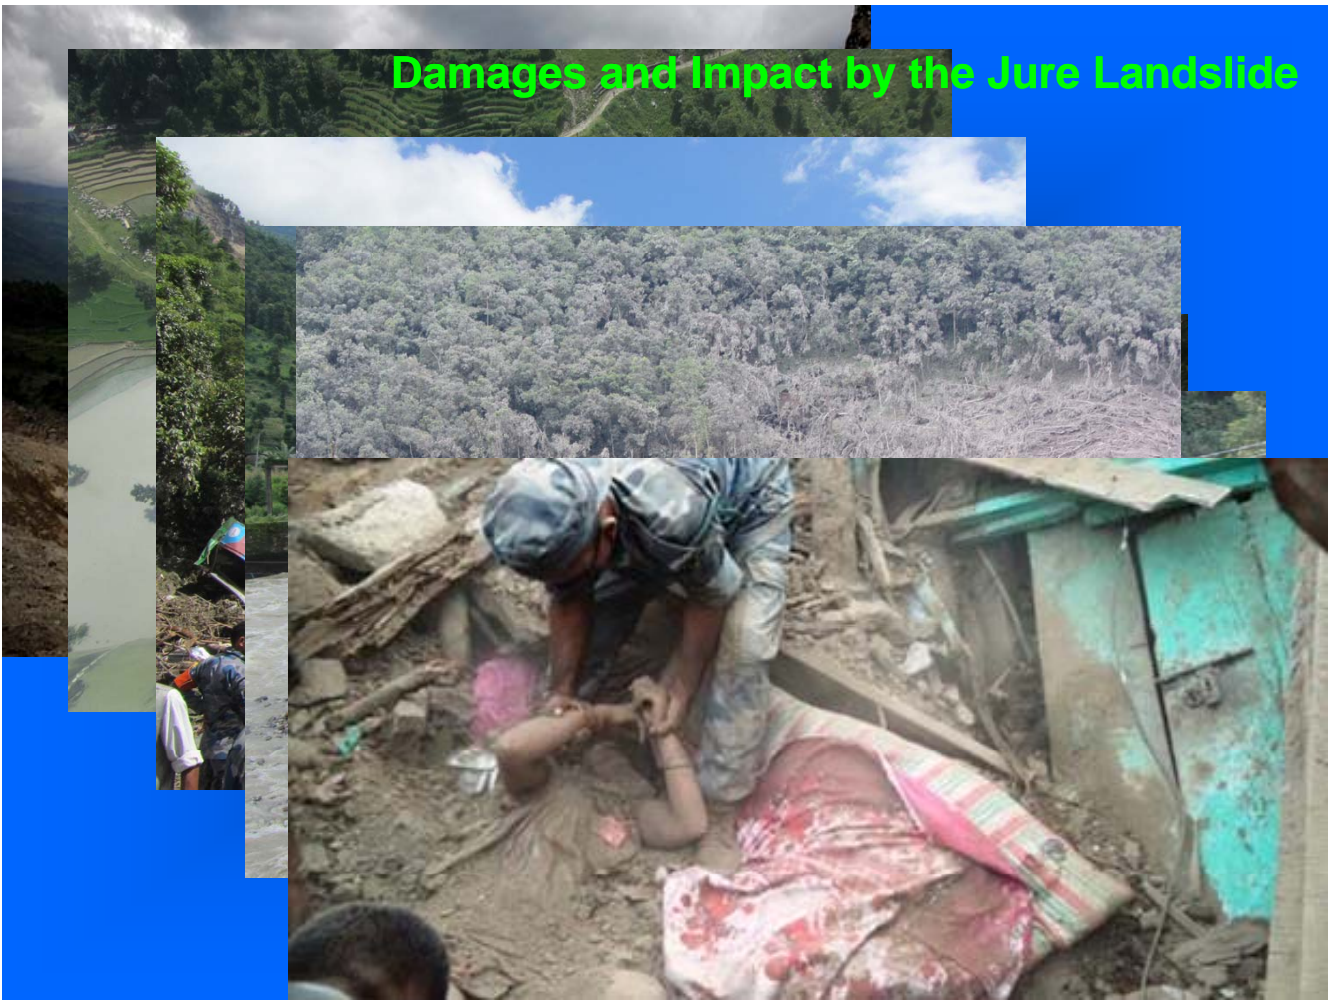
Damages and Impact by the Jure Landslide

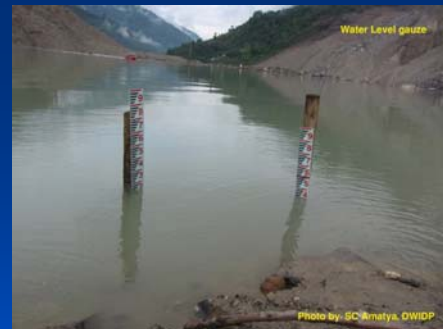
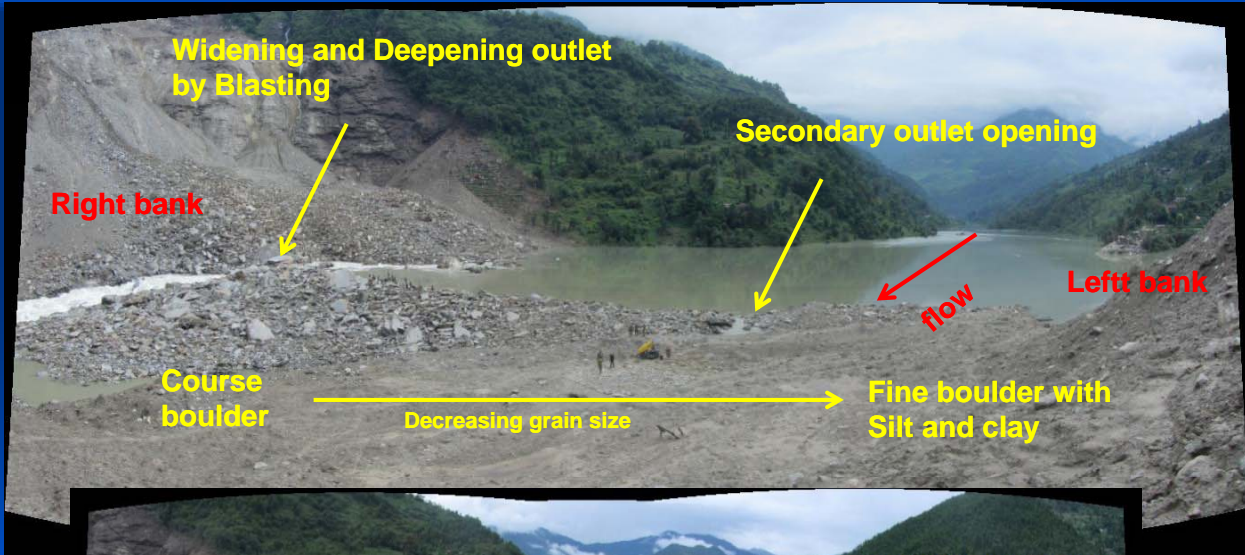
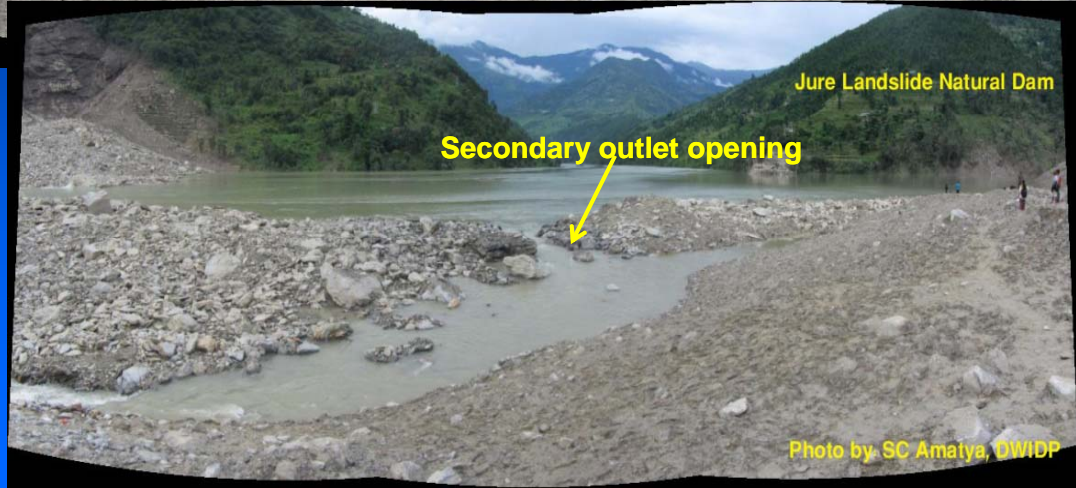
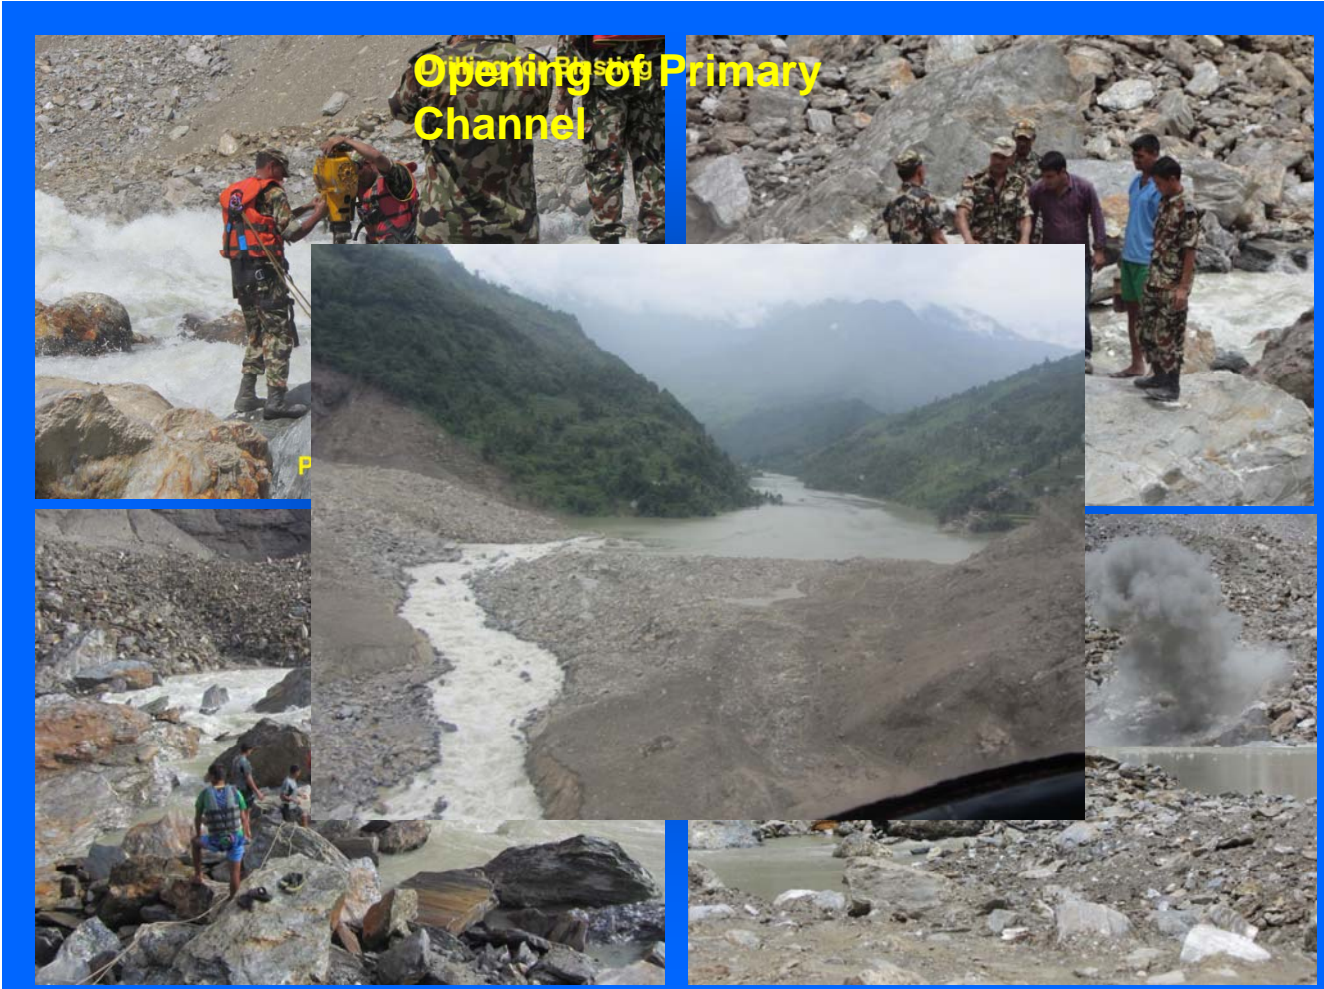
Gauge Plate installed to monitor the lake water level.

Length of Lake:	3.1 KM
Maximum width:	390m
Average width:	195m
Water Surface Area:	4,52,500 m ²
Maximum depth:	47 m
Average depth:	21 m

Approximate volume of water in the lake:
80, 00,000 m³

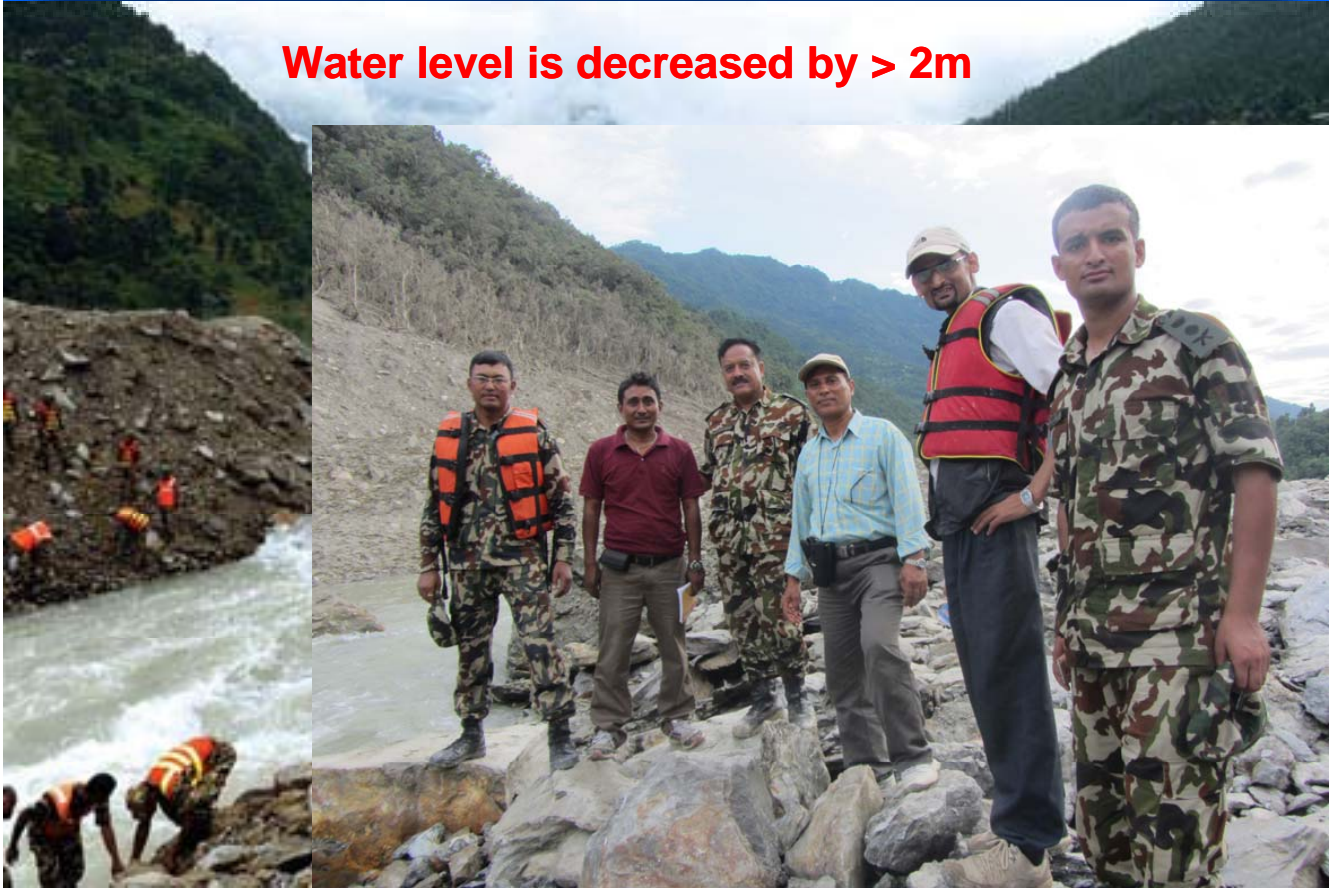
Efforts to open the Secondary Channel

Water level is decreased by $> 2m$

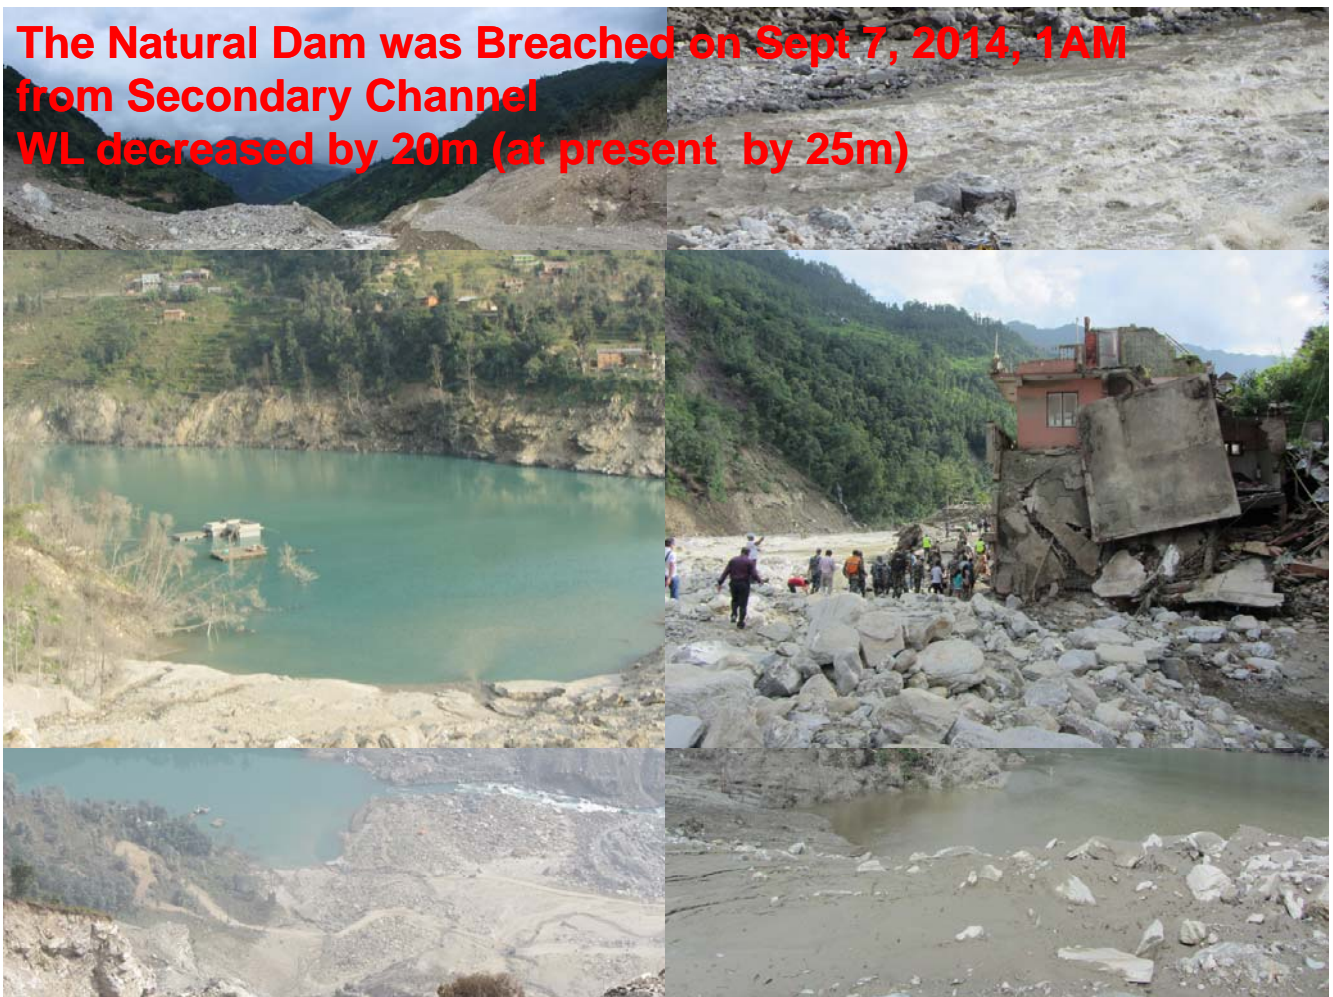
The Natural Dam was Breached on Sept 7, 2014, 1AM
from Secondary Channel
WL decreased by 20m (at present by 25m)

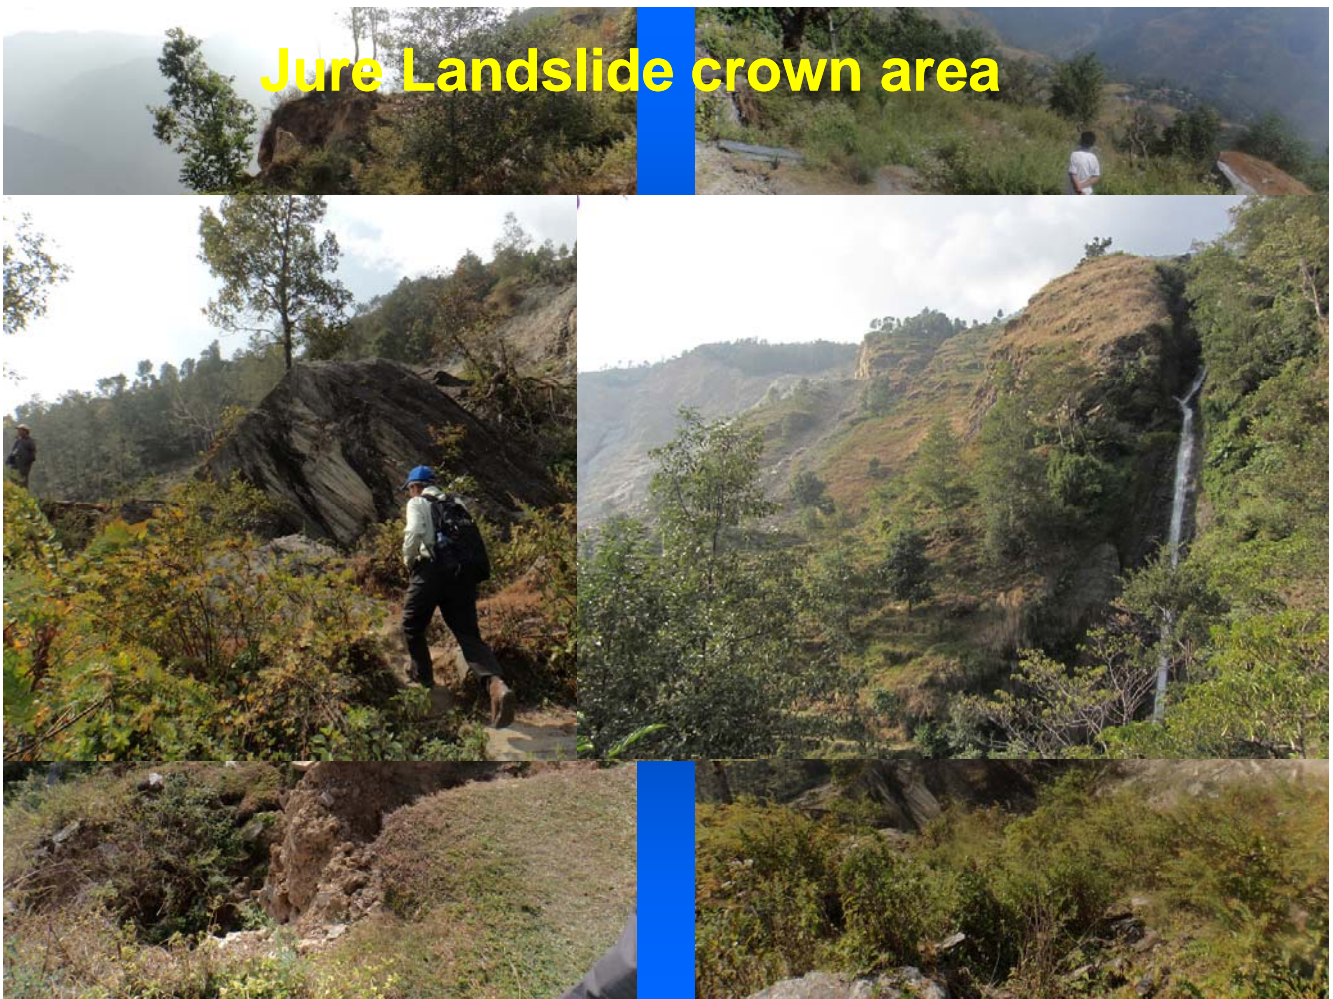
Jure Landslide crown area

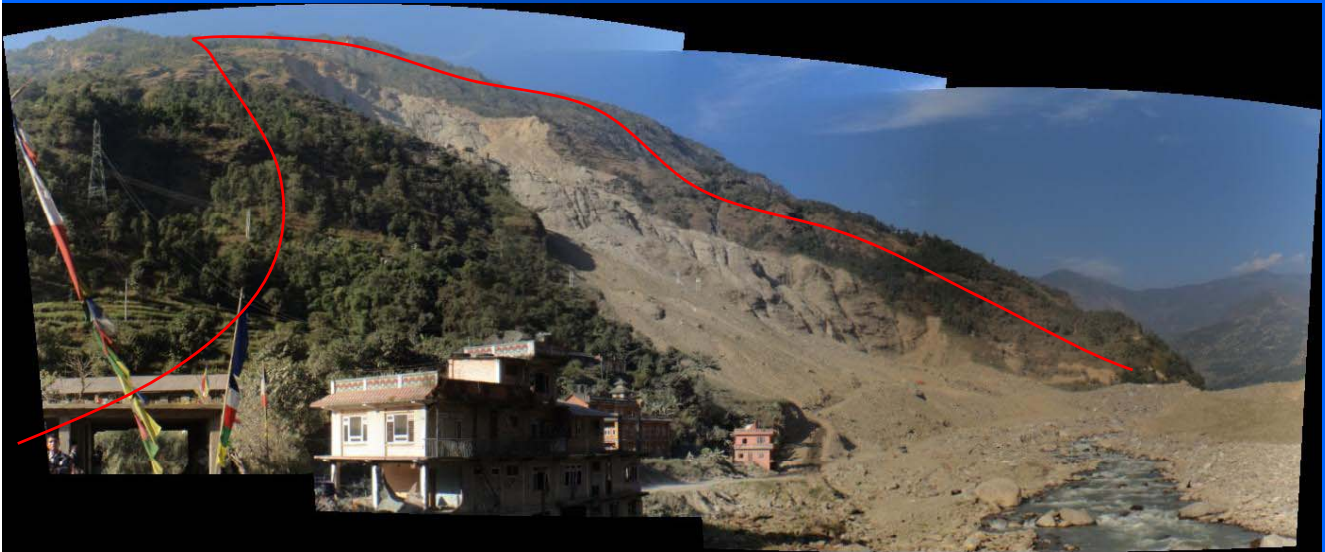
Vulnerable and Early Warning Area

100m periphery of Landslide and flood plane area

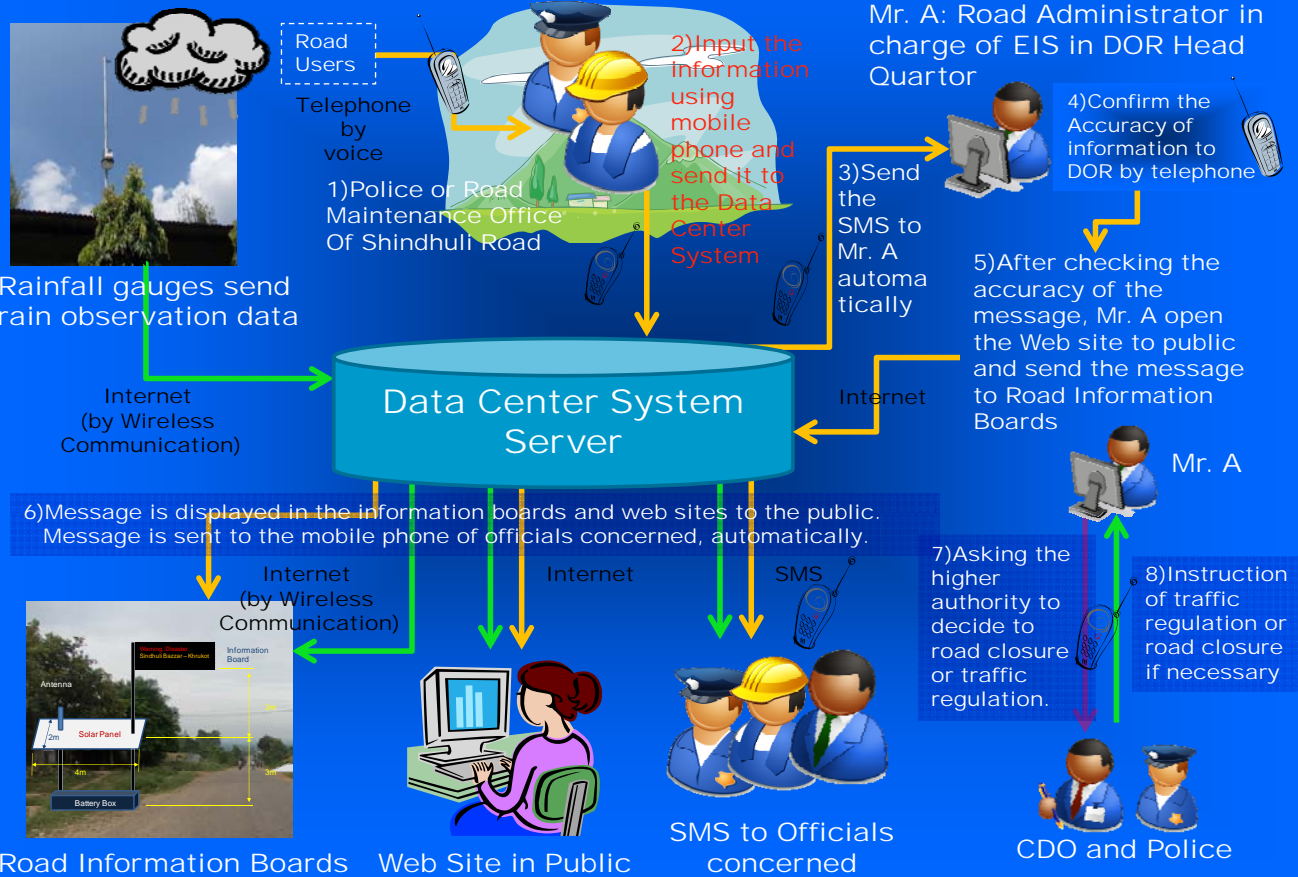
EIS flow in Sindhuli Road

Case1 Heavy rain

Case2 Disaster or Accident

- rain observation data flow (altogether automatic)
- disaster or accident data flow

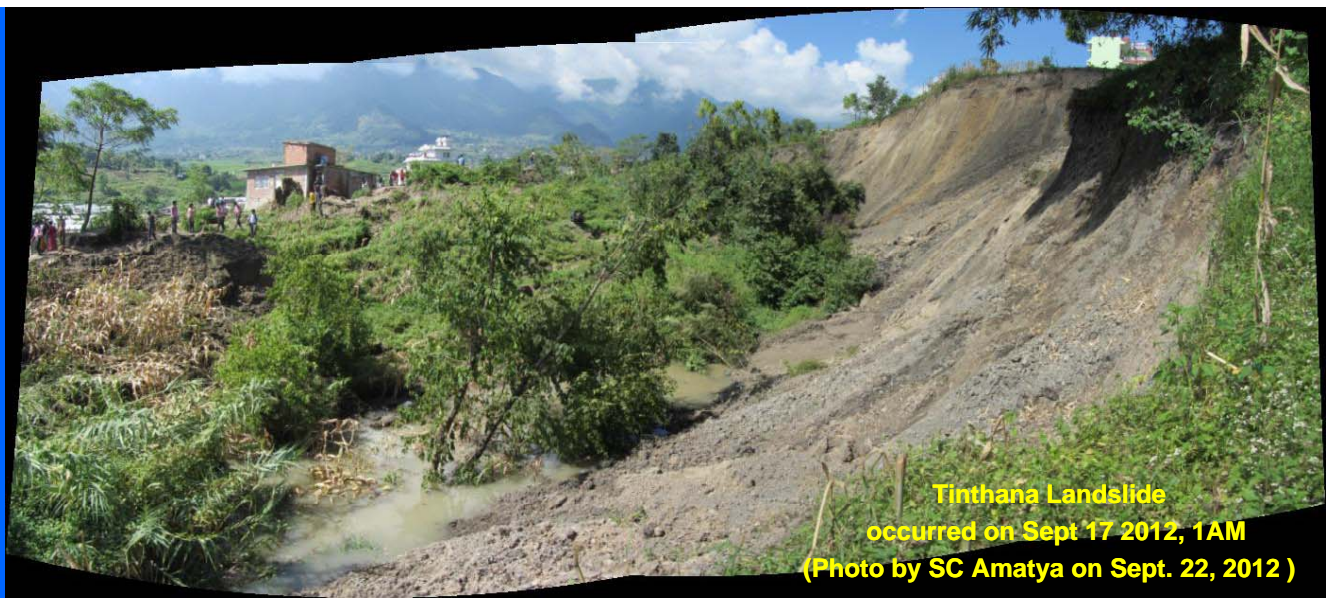
Tinthana Landslide
occurred on Sept 17 2012, 1AM
(Photo by SC Amatya on Sept. 22, 2012)
