Three Large Historical Landslide Dams and Outburst Disasters in the North Fossa Magna Area, Central Japan

Keywords: Landslide Dam, Debris Avalanche, Tobata Landslide, Zenkoji Earthquake, Mt. Iwakura Landslide

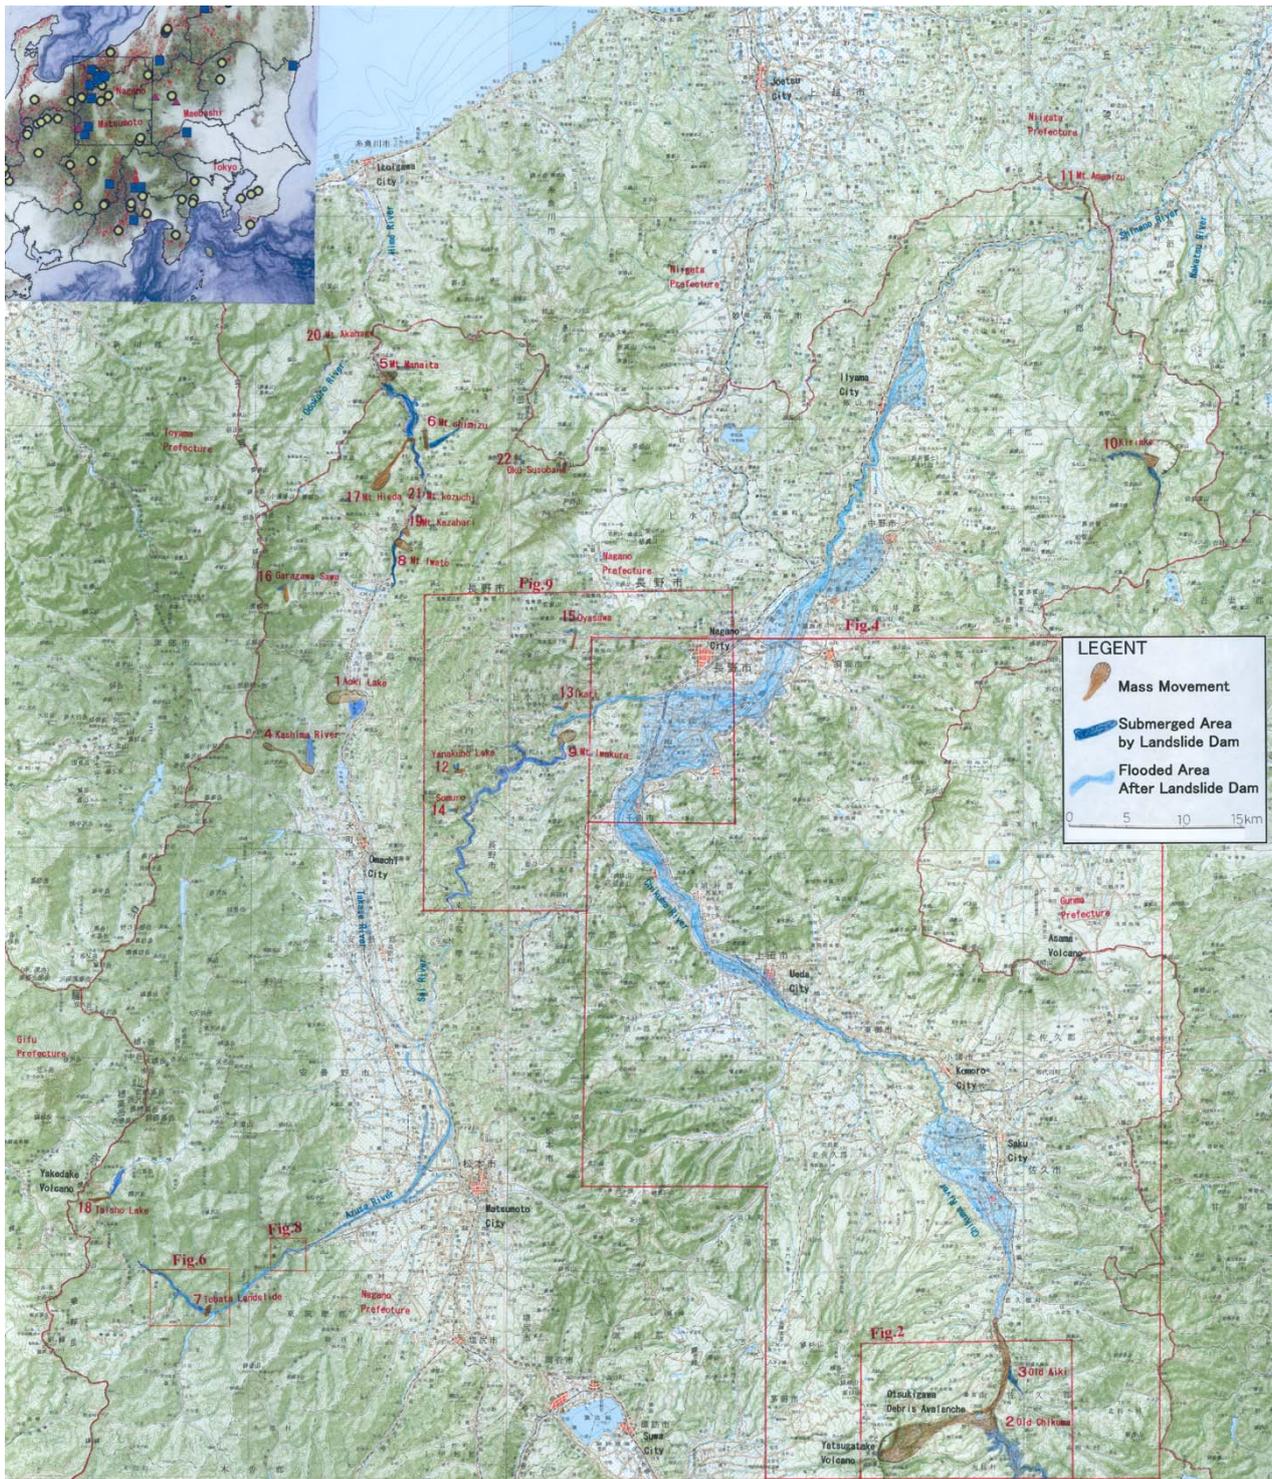
Fig. 1 Distribution of landslide dams in the northern part of Nagano Prefecture, central Japan (See Table 1 for the numbers of landslide dams)

Table 1 lists landslide dams in the northern region of the Fossa Magna, in central Japan. As many as 22 landslide dams have been recorded in this area and all except three of these have broken.

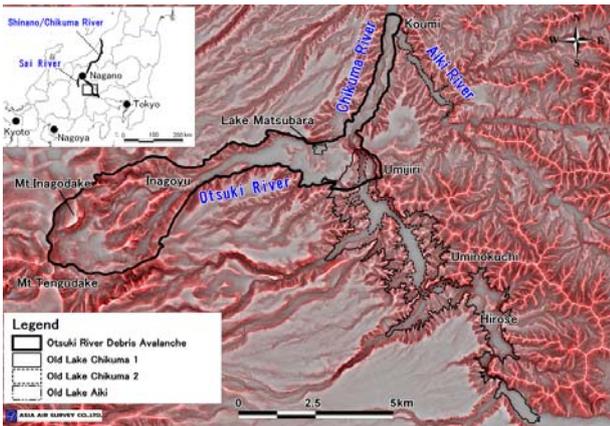
Fig.2 Relief map of Yatsugatake Volcano, the debris avalanche, and the landside dams formed (Inoue et al., 2012)

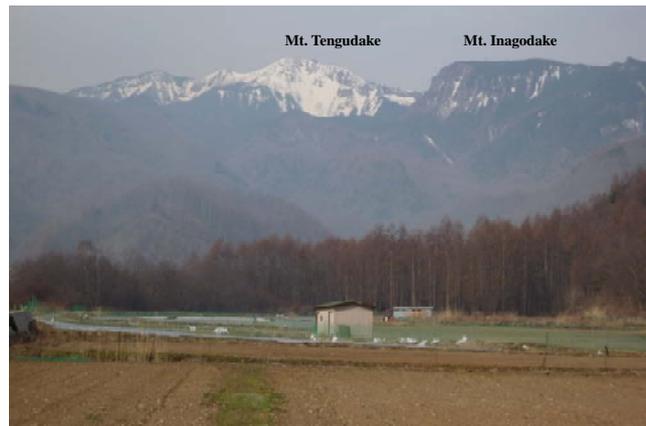
Photo 1 Terrain around the Otsuki River debris avalanche after a large-scale sector collapse in North Yatsugatake

debris avalanche amounted to 350 million m^3 . Photo 1 shows the terrain around the Otsuki River debris avalanche after the large-scale collapse at North Yatsugatake, Shinkai. We later estimated the volume of the horseshoe-shaped caldera as over 1 billion m^3 and postulate that this landform was a result of repeated debris avalanches as large as that which occurred in 887, along with volcanic activity such as phreatic explosions.

Mt. Inagodake remains at the head of the caldera as a massive moving rock body, with an approximately 1000 m long axis, 700 m short axis, 200 m height, and 140 million m^3 in estimated volume (Photo 1 and Figure 3). This moving rock mass may have been formed at the time of the mountain body collapse in 887. Alternatively the moving rock mass may have existed earlier and the mountain body collapse may have occurred on a large scale that included part of the rock mass. This moving rock mass is almost completely separated from the bedrock and may collapse significantly in the future as a result of earthquake activity, torrential rainfall, or post-volcanic activity.

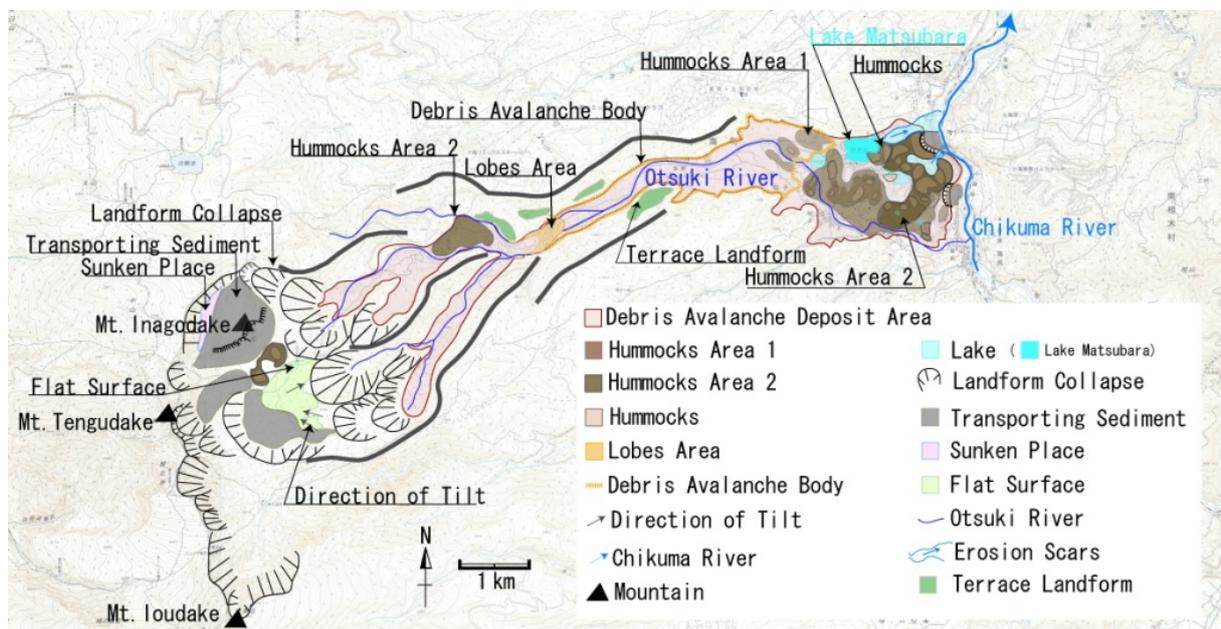
Fig. 3 Landforms of the Otsuki River basin (Machida et al., 2009; Inoue et al., 2012)

Interpretation of a 1/25000 topographic map and aerial photos; suggested that the altitude of the river bed at the point of the river channel blockage was 1000 m above sea level. Debris including avalanche sediment present along the Otsuki River and there are many mudflow hill landforms and lakes including Lake Matsubara, resulting from the debris avalanche. Figure 3 shows a landform classification

map of the Otsuki River basin. Considering the existing of extrusive landforms such as mudflow hills near Lake Matsubara, the inundation height was estimated to be 130 m. Tracing the contour line at this altitude results in an estimated inundation area and volume of approximately 13.5 km^2 and 580 million m^3 , respectively, which would make it one of the largest landslide dams known to have occurred in Japan. This landslide dam formed along the Chikuma River and had an extremely large inundation volume, which gradually collected water for about ten months. The dam eventually became filled during torrential rainfall in the rainy season. It suddenly failed 303 days later, causing a secondary debris avalanche. The water collected behind the landslide dam flowed for over 100 km down the Chikuma River as massive flood waves, which resulted in flooding and the deposit of the Ninna Flood sand. Table 2 shows ruins covered with Ninna Flood sand [Inoue et al., 2010; Kawasaki, 2010].

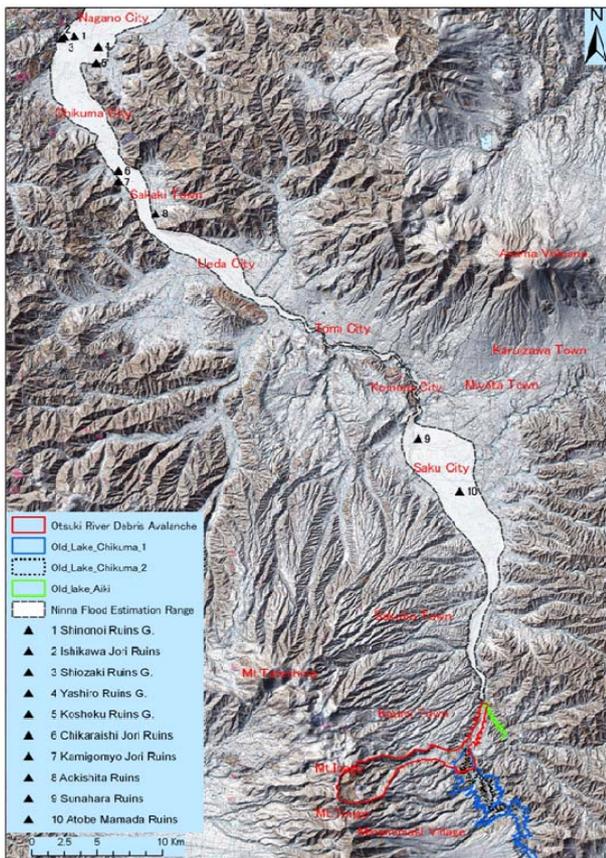
**Fig. 4** Extent of the Otsuki River debris avalanche, landslide dam and flood-distribution of sites covered with Ninna Flood sand (Inoue et al., 2011)

Figure 4 shows the extent of the Otsuki River debris avalanche, the landslide dam, and the flood distribution, estimated based on the sites covered with Ninna Flood sand. Assuming the landslide dam reservoir had filled for 303 days (26.1 million seconds), the average rate of inflow from the upper reaches of the Chikuma River can be calculated as 22.2 m^3/s (the catchment area upstream is 353 km^2).

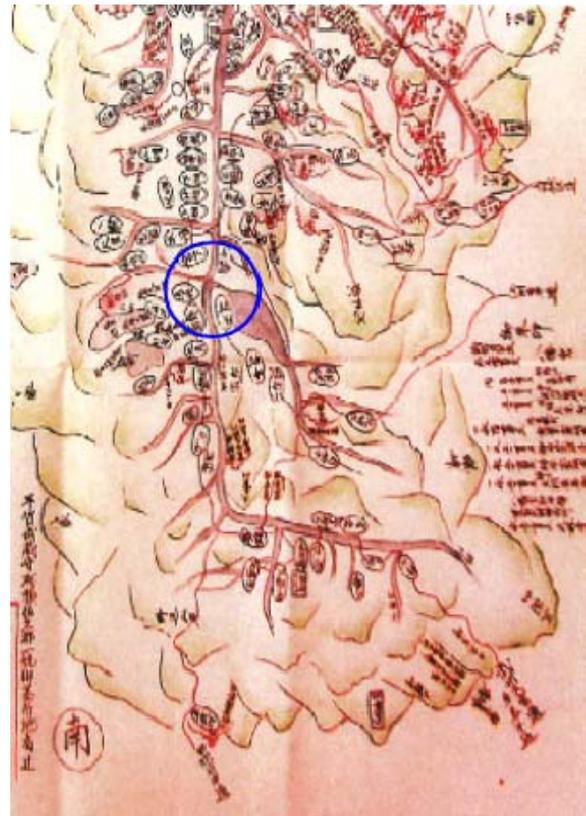
Fig. 5 Map showing the southern part of Saku in Kurumizawa Map (owned by Ryuichi Kurumisawa)

Figure 5 presented a map of the southern part of Saku in Kurumizawa showing Old Aiki Lake (blue circle).

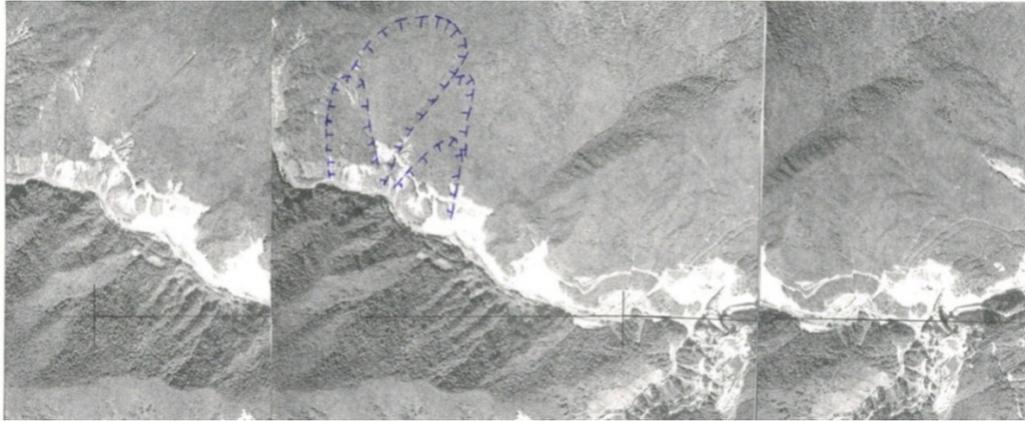
Photo 3 Tobata landslide before the impounding of Lake Azusa (Photographed on 20 Sept. 1968)

Photo 3 is an aerial photograph showing the Tobata landslide before the impounding of Lake Azusa. This area is composed of Mino Terrane rocks of the Jurassic Period. The local geology consists of an alternation of chert and sandstone/mudstone, striking roughly in the northeast-southwest direction [Otsuka & Nemoto, 2003]. A few faults also run in the same direction, together with fractured zones ranging from several tens of centimeters to several meters in width.

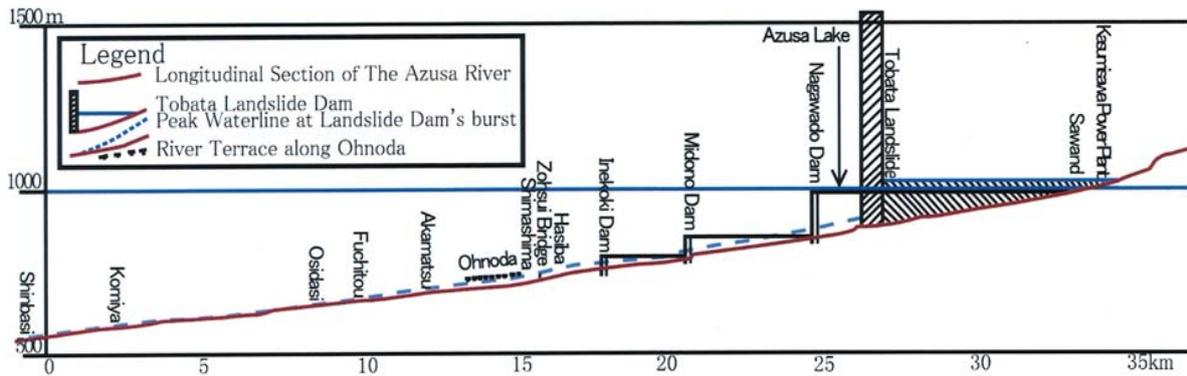
Fig. 6 Longitudinal section of Azusa River and Location of Tobata Landslide dam reservoirs and hydropower dam reservoirs (Mori et al., 2007; Inoue et al., 2008)

In the Azusa River, three dams –the Nagawado, Midono, and Inekoki dams– were completed in 1969 by a power generation company and have since been producing hydropower. The Nagawado Dam is an arch dam, 155 m high, and Lake Azusa, with a total storage capacity of 123 million m³, is its dammed lake. Figure 6 shows the location of the Nagawado Dam and the Tobata landslide in the upstream section of the Azusa River.

Figure 7 shows a longitudinal section of the Azusa River in the upstream area of the Shinano River and the location of the Tobata landslide dam

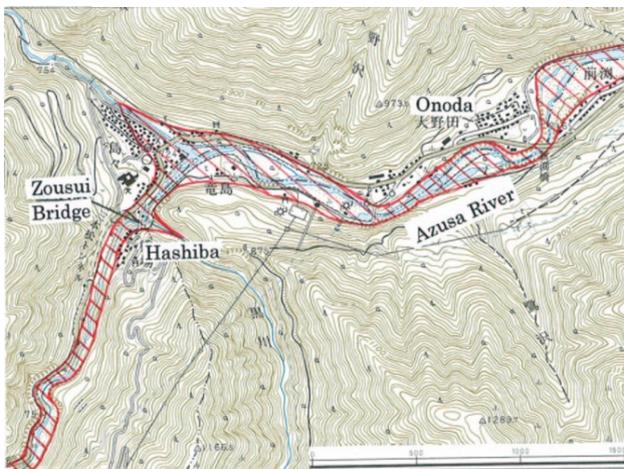
Fig.7 Estimated range of outburst flood 12 km downstream of the landslide dam (Mori et al., 2007)

Figure 7 shows the outburst flood area at 12 km downstream of the landslide dam. The Zousui Bridge, which was 14.4 m above the water level and 34.2 m long, was located 12 km downstream [Azumi Museum of Matsumoto City, 2006]. The bridge was washed away by the flood, suggesting that the water depth at peak flow was 20 m.

According to calculations using Manning’s formula, it was estimated that the flood water flowed down the river in a concentrated path with a velocity of 12 m/s and a peak flow of 27,000 m³/s.

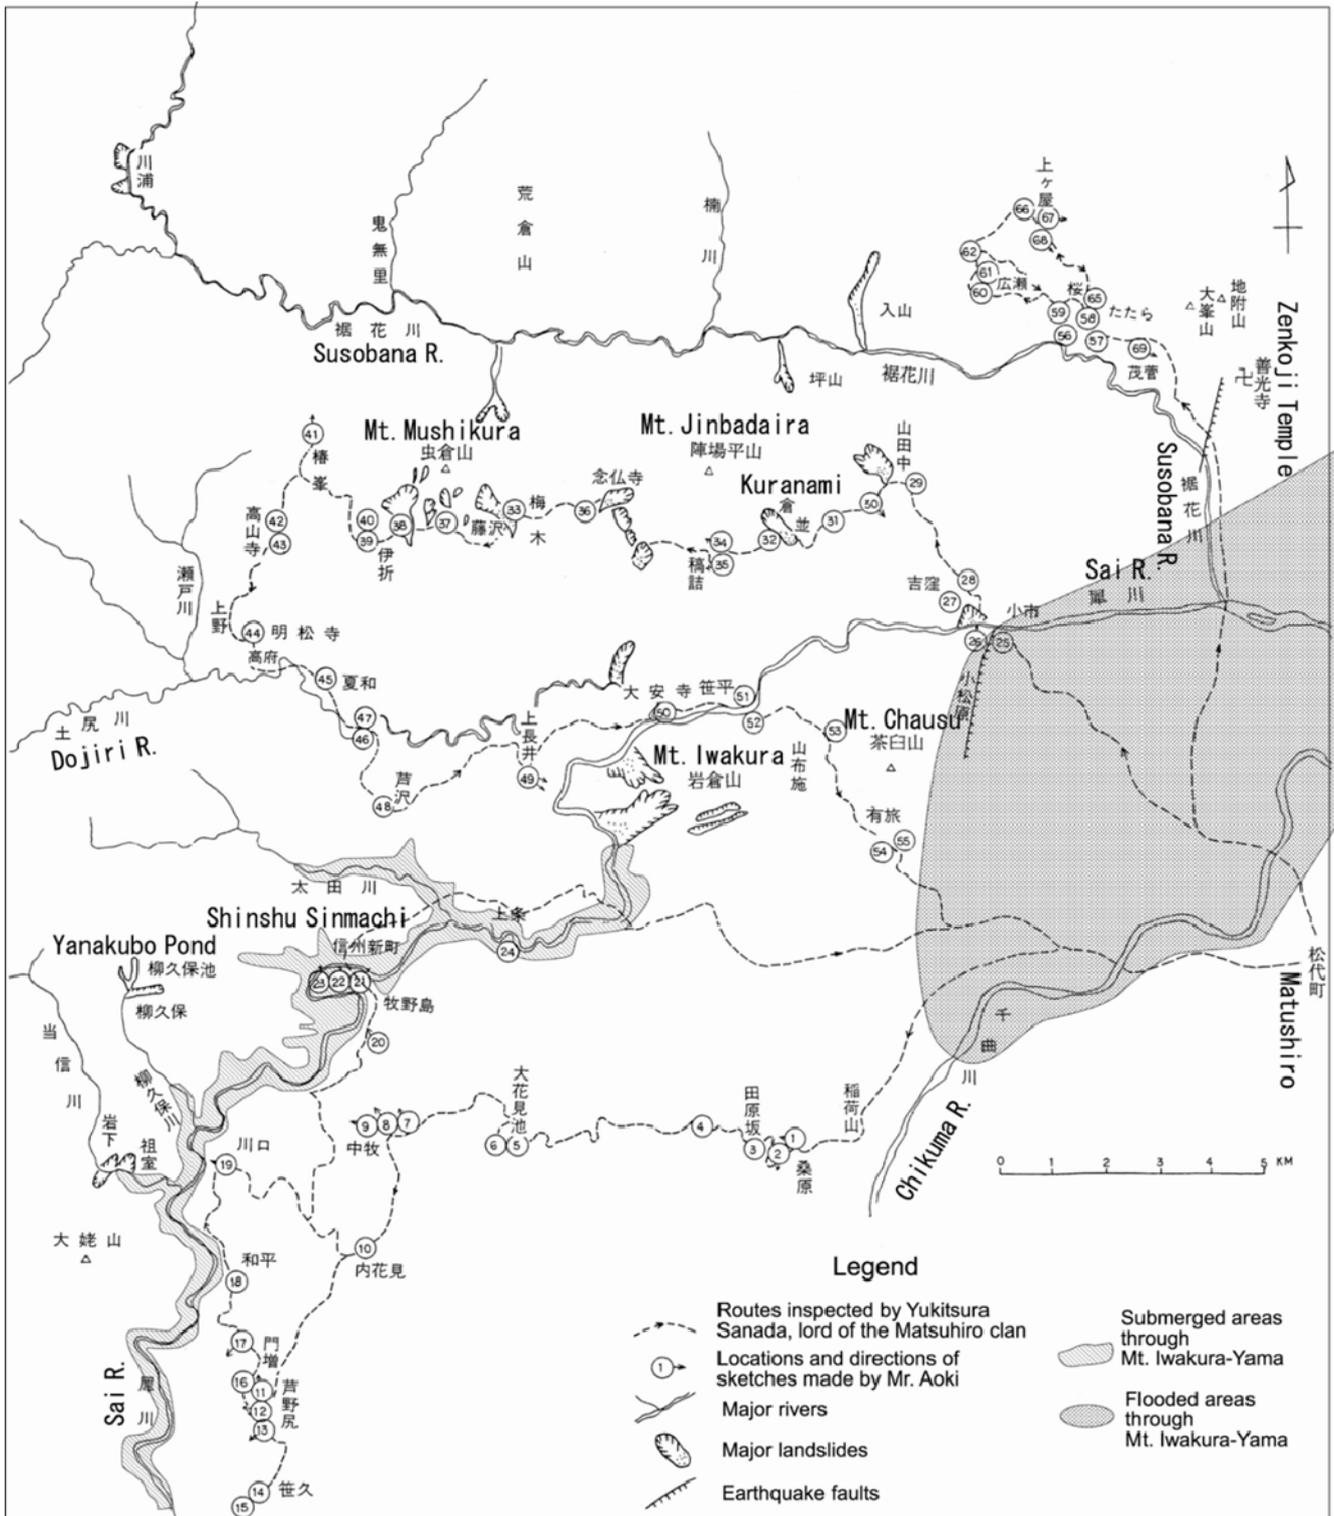
Fig.9 Mt. Iwakura landslide dam, outburst flood area and sketch point of painter Sekkei Aoki (Zenkoji Earthquake Disaster Study Group, 1994, Inoue et al., 2008)

Chuetsu (Mid-Niigata) Earthquake on 24 October, 2004. Figure 9 shows the Mt. Iwakura landslide dam and the outburst flood area. The largest landslide resulting from the Zenkoji Earthquake, with an estimated sediment movement of 20 million m³, occurred at Mt. Iwakura and created a large landslide dam which blocked the midstream section

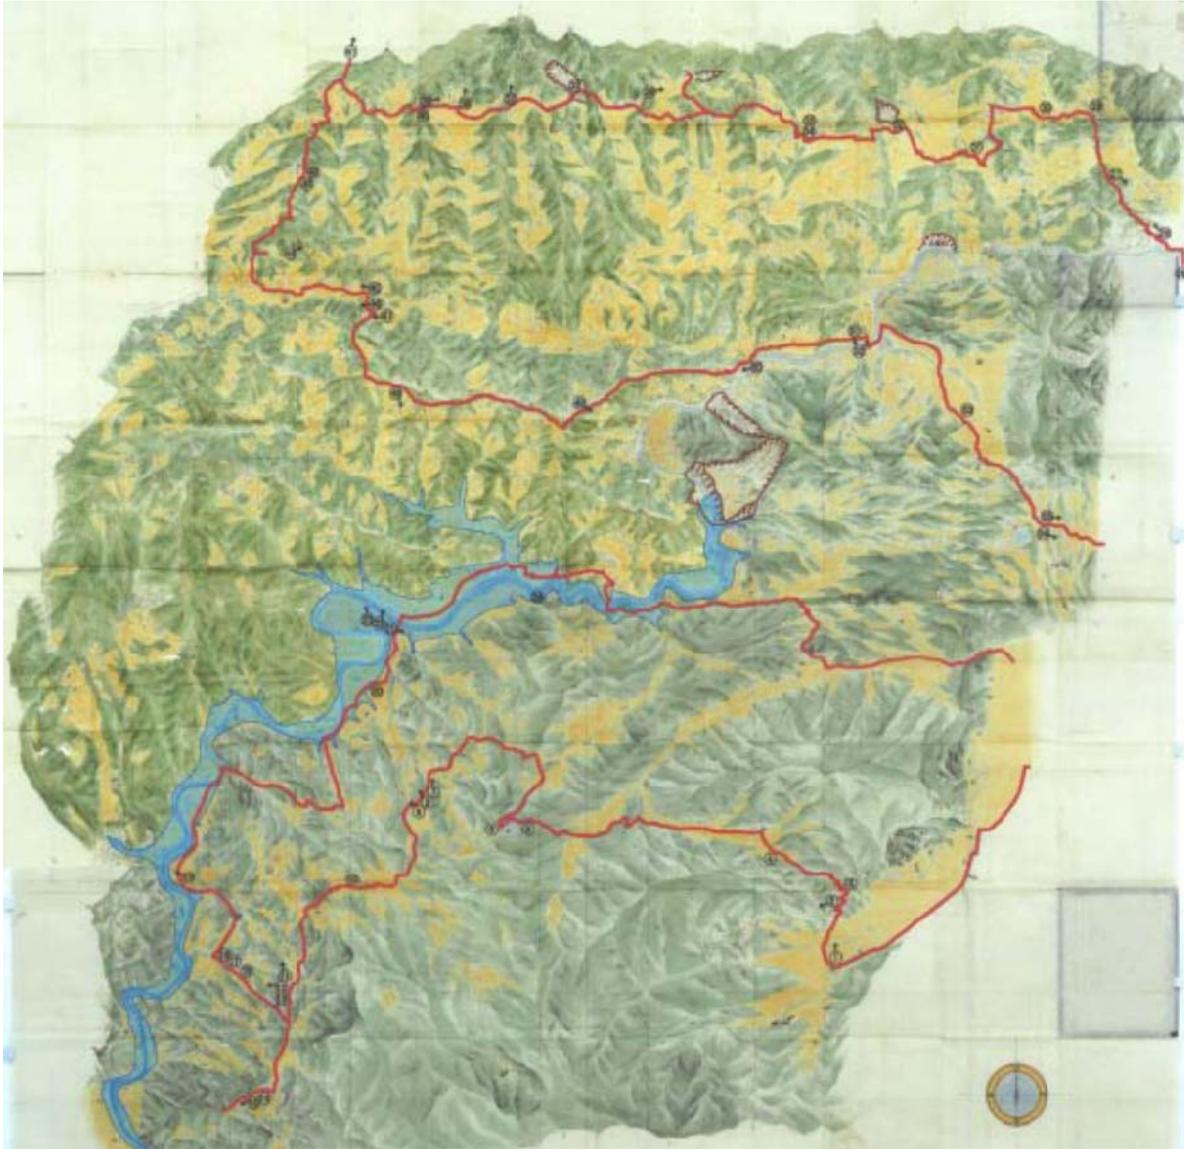
Fig. 10 Maps No.3 and No.4 from the Matsushiro Territory Survey (Kyoto University Museum)

the Matsushiro Territory Survey. These maps (eight sheets in all) were drawn five years after the earthquake and are owned by Kyoto University Museum. Red lines on the maps indicated the course of the inspection tour by the party of Yukitsura Sanada. The blue area was submerged by the Iwakura landslide dam. Figure 11 is a close up view of the Mt. Iwakura landslide dam area in map No.4 of the Matsushiro Territory Survey.

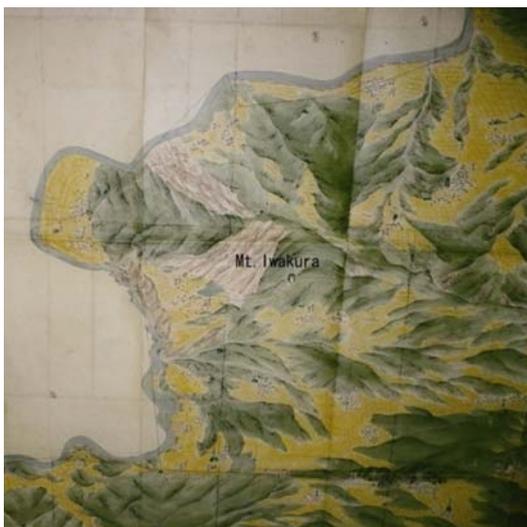
Fig. 11 Mt. Iwakura landslide dam mapped by the Matsushiro Clan in 1852, five years after the earthquake (Kyoto University Museum)

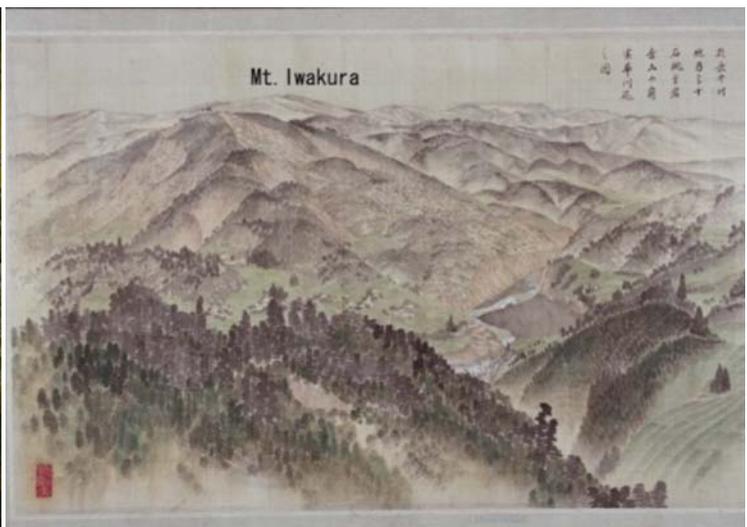
Fig. 12 Mt. Iwakura landslide dam sketched by Sakkei Aoki, (sketch No. 49) in 1849, two years after the earthquake (Sanada Museum in Nagano City)

Sekkei Aoki also sketched the Mt. Iwakura landslide, in 1849 two years after the earthquake, as shown in sketch No.49 in Figure 12. Figure 13 presents a topographical map of the Mt. Iwakura landslide [Zenkoji Earthquake Disaster Study Group, 1994], Figure 14 shows a longitudinal section of the Iwakura landslide [Nakamura et al., 2000; Inoue et al., 2008]. Although the river blockage was only 65 m high, the water volume reached as much as 350 m³. The water level reached its maximum 16 days after the landslide, fed by abundant water supply from melted snow (the average flow rate was 254 m³/s). The water gradually began to overflow from the top of the dam, eroding the 1,000 m-long mass of debris. The landslide dam finally collapsed on the 19th day. The

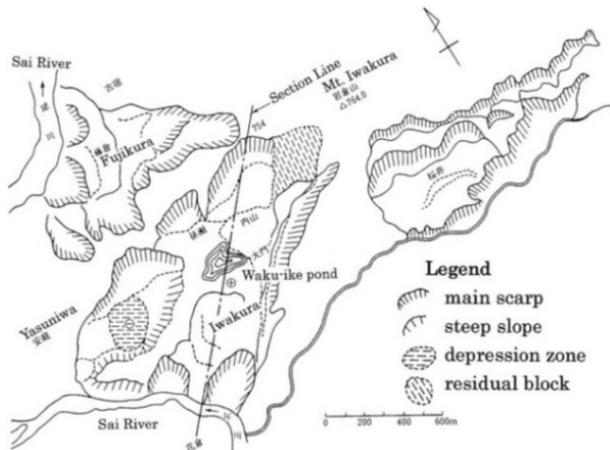
Fig. 13 Topographical map of Iwakura Landslide (Zenkoji Earthquake Disaster Study Group, 1994)

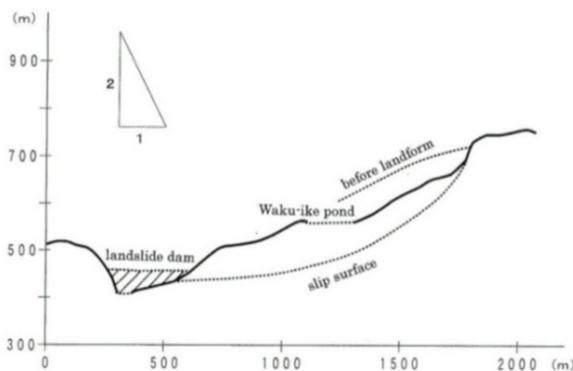
Fig. 14 Longitudinal Section of Iwakura Landslide (Nakamura et al., 2000; Inoue et al., 2008)

resulting flood reached a height of 21 m and a peak flow of 34,000 m³/s, damaging downstream area that are now part of Nagano Prefecture.
