THE FORMATION AND OUTBURST FLOODING OF THE LARGEST LANDSLIDE DAM ON THE YATSUGATAKE VOLCANO IN JAPAN

Kimio Inoue¹, Toshio Mori¹ and Takahisa Mizuyama²

Keywords: landslide dam, Yatsugatake Volcano, debris avalanche, outburst flood

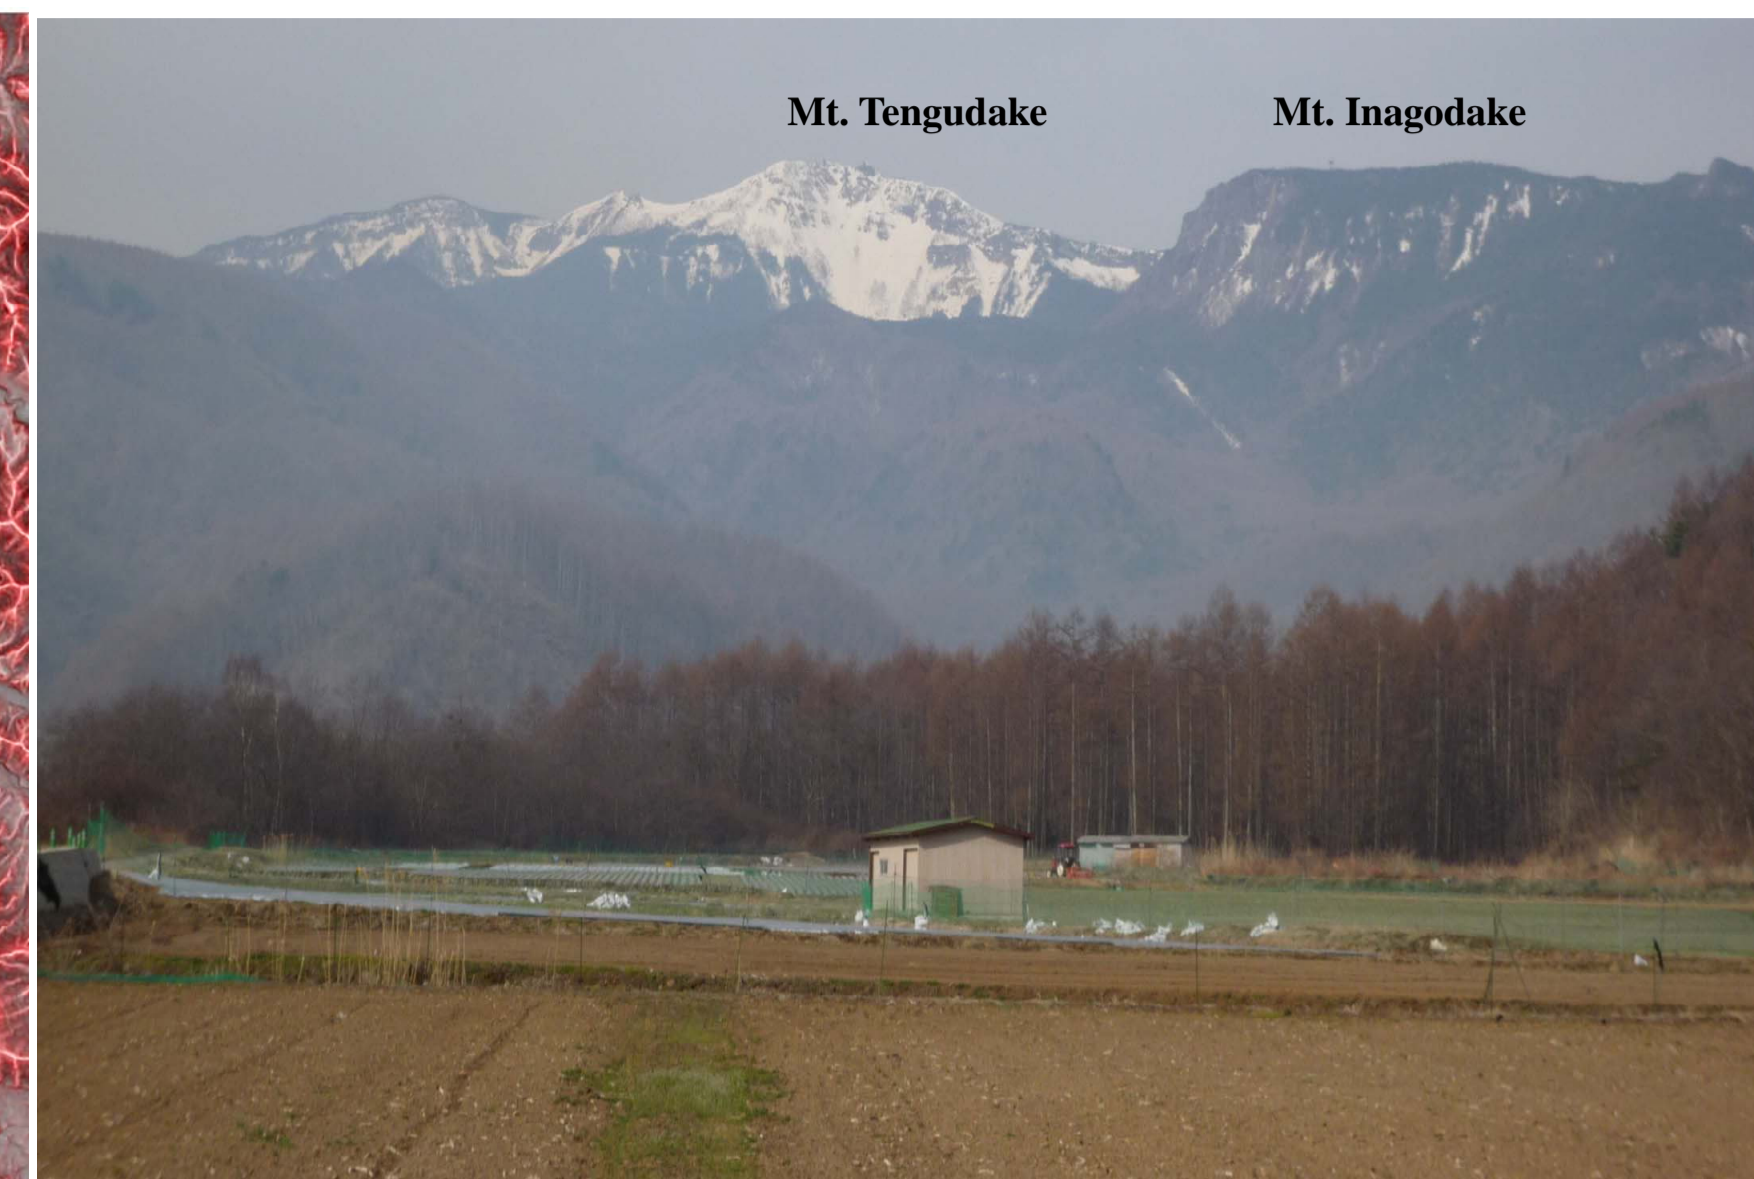
Photo 1 Terrain after large-scale sector collapse of Kita Yatsugatake at Shinkai on the Otsuki River Debris Avalanche (photo by Inoue)

Mt. Inagodake remains at the head of the caldera as a massive moving rock body of about 1000 m in long axis, 700 m in short axis, 200 m in height and 140 million m³ in estimated volume (Photo 1). This moving rock mass may have been formed at the time of the mountain body collapse in 887. It may also be the case that the moving rock mass had existed earlier and that the mountain body collapse may have occurred on a large scale that included that part of the rock mass. This moving rock mass contains a wind cave and is almost completely separated from the bedrock. The moving rock mass carrying Mt. Inagodake, which still exists, may collapse significantly due to future earthquakes, torrential rainfalls or post-volcanic activity, which may cause a new debris avalanche to block the channel of the Chikuma River and form a landslide dam.

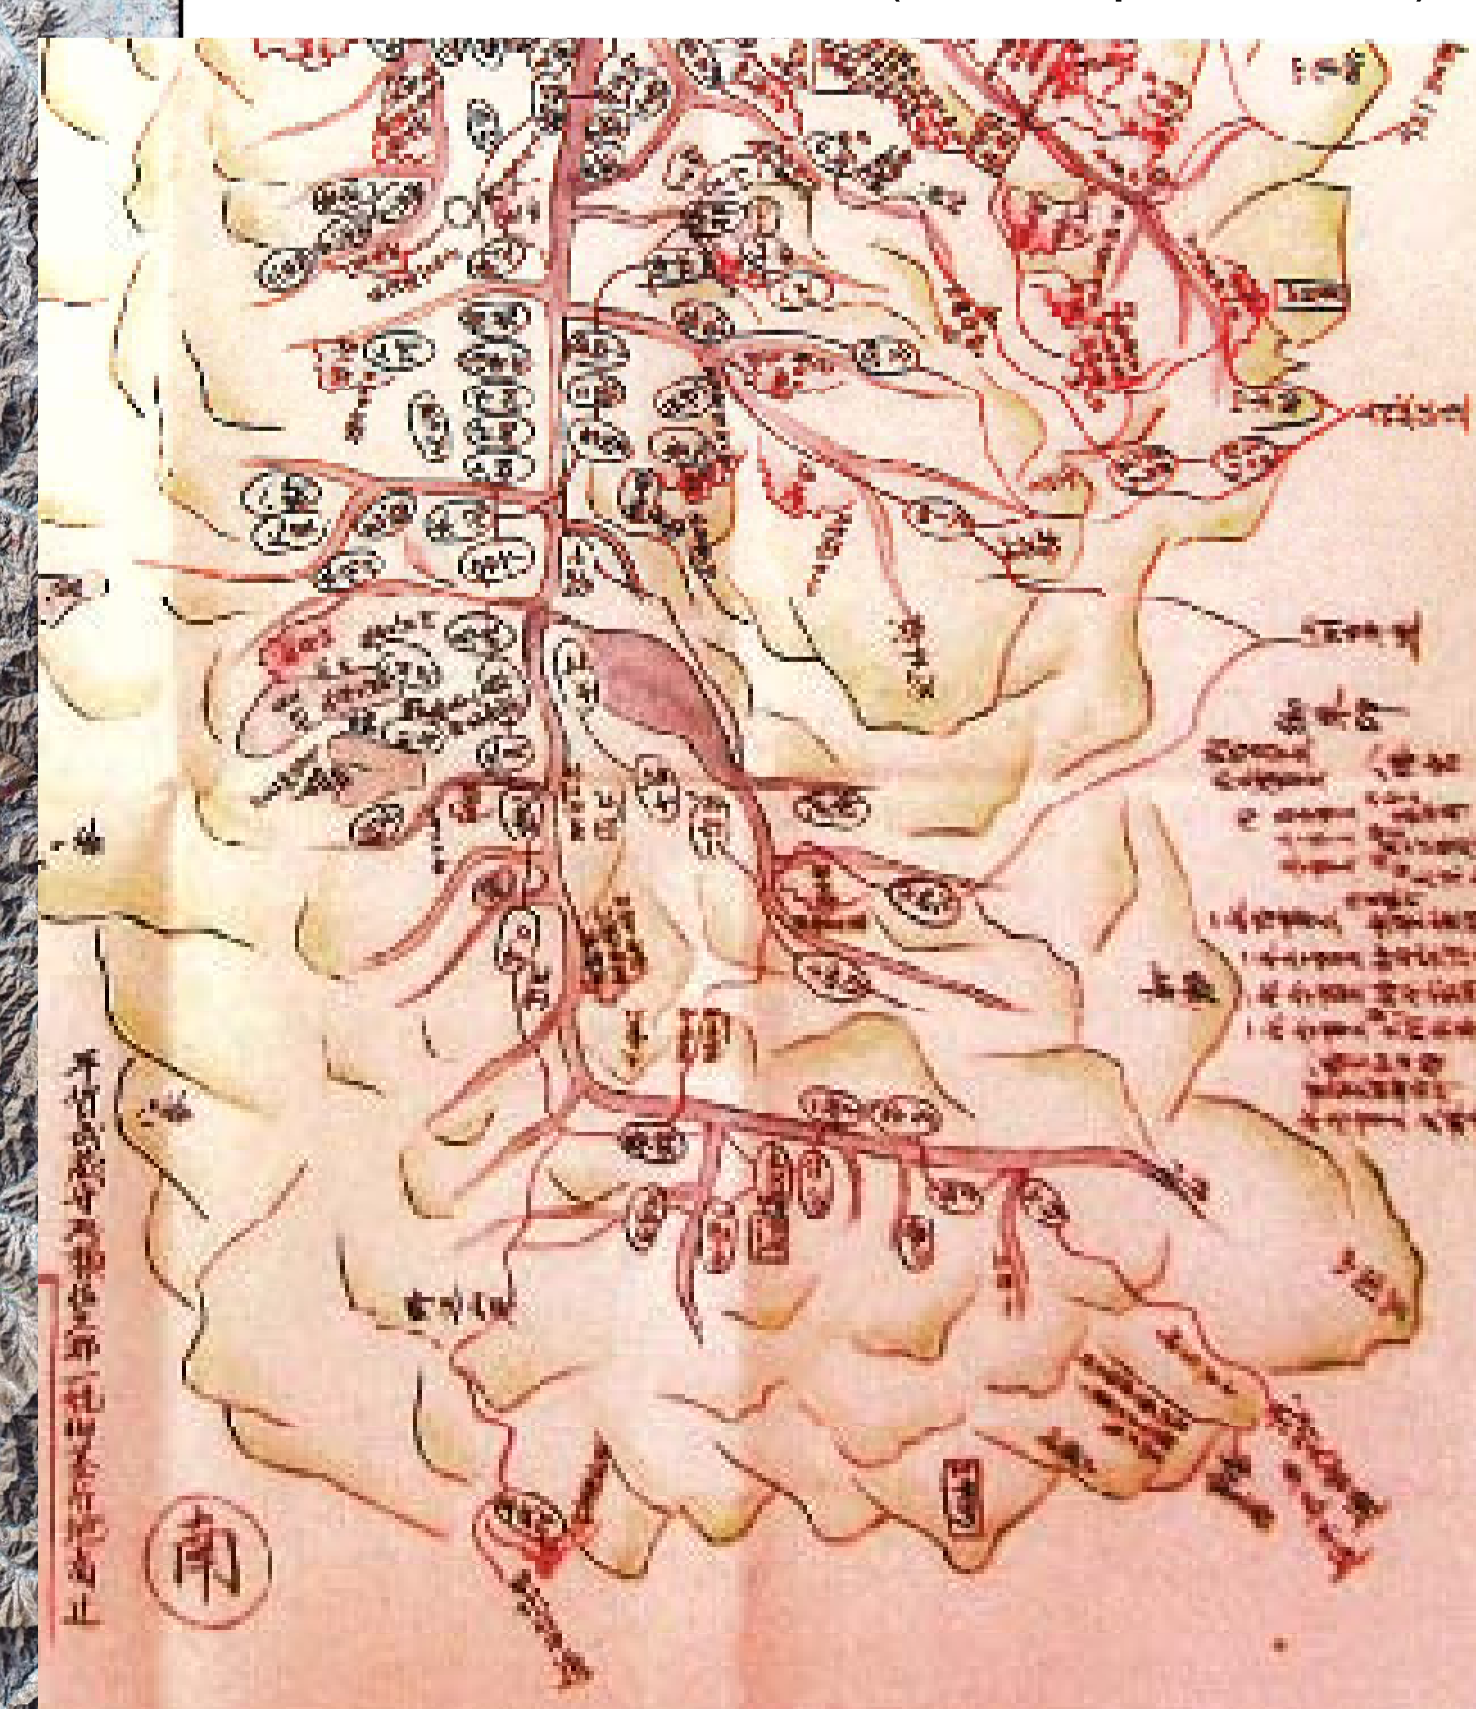
Figure 4 Southern part of Saku in Kurumisawa Map (owned by Ryukichi Kurumisawa)

A considerable amount of literature has been published in relation to the Yatsugatake Volcano Otsuki River Debris Avalanche and Ninna Flood and there have been many discussions that include the 887 and 888 theories. As explained above, the phenomena mentioned in literature can be explained by a theory that the large-scale landslide dam of 130 m in height (with an inundation volume of 580 million m³) that was formed took as long as 303 days to be filled before it could fail. The failure caused a secondary debris avalanche, which blocked the Aiki River near Koumi and formed Old Lake Aiki (that remained for over 600 years). Although Old Lake Chikuma 1 collapsed, Old Lake Chikuma 2 of 50 m in height remained for 123 years (Photo 2). Various place-names that still exist in the upper reaches of the Chikuma River could be construed as records of these landslide dam phenomena (Figure 4).
