IMPROVING WIRE NET DAMS AND CAPTURING RESULTS

Shigekiyo Tabata¹, Masaaki Watari², Hiroshi Moriyama³, Kazuhito Shimojo⁴

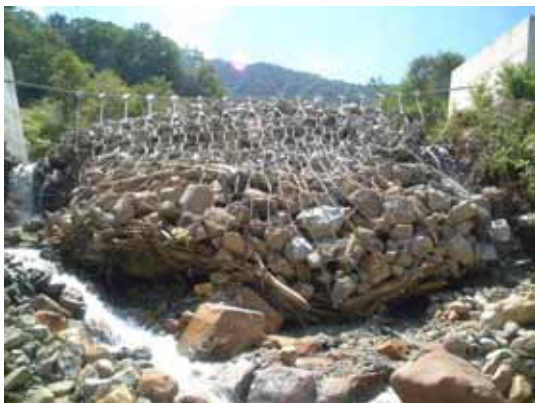
Photo 1 : Situation of capturing debris flow (Front view)

Photo 1 shows the situation of capturing the debris flow as taken from the downstream side, and **Photo 2** shows the same from the right bank. **Photo 3** shows a longitudinal section of sediment deposited.

1) It can be seen from **Photo 1** that the wire net dam is filled up with sediment. And, when also considering that little sediment was observed deposited downstream, it can be said that

1) It can be seen from **Photo 1** that most of the rings have been deformed almost uniformly. It can be considered from this that the debris flow load has dispersed among all of the rings; thus, it can be said that the improvement produced the expected effect.

4) As can also be seen in **Photos 1** and **2**, almost all of the sediment was captured, therefore, it can be considered that the estimated debris flow load and soil pressure were correct.
