# TWO LARGE-SCALE LANDSLIDE DAMS AND OUTBURST DISASTER IN THE SHINANO RIVER, CENTRAL JAPAN

Kimio Inoue <sup>1</sup>, Toshio Mori <sup>2</sup>  
& Takahisa Mizuyama <sup>3</sup>

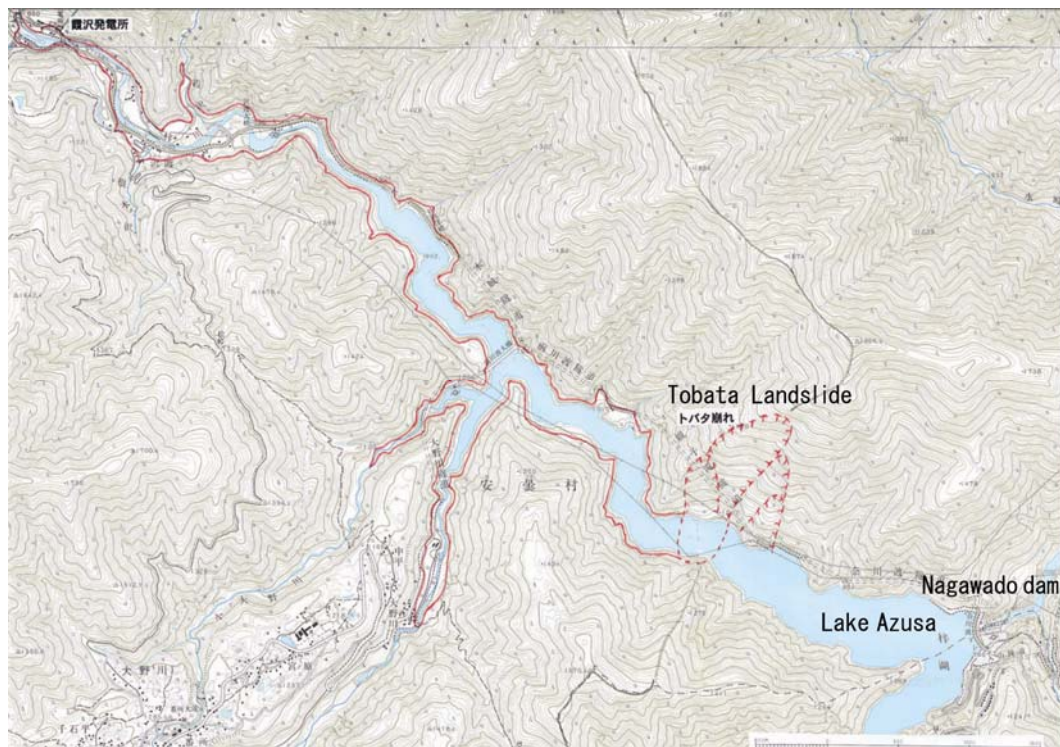
**Fig. 2 Nagawado Dam and Tobata Landslide upstream in the Azusa River**

At the Azusa River, three dams – the Nagawado, Midono, and Inekoki Dams – were completed in 1969 by a power generation company and have since been producing hydropower. The Nagawado Dam is an arch dam, 155 m high, having Lake Azusa with a total storage capacity of 123 millions m<sup>3</sup> as the dam lake. Fig. 2 shows the location of the Nagawado Dam and Tobata Landslide at upstream section of the Azusa River.

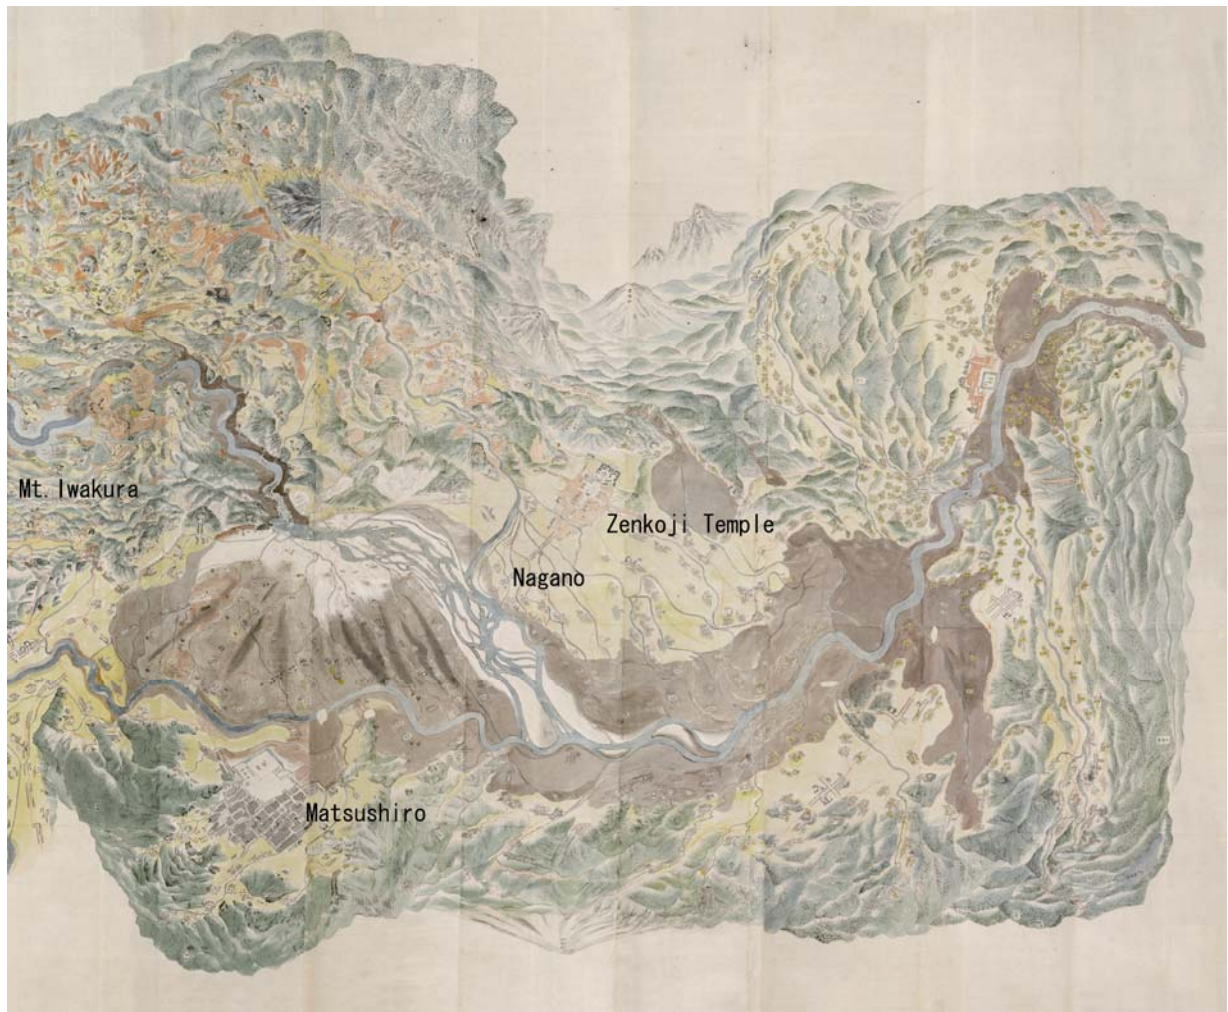
**Fig. 5 Large-scale Earthquake Disaster Map after 3 months of the earthquake**  
(Sanada Museum in Nagano City)

Immediately after the earthquake, Yukitsura Sanada, who was lord of the Matsushiro feudal clan at the time, ordered his men to draft a “Large-Scale Earthquake Disaster Map” (see to Fig. 5) and reported the state of damage to the Edo feudal government that was ruling Japan at that time. With support from this feudal government, the Matsushiro clan started a disaster restoration effort. Two years later, the lord himself made an inspection tour of his territory and ordered the renowned painter Sekkei Aoki to make 67 sketches of the earthquake damage (see to Fig. 6). After about four to five years when the first stage of restoration work ended, the lord also ordered the preparation of a land survey map, and eight large-size maps (1/6000 scale) collectively called the “Survey Map of the Matsushiro Territory” were completed (see to Fig. 7).

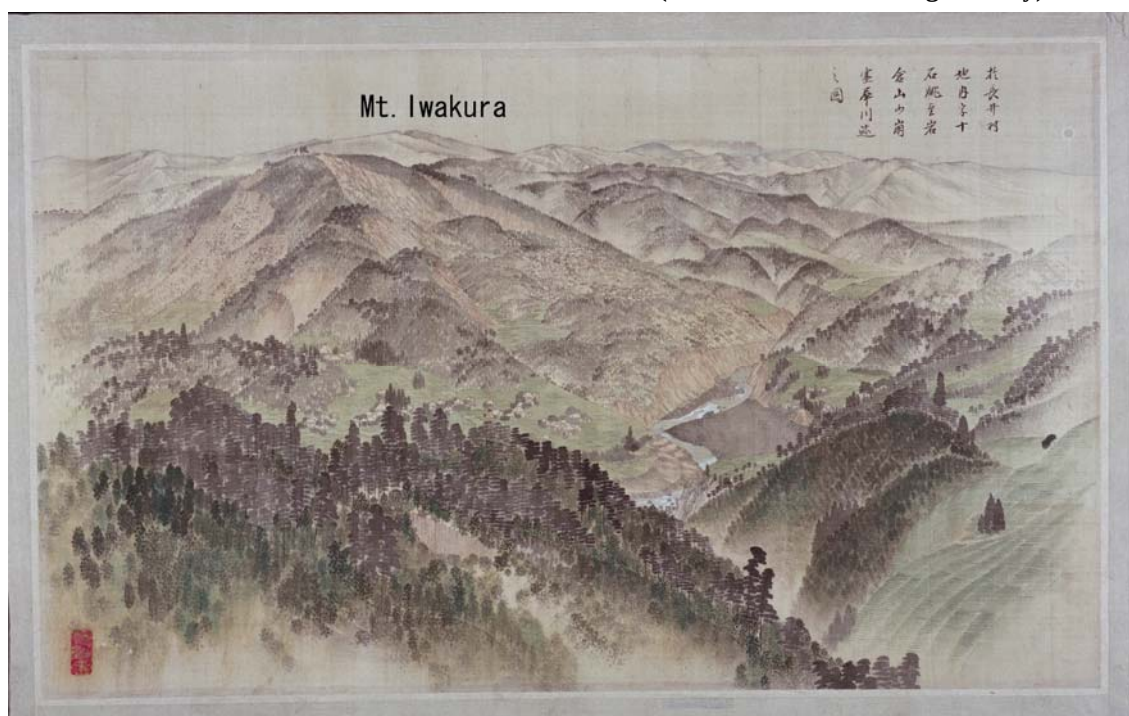
**Fig. 6 Mt. Iwakura landslide dam sketched by Sekkei Aoki after 2 years of the earthquake**  
(Sanada Museum in Nagano City)

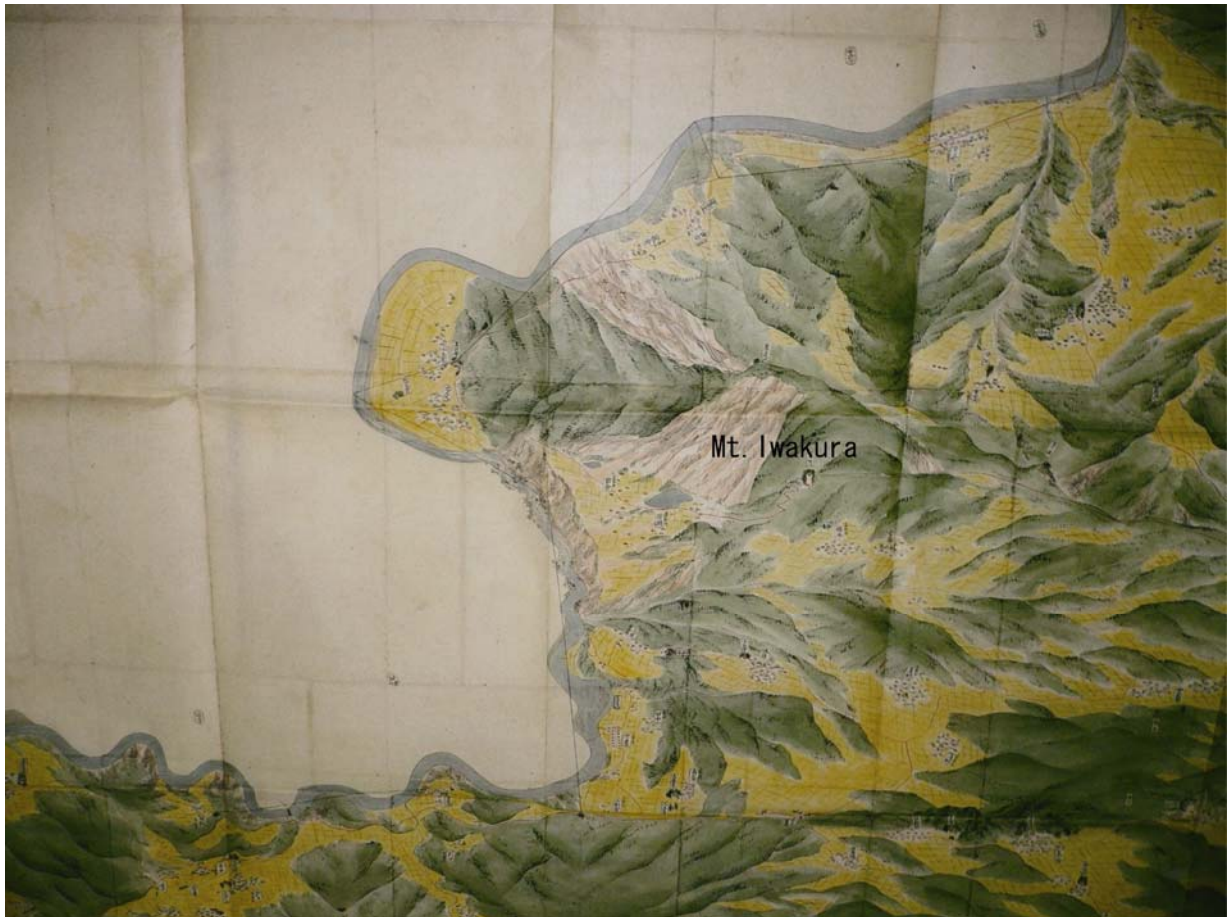
**Fig. 7 Mt. Iwakura landslide dam mapped by Matsushiro Clan after 5 years of the earthquake  
(Kyoto University Museum in Kyouto City)**
