Assessment of Existing and Potential Landslide Hazards Resulting from the April 25, 2015 Gorkha, Nepal Earthquake Sequence

Open-File Report 2015-1142

By Brian D. Collins and Randall W. Jibson

U.S. Department of the Interior
U.S. Geological Survey

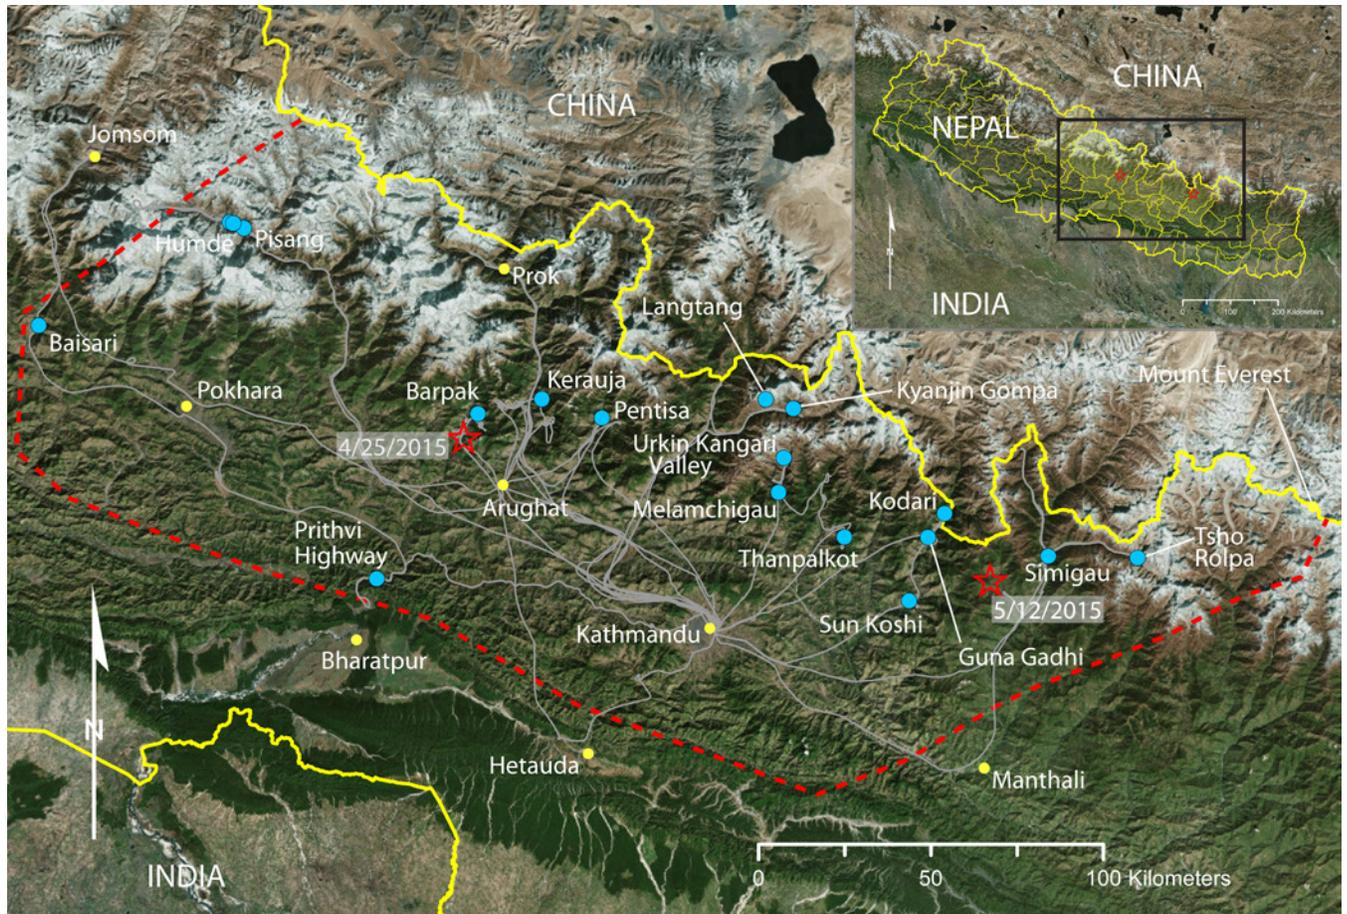
Limits of significant landsliding were observed in some of our traverses (fig. 8). To the west of the main shock epicenter, landslides were sparse or absent along most reaches of the Kali Gandaki valley (fig. 4), and we place a limit in that direction roughly along that valley. We flew south as far as Hetauda, at the boundary between the Himalayan foothills and flatter terrain (Terai region) to the south. Landslides in steep valleys north of Hetauda decreased in size and number as we flew south. The boundary of landslide-susceptible terrain was observed at about the point where it appeared that shaking had attenuated to a level at which few landslides were triggered, and so we place a southern landslide limit along the mountain front where the Himalayan foothills begin. To the east of the main shock epicenter, the landslide limit is complicated by the occurrence of the *M*7.3 aftershock; in most cases, it is difficult or impossible to determine which earthquake triggered landslides in a specific area. During our reconnaissance, we observed evidence of a few recent rock falls in the Tsho Rolpa area of Dolakha district, but widespread landsliding was absent. However, we propose an eastern limit approximately 90 km to the east of Tsho Rolpa, in the vicinity of Mount Everest base camp, based on eye-witness accounts of rock falls and a fatal avalanche from the main earthquake shock. The actual landslide limit probably lies somewhere east of that location, but we have no specific evidence other than the reports from Everest base camp. The landslide limit to the north is undetermined because it lies in China, in which we did not perform reconnaissance. Based on these observed limits, we estimate the total area affected by landsliding in Nepal to be about 30,000 square kilometers (km²). The total landslide area is larger (perhaps by as much as 25 percent) because it extended into China; recent satellite-imagery mapping suggests that landsliding extended about 30 km into China from the border with Nepal (see, for example, <http://ewf.nerc.ac.uk/2015/06/30/updated-30-june-landslide-inventory-following-25-april-and-12-may-nepal-earthquakes/>) [last accessed July 14, 2015].

In general, landslide concentrations were highest near the epicenter of the main Gorkha, Nepal earthquake, but significant landslide concentrations extended about twice as far to the east than to the west. This likely was the result of the eastward-directed fault rupture of the main shock as well as the occurrence of the *M*7.3 aftershock east of the main shock.

Figure 8. Regional map of central Nepal showing approximate limits of landslides (red dashed line) resulting from the April 25, 2015 Gorkha, Nepal earthquake and subsequent aftershocks (including $M7.3$ earthquake on May 12, 2015). Locations of select areas where landslide hazard assessments were performed are indicated by blue dots. Major earthquake epicenters with dates are represented by red stars. Select city place names (smaller yellow dots) are included for geographic reference. Yellow lines show political boundaries.

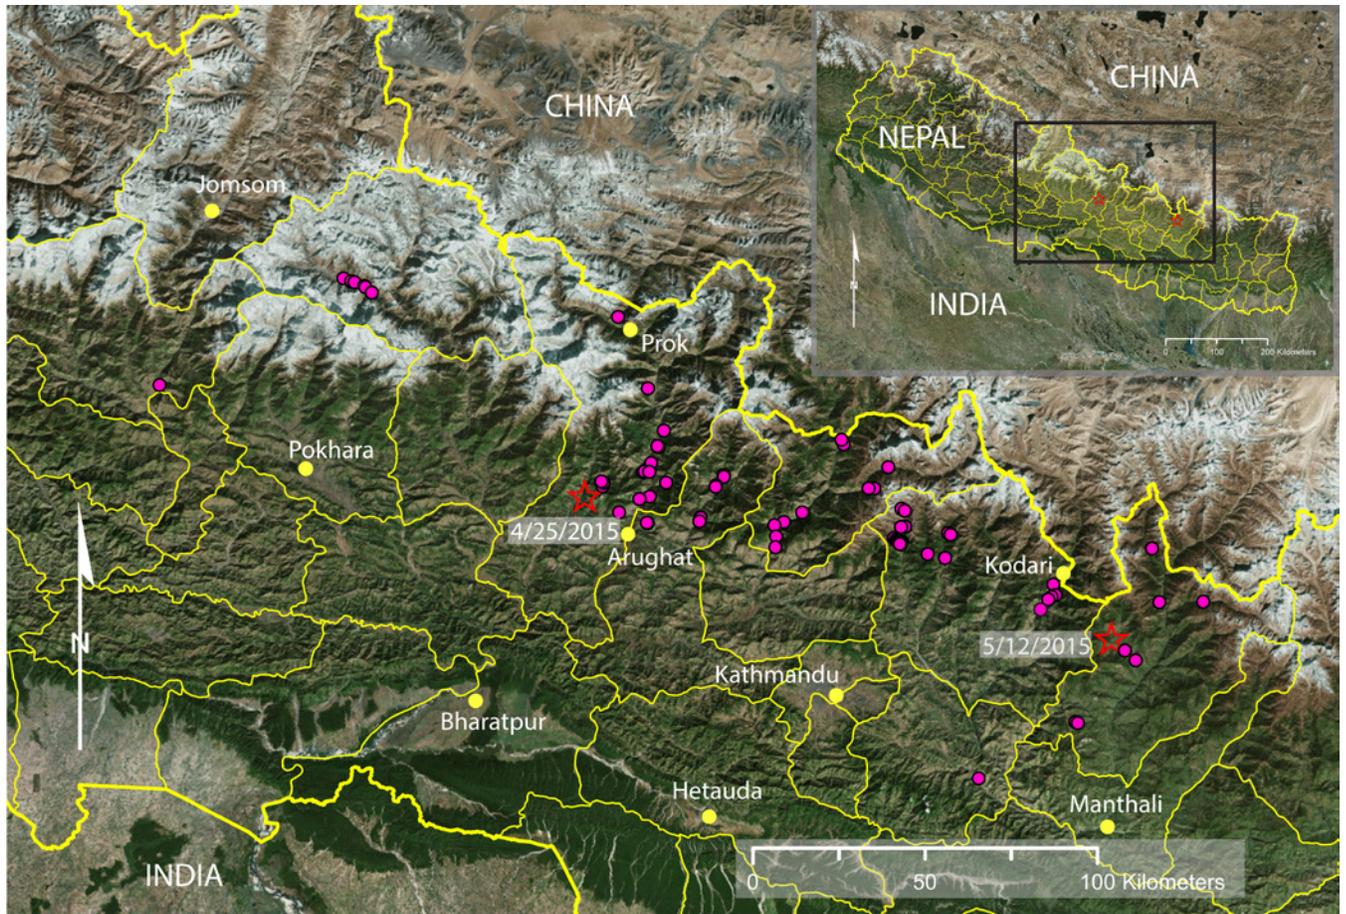
We assessed 74 landslide dams in the earthquake-affected region (table 1; fig. 9). This inventory is not complete and only reflects those features identified during our helicopter-based assessments and subsequent analysis of our data sets. We limited our evaluations to landslides that dammed named rivers or significantly large tributaries listed on official topographic maps published by the Government of Nepal’s Survey Department. Dams ranged in volume from 500 to 2,000,000 cubic meters (m^3), averaged approximately 50,000 m^3 and had a median volume of 6,000 m^3 (fig. 10A). The average is skewed towards the high end due to a single large landslide—the Langtang debris avalanche (described in a subsequent section). Only half of the dams had lakes impounded either because rivers were dry at the time of the earthquakes or, more commonly, because the dams had already been breached. For those with impounded lakes, the lake surface areas ranged between 50 and 35,000 square meters (m^2) and averaged 1,500 m^2 . Only 18 dams had lakes exceeding 500 m^2 in surface area. The lack of dams having large impoundments (that is, those $>500 m^2$ in surface area) at the time of our assessment (May 27–June 1, 2015) is a welcome observation given the statistics for landslide dams. Using a database of 73 natural

Figure 9. Regional map of central Nepal showing locations of valley-blocking landslides (pink dots) identified during helicopter- and satellite-based reconnaissance (see table 1). Some dots are obscured due to close proximity with other landslides. Major earthquake epicenters with dates are represented by red stars. Nepal district boundaries are indicated by yellow lines. Select city place names (yellow dots) are included for reference.

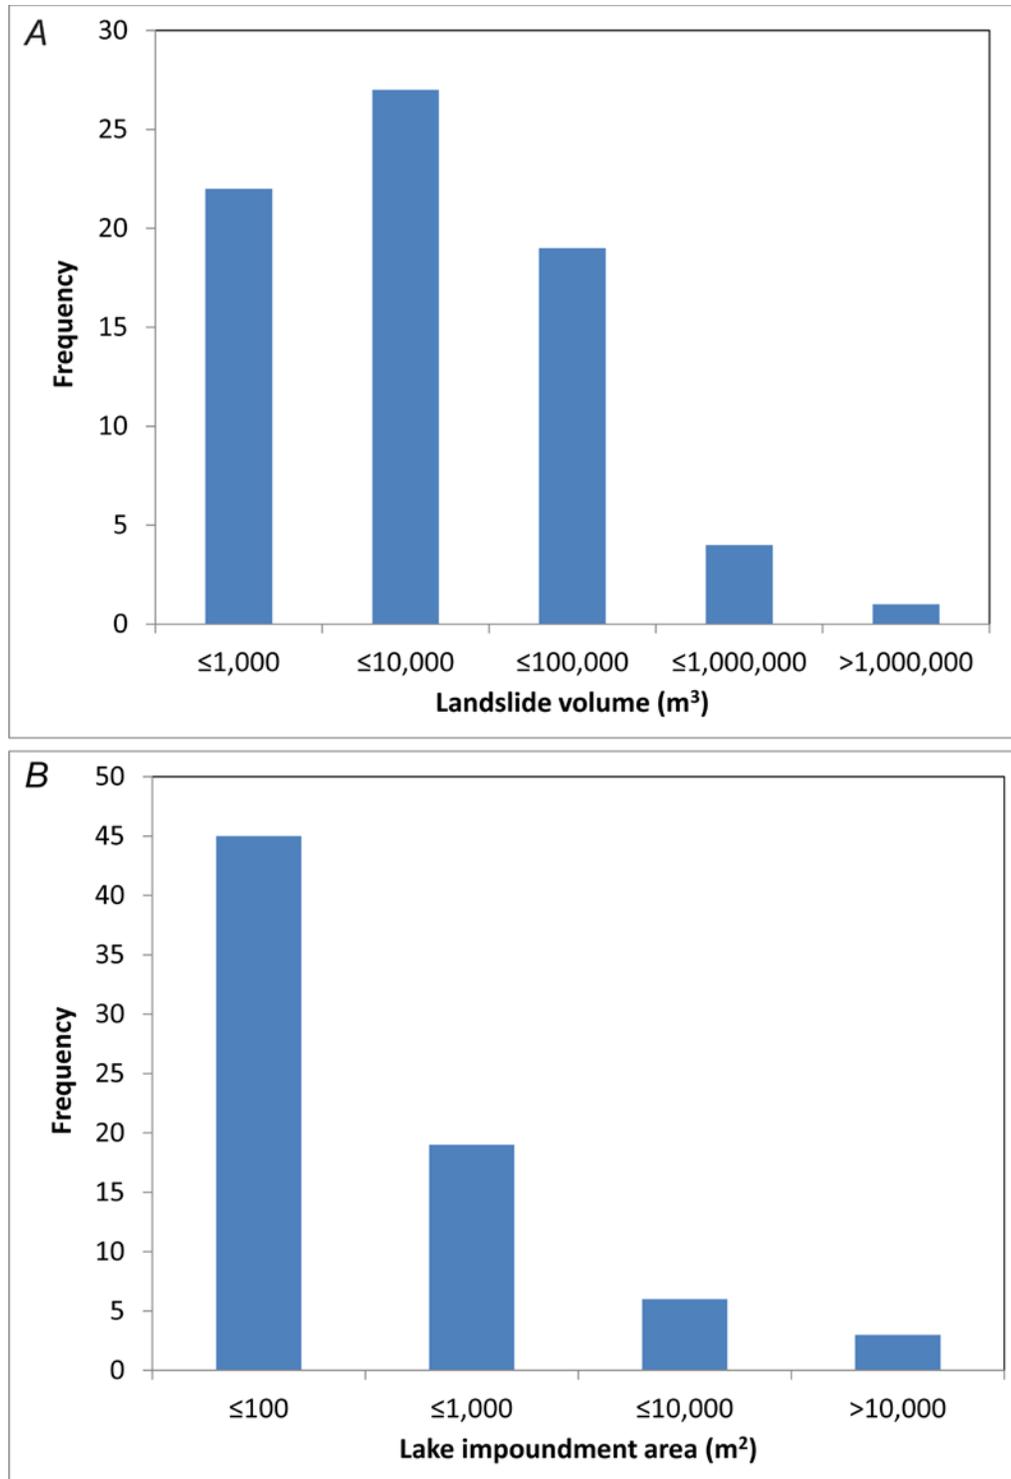
Figure 10. Histogram plots of valley-blocking landslide volume (A) and valley-blocking landslide lake impoundment (B) at the time of our assessment (May 27 to June 1, 2015), approximately one month following the main earthquake. Some dams without impoundments currently drain water through the dam debris or had dry rivers at the time of assessment.
